Prospect Reservoir #1  
Refurbishment

**Addendum One**

# Site Investigation and Condition Assessment Report

Reservoir 1  
40 Fort Hill Road  
Devonshire

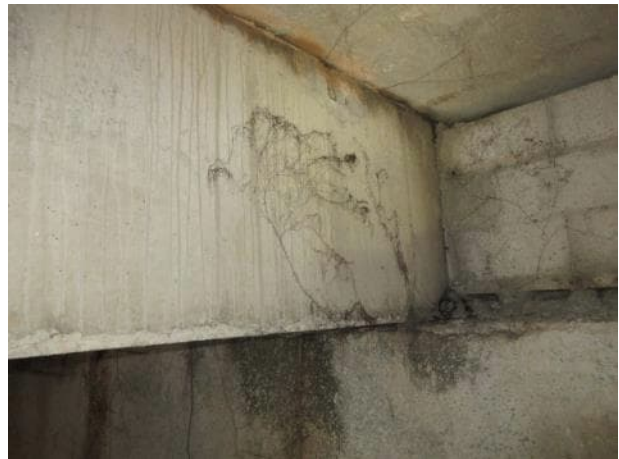
Photo 5.1.14. North bearing B2. Small roots observed.

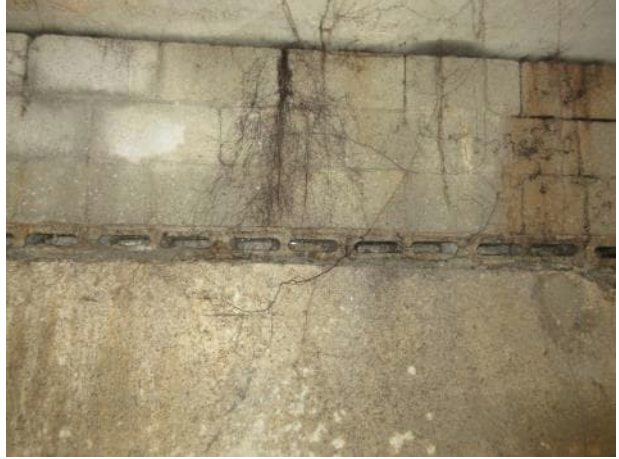
Photo 5.1.24. North Bearing area between B3 and B4. Roots observed growing into concrete block.

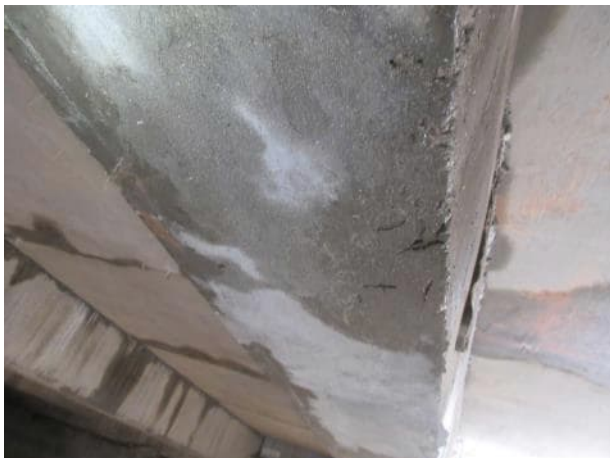
Photo 5.1.27. Old repair under B4.

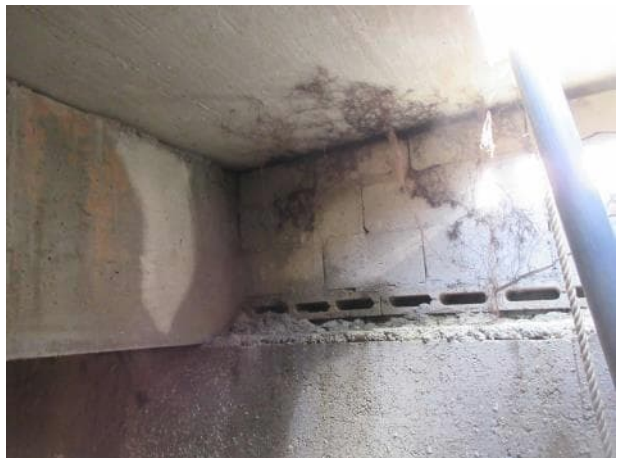
Photo 5.1.28. Beam B4 north bearing. Roots visible.

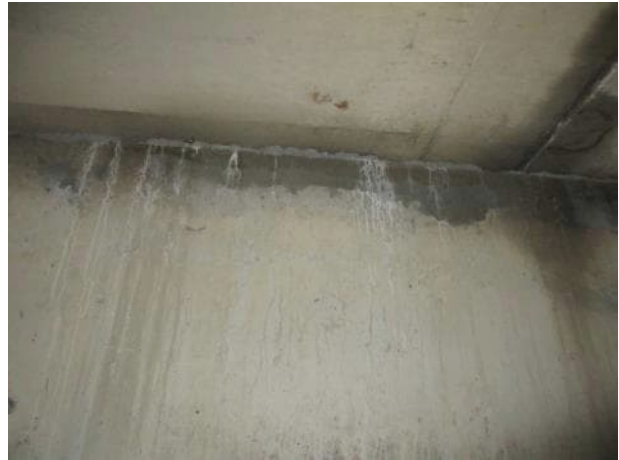
We noted that there were numerous leaks through the roof slabs. This has left staining and deposits on the beams but the leaks did not appear to cause any detrimental effects to the structure.

Photo 5.2.2. Water ingress and staining B6.

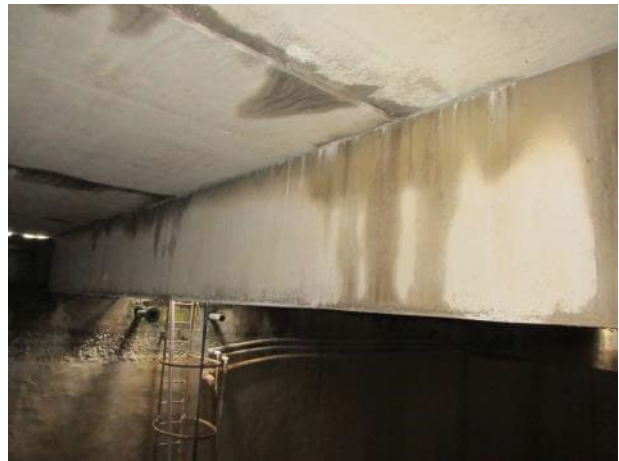
Photo 5.2.10. B7 with water ingress staining.

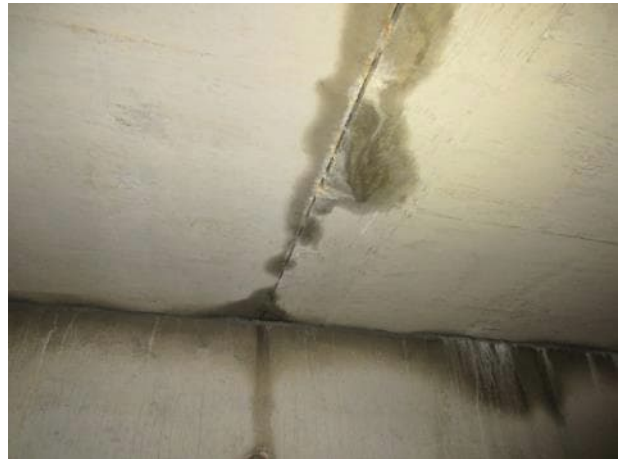
Photo 5.2.12. Water and staining visible under slab.

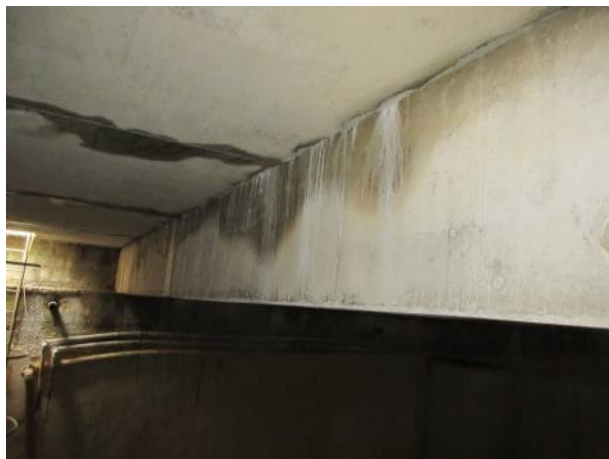
Photo 5.2.16. Beam B8 with staining visible from water ingress.

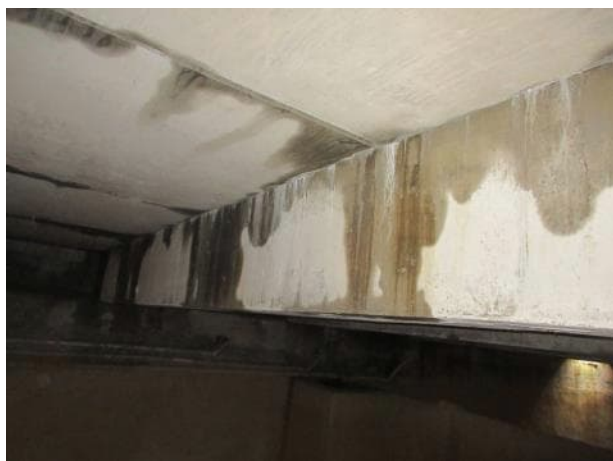
Photo 5.2.21. B9 with staining visible.

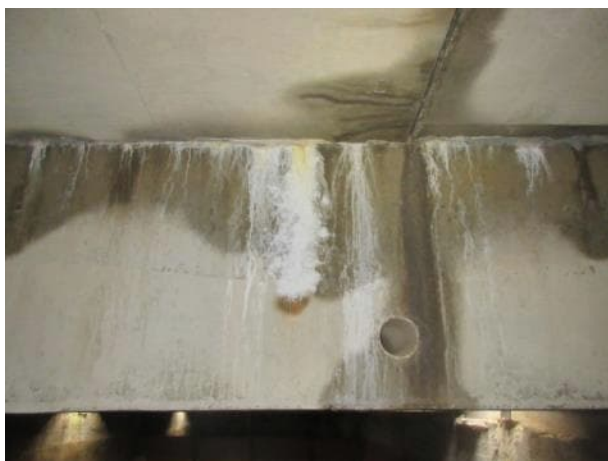
Photo 5.2.22. B9 with staining from water ingress.

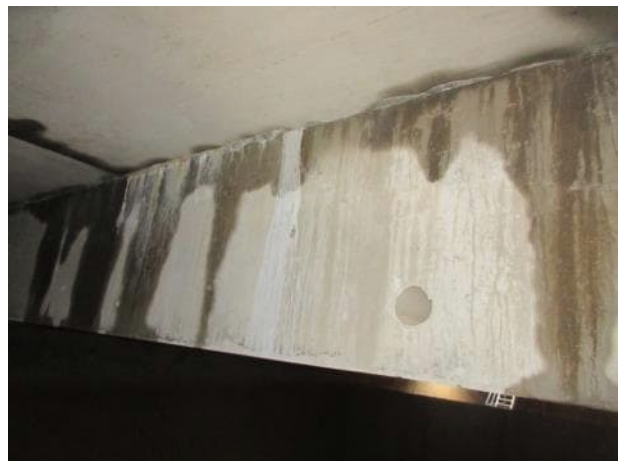
Photo 5.2.36. B9 with water staining visible.

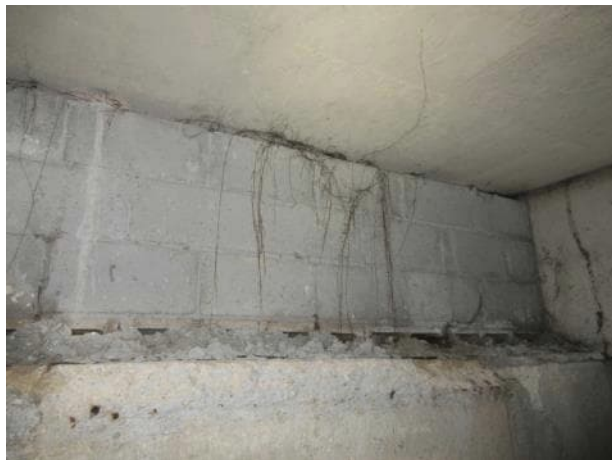
Photo 5.2.37. North bearing area between B8 and B9. Roots visible.

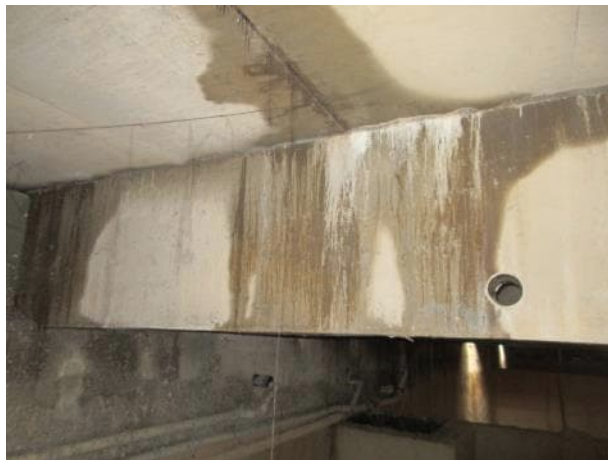
Photo 5.2.38. Deposits and staining on north side of B9.

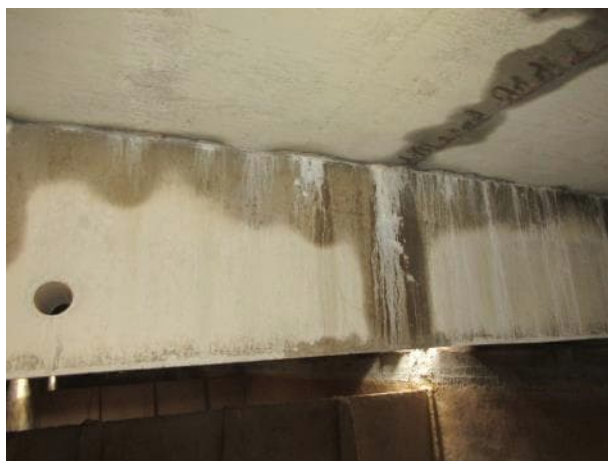
Photo 5.2.42. B8 staining and water ingress.

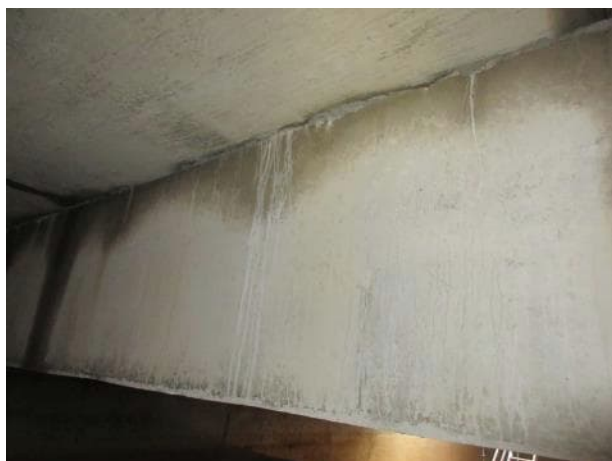
Photo 5.2.45. B7 with water staining.

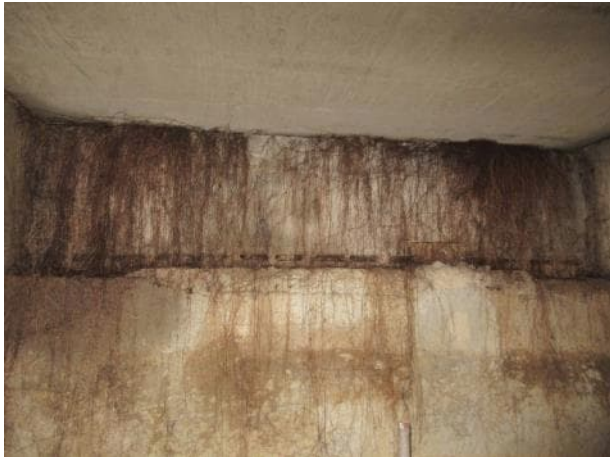
Photo 5.3.1. North bearing between B11 and B12.  
Roots observed.

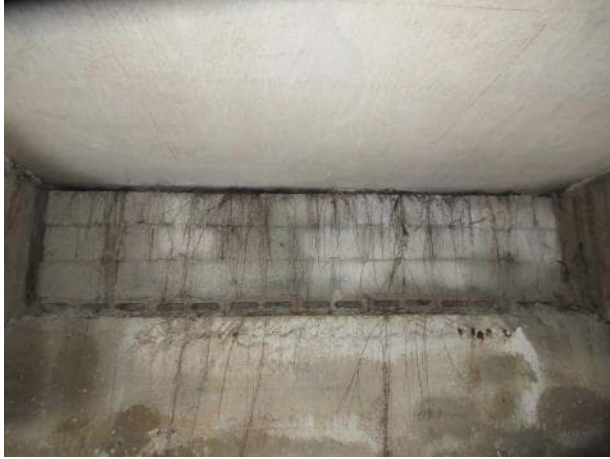
Photo 5.3.23. North bearing area between B14 and B15. Tree roots observed.

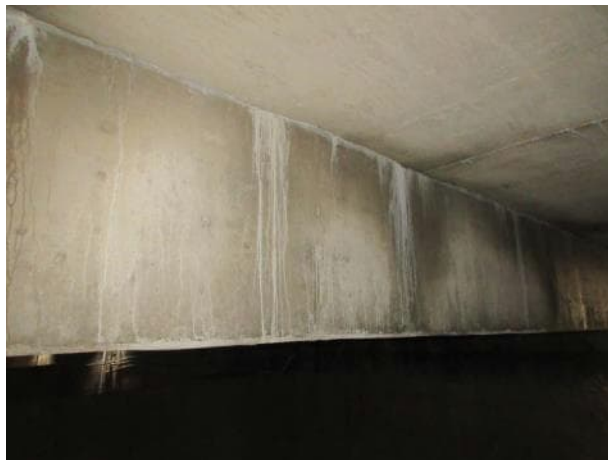
Photo 5.3.42. Beam B13 with staining visible.

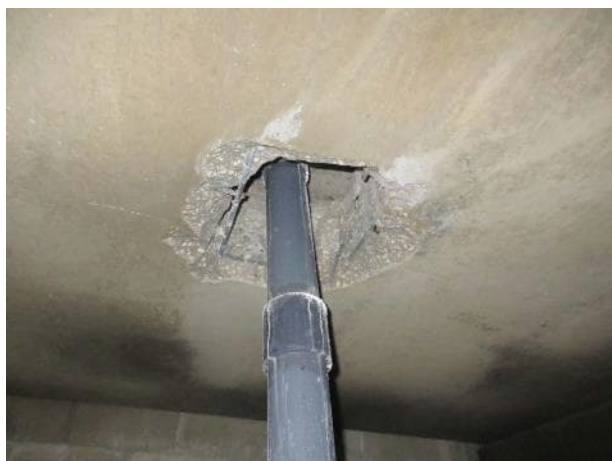
Photo 5.3.43. Opening created in the slab between B13 and B14.

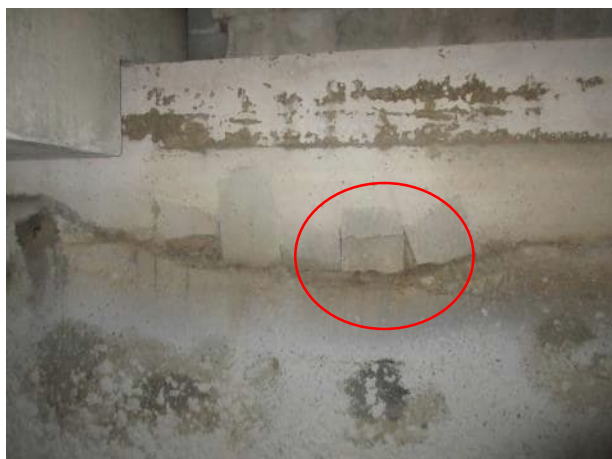
Photo 5.3.45. Minor damage to concrete block between B13 and B14.

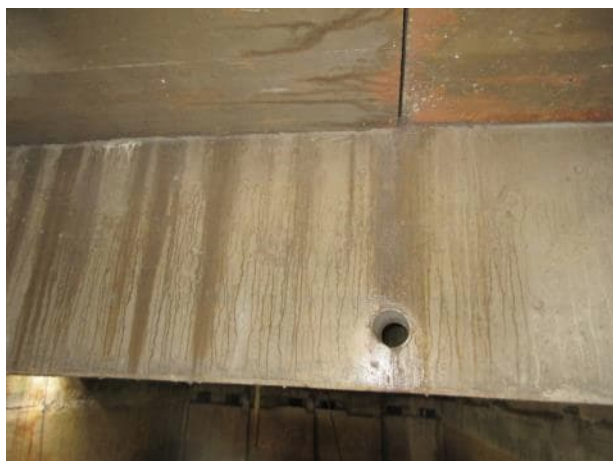
Photo 5.3.51. Beam B15 with active leaks visible.

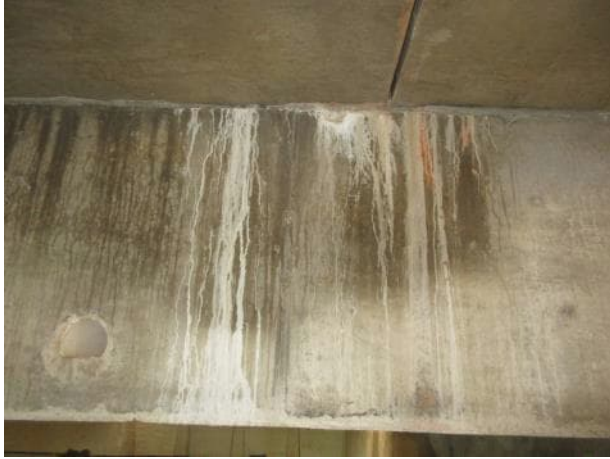
Photo 5.4.11 Staining on B17.

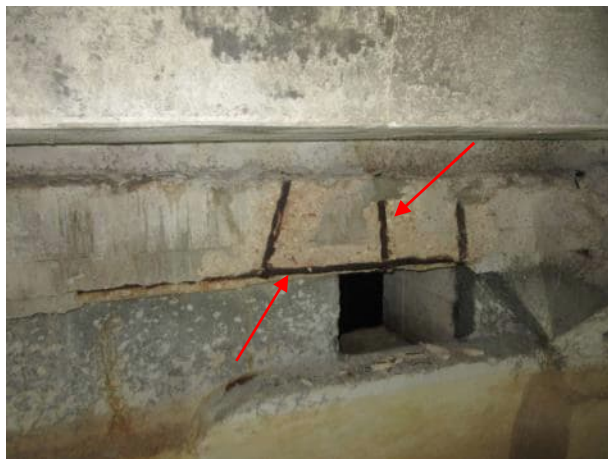
At the eastern end of the reservoir, an older reinforced concrete beam was positioned over the overflows into Reservoir 2. Two areas of spalled concrete and corroded reinforcing steel were observed. The beam appeared to be part of the original reservoir construction.

Photo 5.4.32 Corroded reinforcing steel at the eastern edge beam.

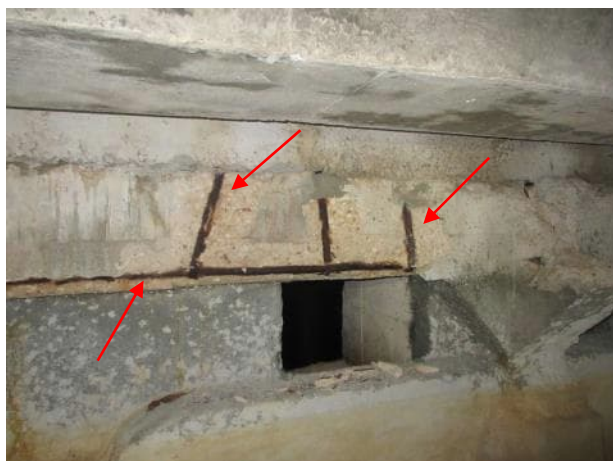
Photo 5.4.33 Corroded reinforcing was observed.

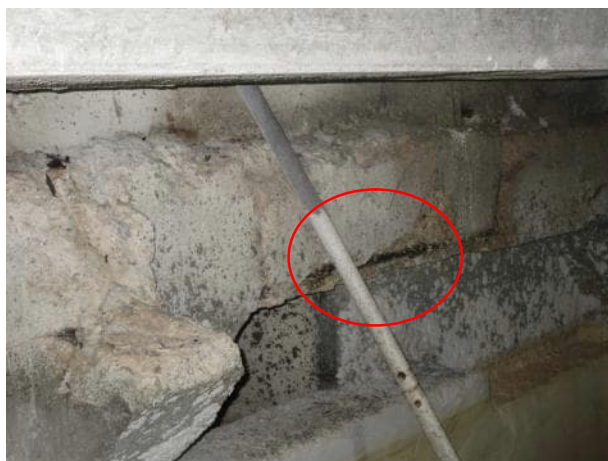
Photo 5.4.34 Corroded reinforcing at eastern edge beam.

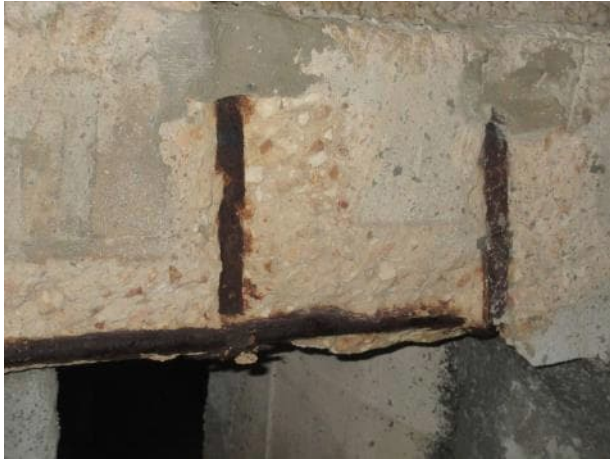
Photo 5.4.35 Corroded stirrups.

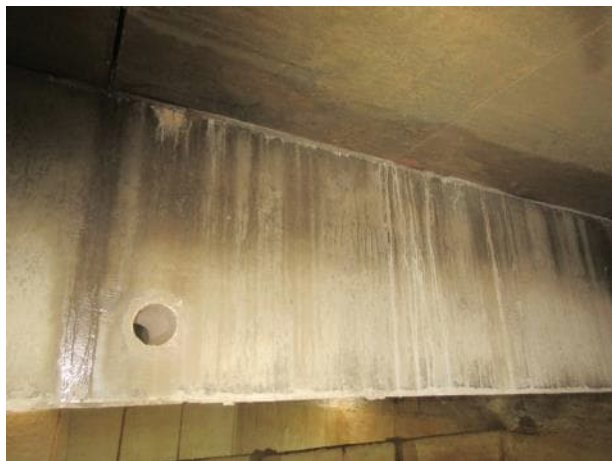
Photo 5.4.43 Staining on B17.

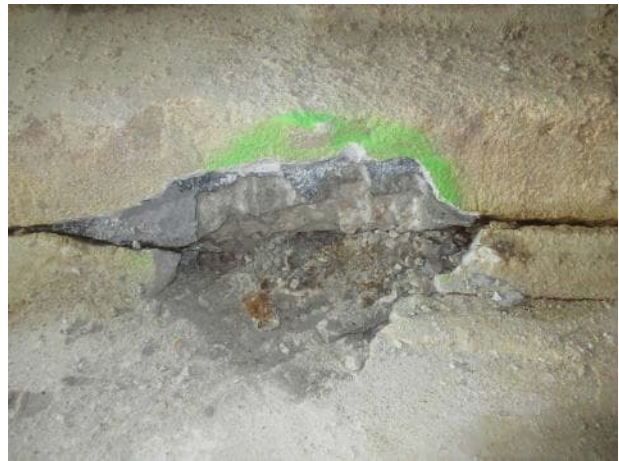
The initial scope of work included more cores in Section 4 due to the presence of large cracks at the base of the north and south walls. No voids were found behind the walls or under the floor, however, the closest core to the south crack (Core #78) appeared to have fill material below the slab.

The south crack in Section 4 was excavated to determine if there was a void behind. Approximately 6 inches was removed and no void was uncovered. The crack extended further into the wall.

No void was found in Section 4 where the large cracks were located. There appeared to be fill material under one section of the floor and we believe that settlement of the structure over the fill has caused the cracks at the base of the north and south walls. The filled area did not appear to extend far based on the core samples. No reinforcing steel was found in any of the cores confirming that the walls and floors are not reinforced. This is not unusual given the age of the reservoir.

Photo 5.5.18 Exposed crack at base of wall on south side of Section 4.

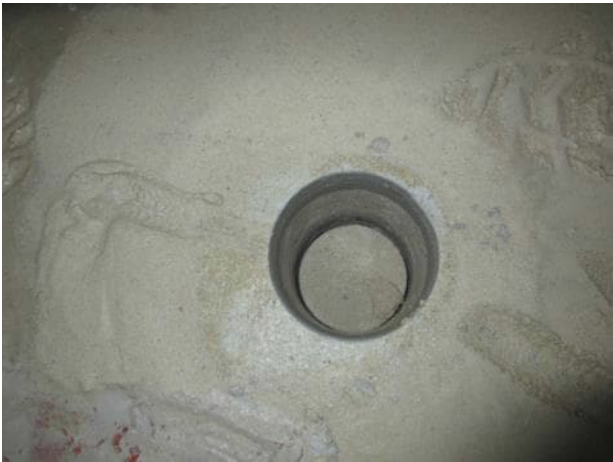
| 30 | 29 Nov 25 | Section 2; floor | 5" | 4" |
| Core broken | | | | |

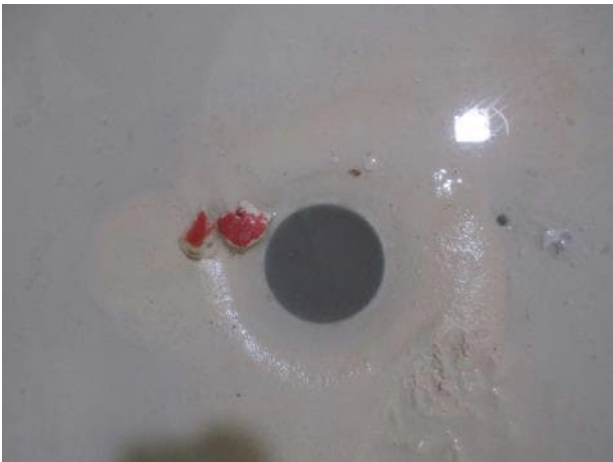
| 31 | 29 Nov 25 | Section 2; floor | 5" | 4" |
| Core broken | | | | |

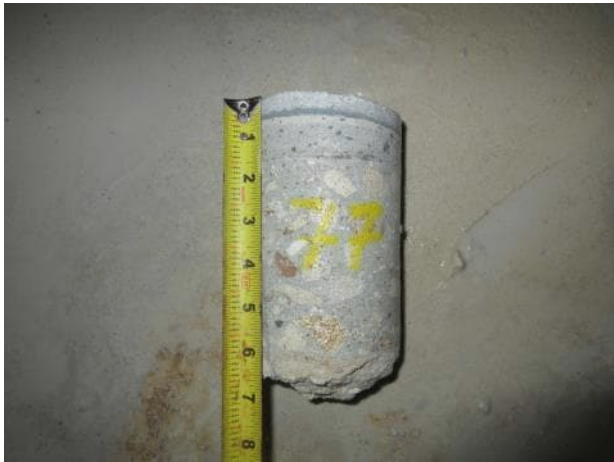
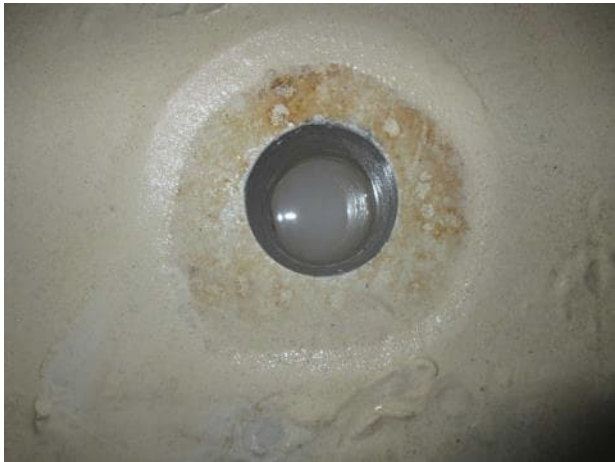
| 77 | 2 Dec 25 | Section 4; floor – adjacent to south crack | 6 ½" | 4" |

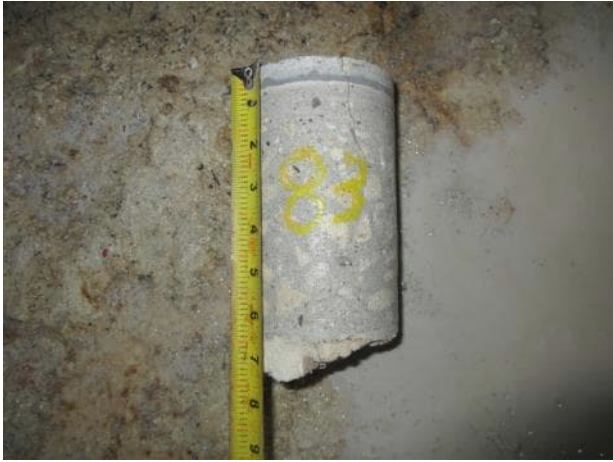
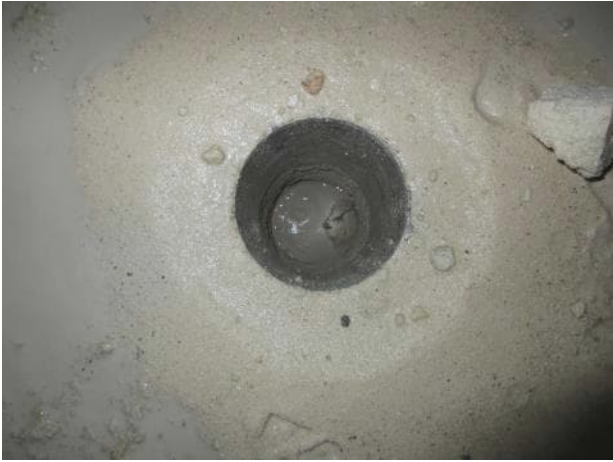
| 83 | 3 Dec 25 | Section 4; floor<br>@ crack in floor | 6 ½" | 4" |
