# Site Investigation and Condition Assessment Report

Reservoir 1  
40 Fort Hill Road  
Devonshire

Mason and Associates Ltd.  
January 14, 2026

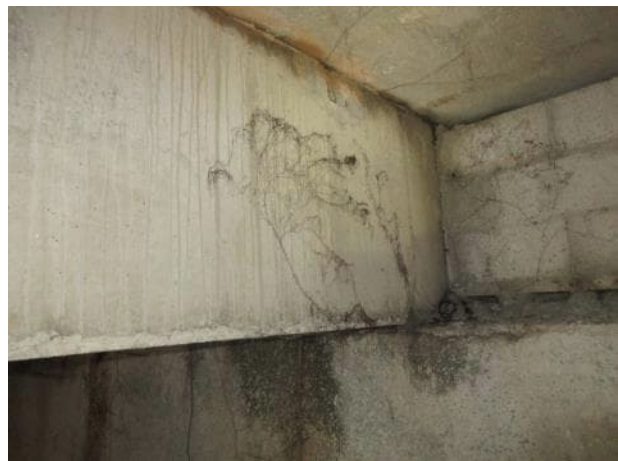
Photo 5.1.14. North bearing B2. Small roots observed.

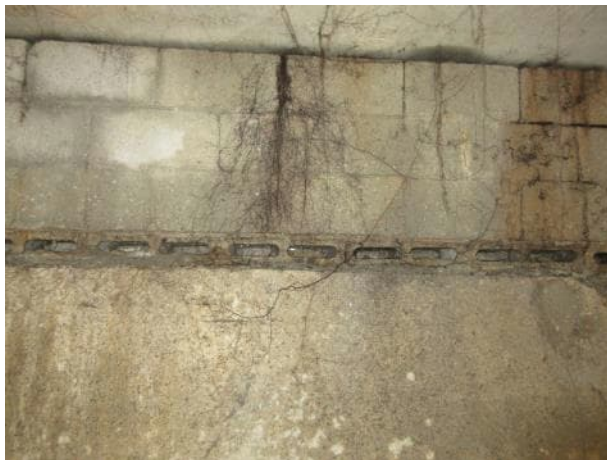
Photo 5.1.24. North Bearing area between B3 and B4. Roots observed growing into concrete block.

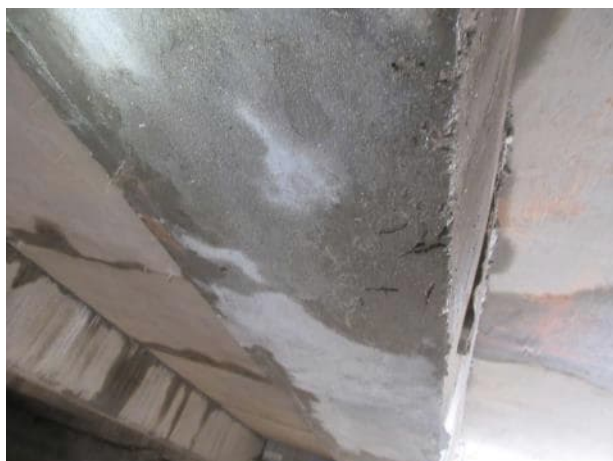
Photo 5.1.27. Old repair under B4.

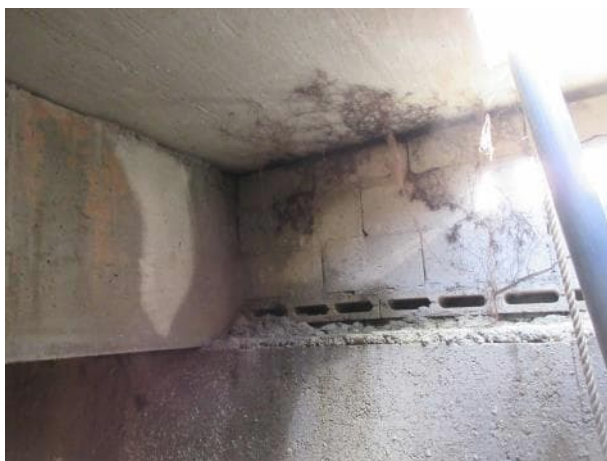
Photo 5.1.28. Beam B4 north bearing. Roots visible.

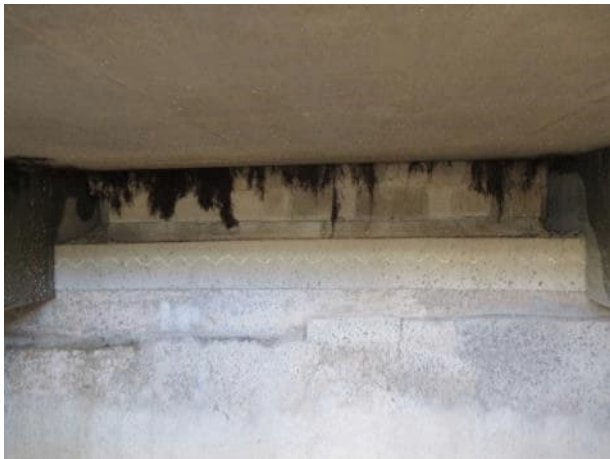
Photo 5.1.37. South bearing area between B3 and B4. Roots observed.

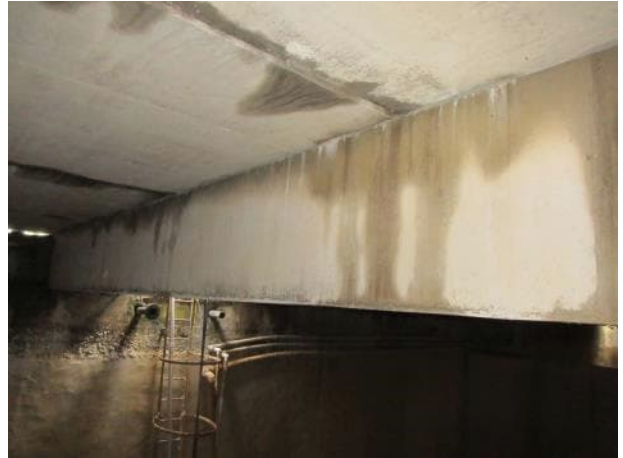
Photo 5.2.10. B7 with water ingress staining.

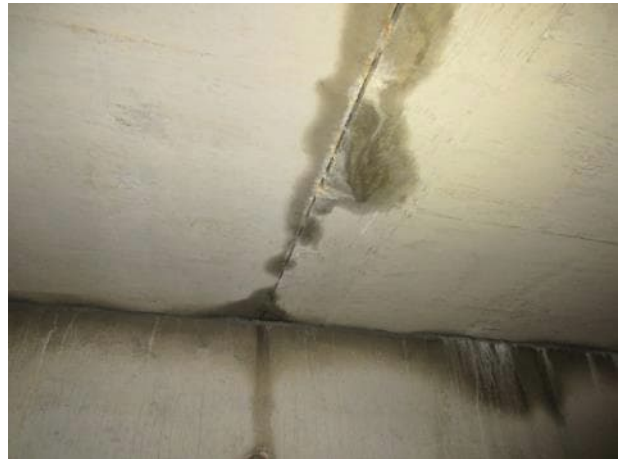
Photo 5.2.12. Water and staining visible under slab.

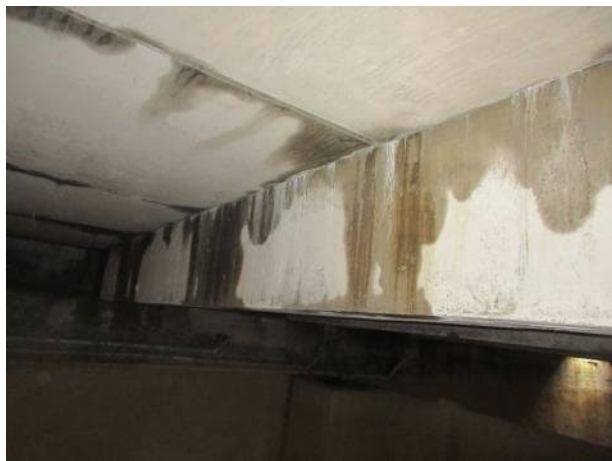
Photo 5.2.21. B9 with staining visible.

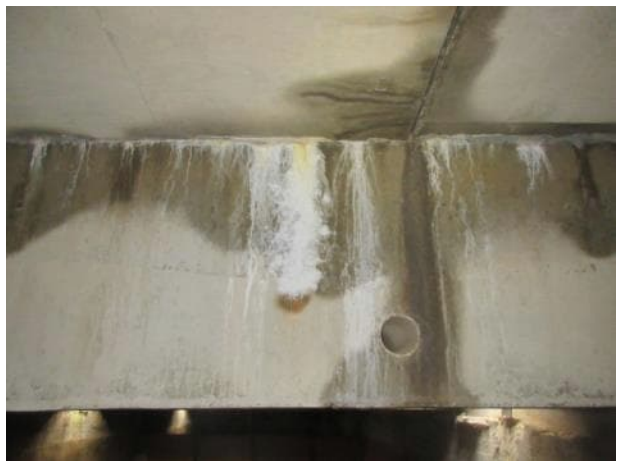
Photo 5.2.22. B9 with staining from water ingress.

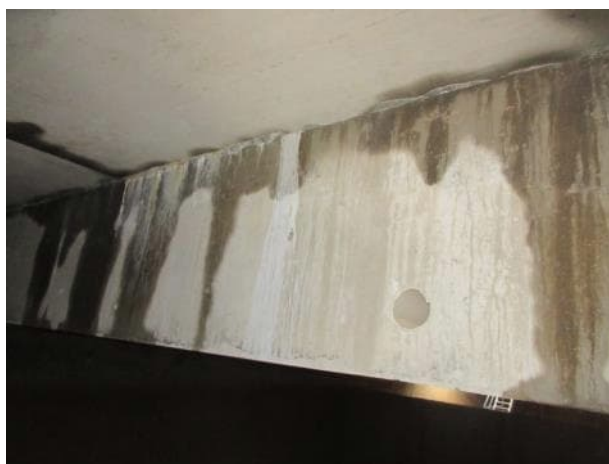
Photo 5.2.36. B9 with water staining visible.

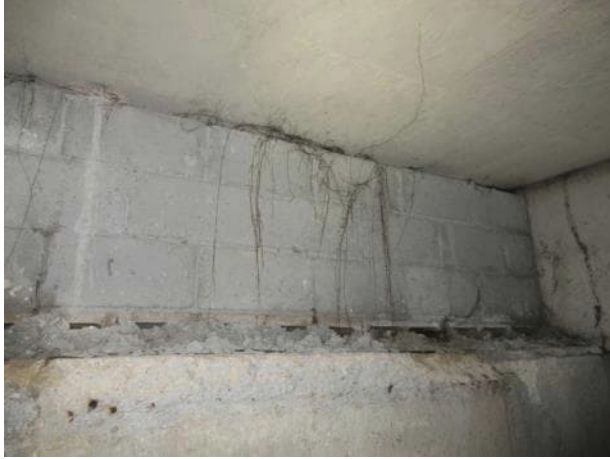
Photo 5.2.37. North bearing area between B8 and B9. Roots visible.

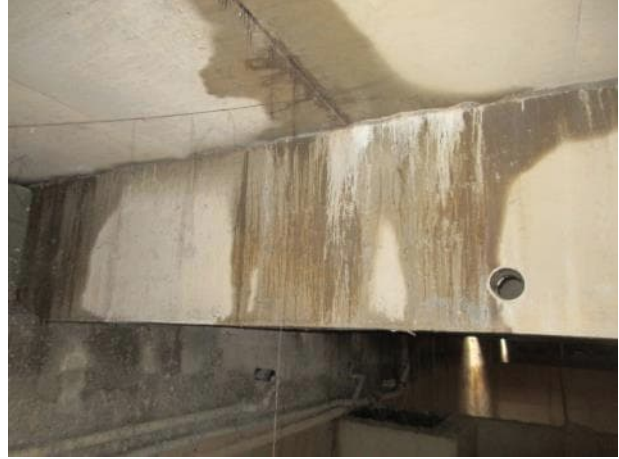
Photo 5.2.38. Deposits and staining on north side of B9.

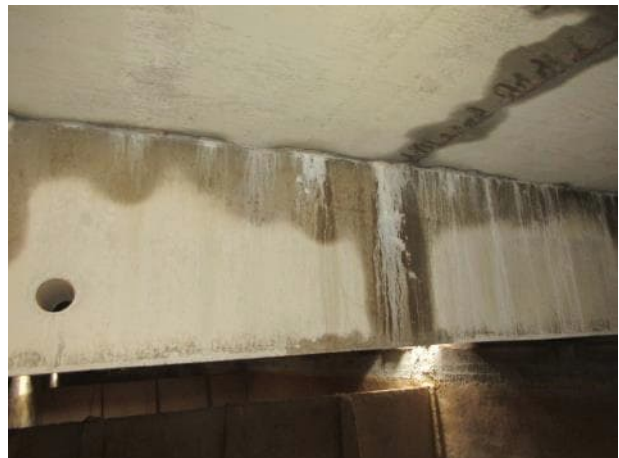
Photo 5.2.42. B8 staining and water ingress.

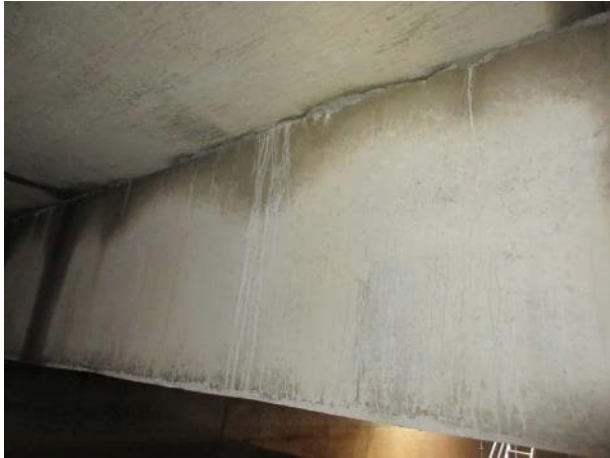
Photo 5.2.45. B7 with water staining.

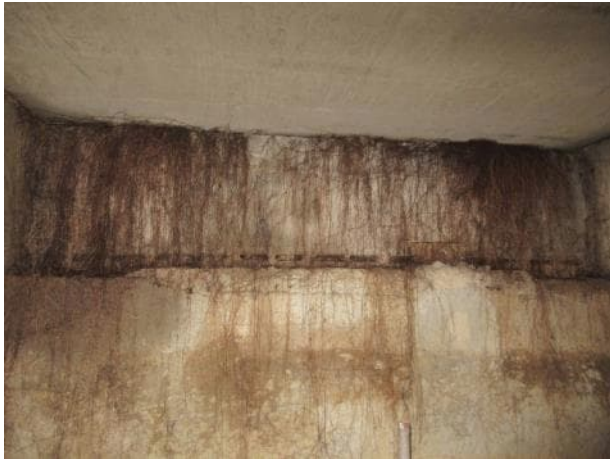
Photo 5.3.1. North bearing between B11 and B12.  
Roots observed.

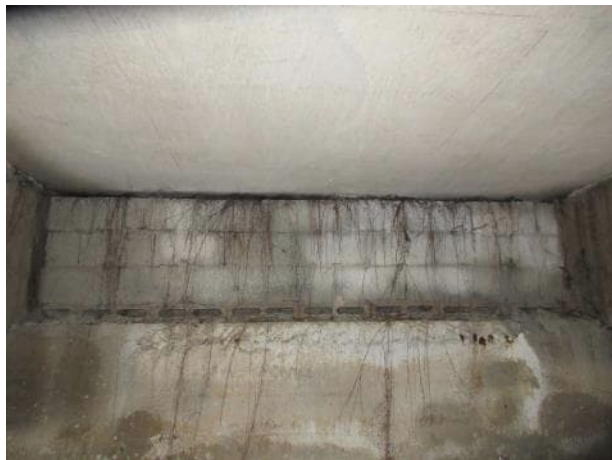
Photo 5.3.23. North bearing area between B14 and B15. Tree roots observed.

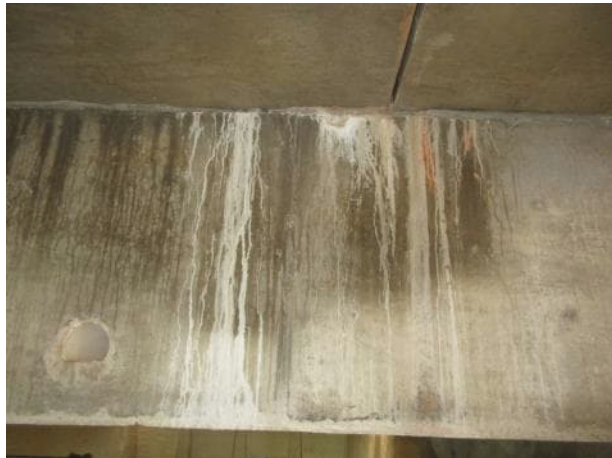
Photo 5.4.11 Staining on B17.

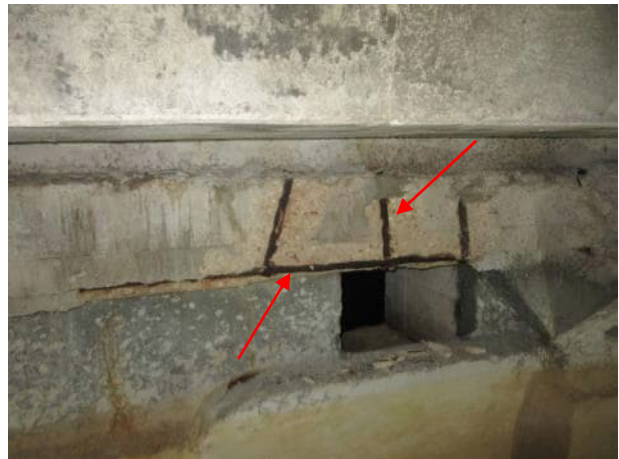
At the eastern end of the reservoir, an older reinforced concrete beam was positioned over the overflows into Reservoir 2. Two areas of spalled concrete and corroded reinforcing steel were observed. The beam appeared to be part of the original reservoir construction.

Photo 5.4.32 Corroded reinforcing steel at the eastern edge beam.

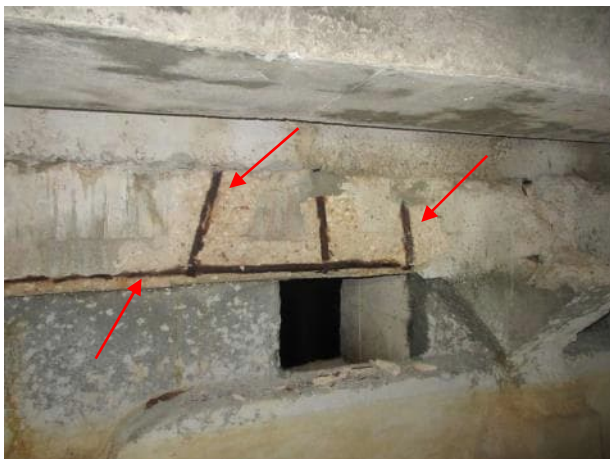
Photo 5.4.33 Corroded reinforcing was observed.

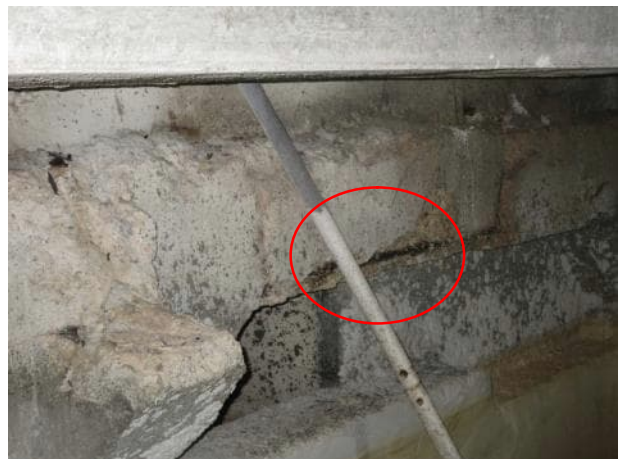
Photo 5.4.34 Corroded reinforcing at eastern edge beam.

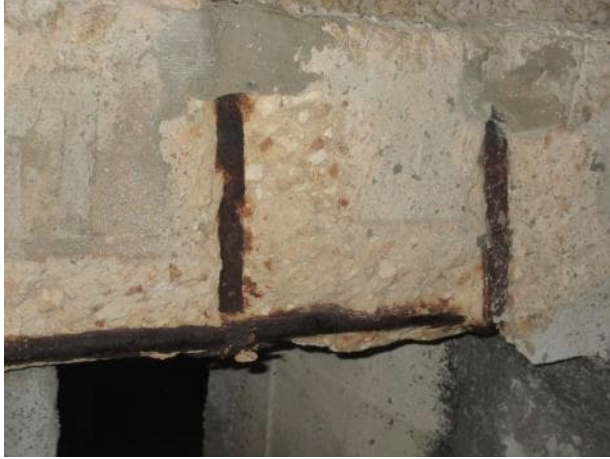
Photo 5.4.35 Corroded stirrups.

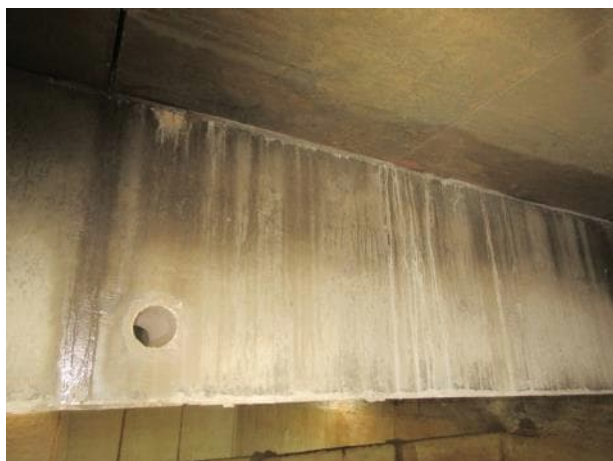
Photo 5.4.43 Staining on B17.
