# ASBESTOS ASSESSMENT AND REPORTING AIRPORT INDUSTRIAL SITE

Works & Engineering  
St. George's, Bermuda

July 22<sup>nd</sup>, 2021

**SCOPE OF ASSESSMENT:** Asbestos assessment and reporting.

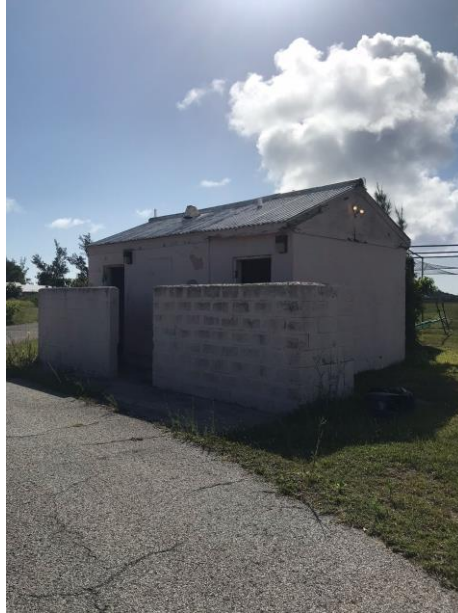
Sample KOBE 8B – Building B Roofing – 20% Chrysotile

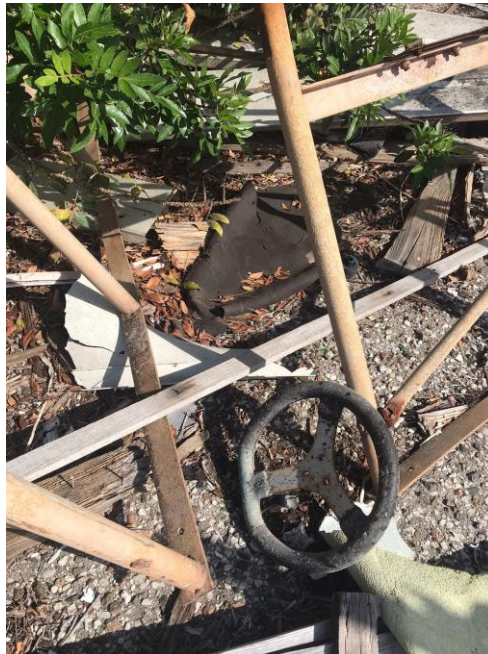
Sample KOBE 3B – Building A Thick Black Tar – No asbestos

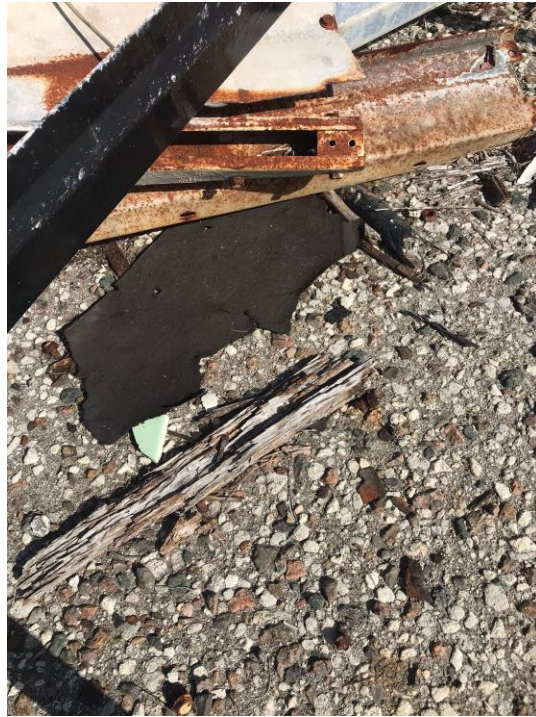
Sample KOBE 4B - Building A Tar Paper – No asbestos

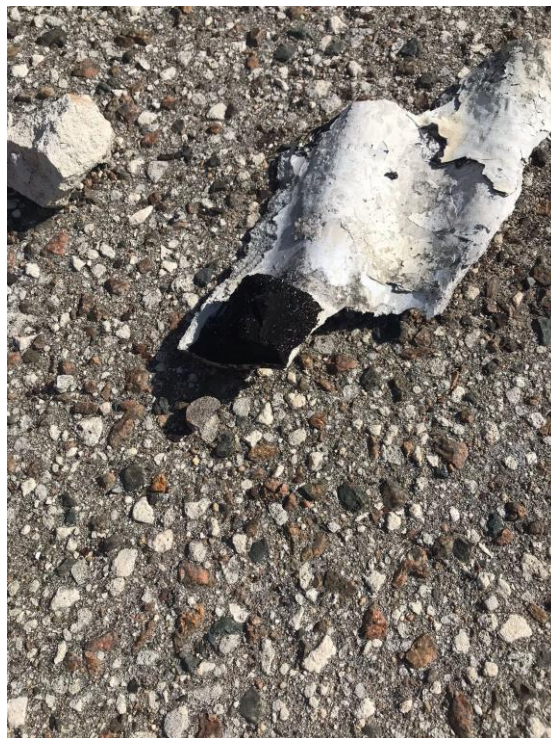
Sample KOBE 1B – Building A Roofing West – 20% Chrsotile

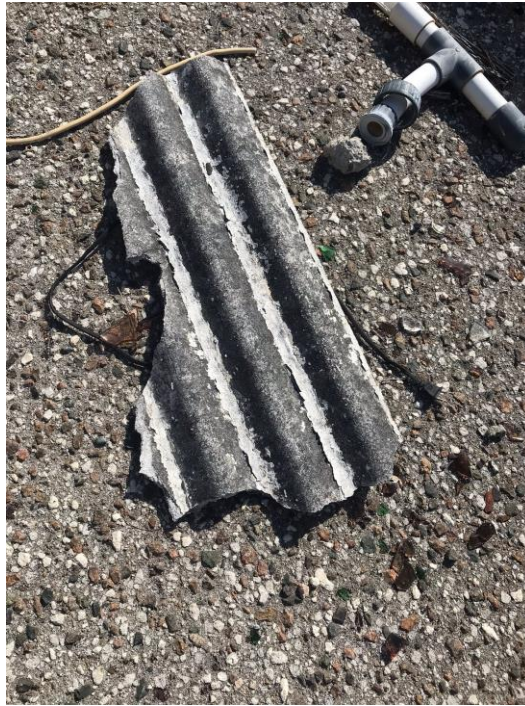
Sample KOBE 2B – Building A Roofing East – 20% Chrysotile

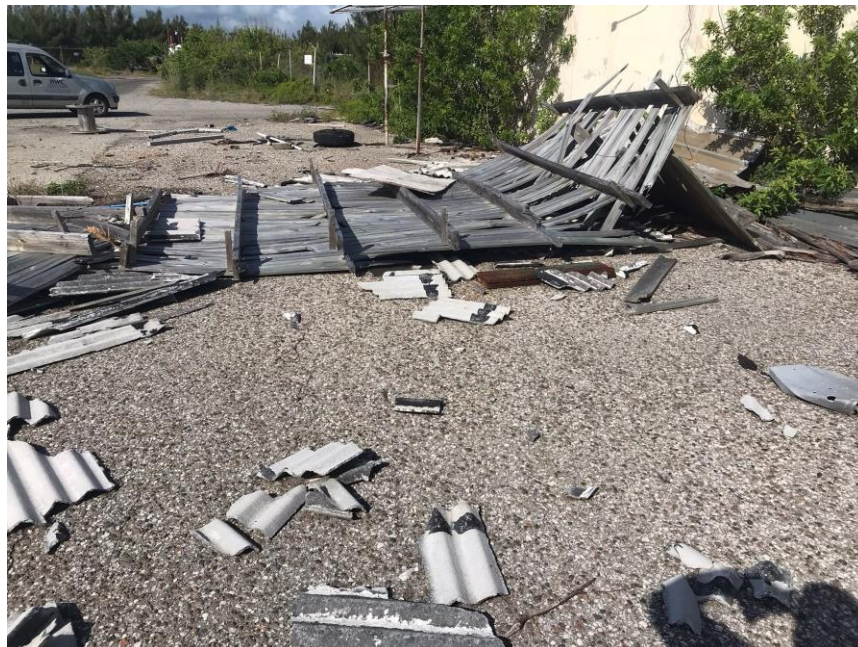
Roofing from Building A

Sample KOBE 1B – Building A Roofing West – 20% Chrysotile

Sample KOBE 2B – Building A Roofing East – 20% Chrysotile

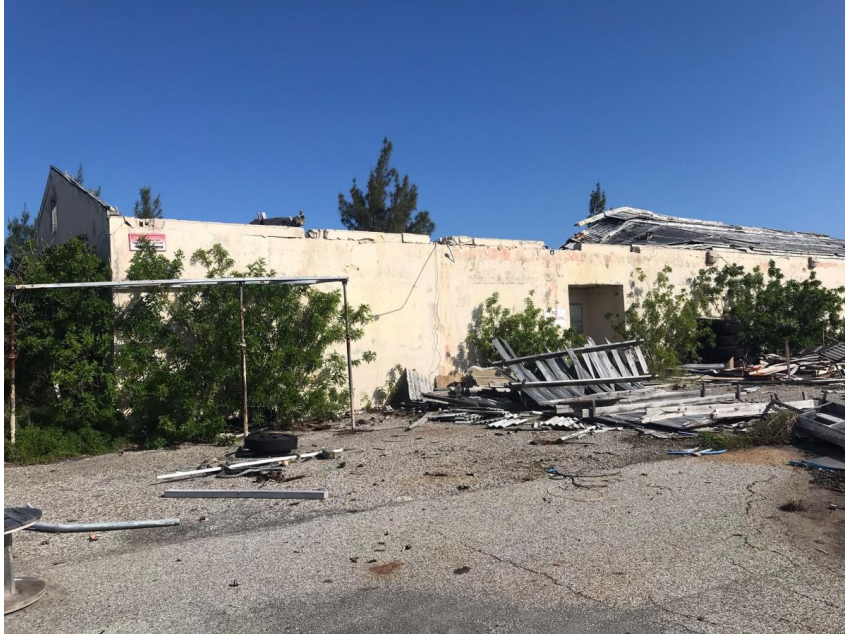
**Building A**

Sample KOBE 5B Floor Tile – Building A Floor Tile – No asbestos

Sample KOBE 5B Mastic – Building A Mastic – No asbestos

Sample KOBE 6B Floor Tile – Building A Floor Tile – No asbestos

Sample KOBE 6B Mastic – Building A Mastic – No asbestos

Sample KOBE 7B – Building A Ceiling Tile – No asbestos
