Site Name:	Prospect Tower
Structure Type:	Guyed Tower
Structure Height:	220'
Make:	Rohn
Model:	Model 80
Tower Owner:	Government of Bermuda
Latitude:	32.299186
Longitude:	-64.765877
Date of Visit:	4/26/2017
Employees on Site:	Angie Shyrigh

Proventus Structural Services, LLC

To fulfill the inspection requirements set forth in the TIA/EIA222-G, Annex J.1 standard for Maintenance and Condition Assessment of communication structures.

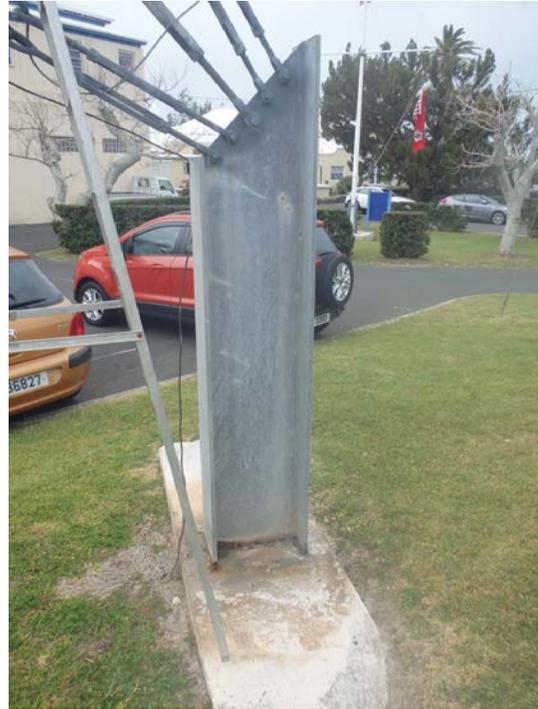
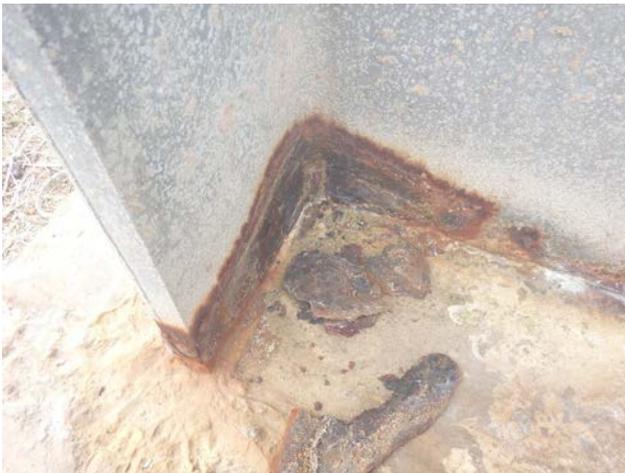
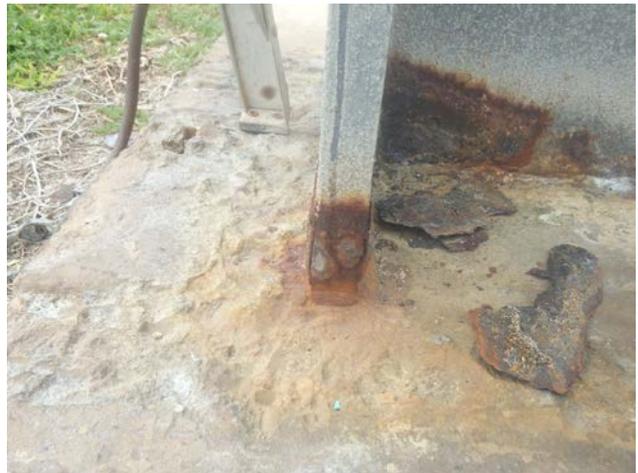
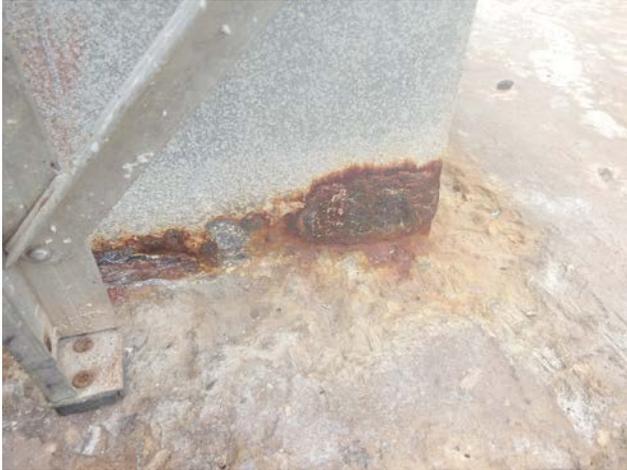
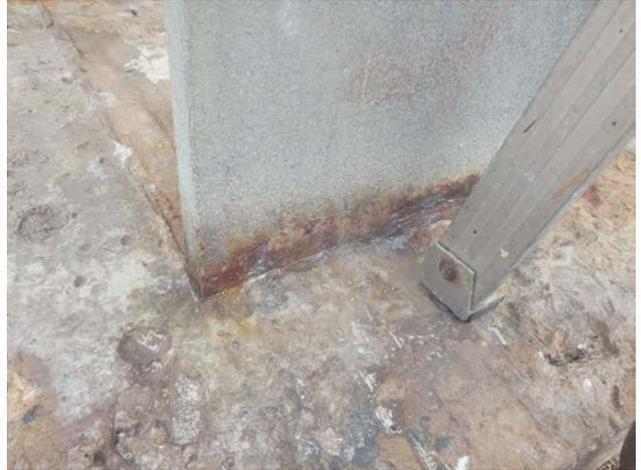
Elevation	Location	Description	Recommendation	Priority
Ground	Anchor A	Scaling rust is present and advancing at the base of the Anchor A elevation beam.	It is recommended the Engineer of Record be consulted to determine corrective action.	To be scheduled within 12 months
Ground	Anchor B	Scaling rust is present at the guy anchor rods and approximately ¼" material from the diameter of each anchor rod is present.	It is recommended the Engineer of Record be consulted to determine corrective action.	To be scheduled within 12 months
Ground	Base plate	Extensive category 3 pitting rust is present on the base plate as well as the bearing plate.	It is recommended the Engineer of Record be consulted to determine corrective action.	To be scheduled within 12 months
Throughout height	Tower bracing	Numerous tower bracing members (approximately 35% of the diagonals and horizontals) have category 3 rust and are rusted from the inside out at the weep holes.	Replacement of the members would be recommended for much smaller quantities of rusted through bracing members, however due to the quantity, and in light of the condition of other essential components, it is recommended the tower be replaced.	To be scheduled within 2 years

Scaling rust at Anchor A
File 003

Scaling rust at Anchor A
File 004

Scaling rust at Anchor A
File 005

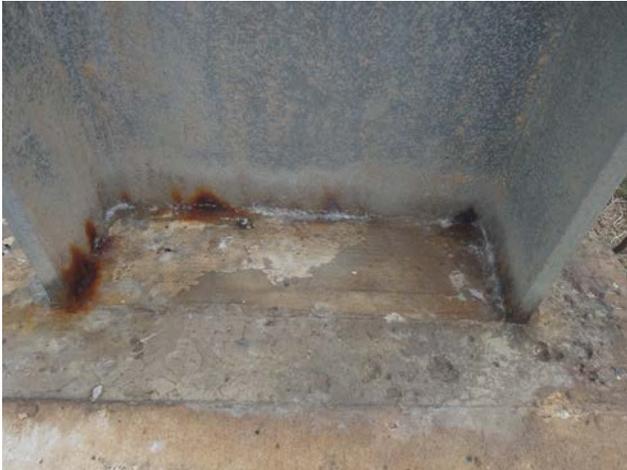
Additional rust forming at Anchor A
File 007

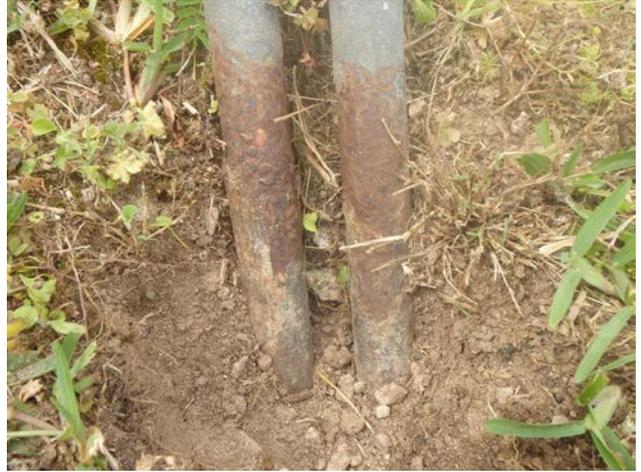
Scaling rust on Anchor B rods
File 042

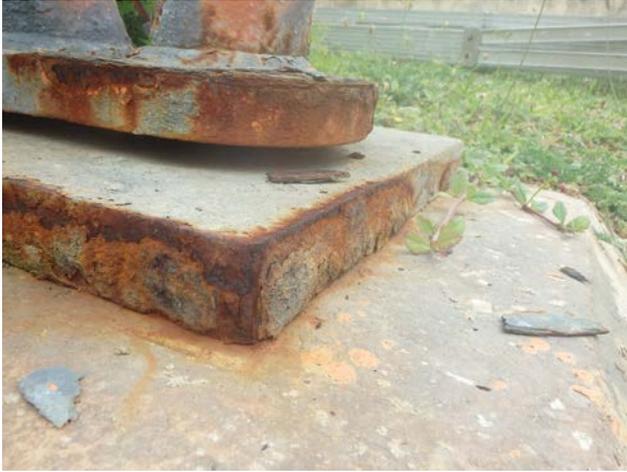
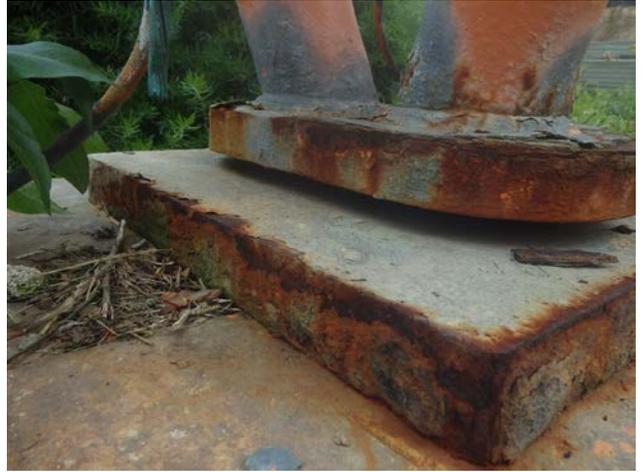
Corrosion on base plate and bearing plate
File 085

Corrosion on base plate and bearing plate
File 086

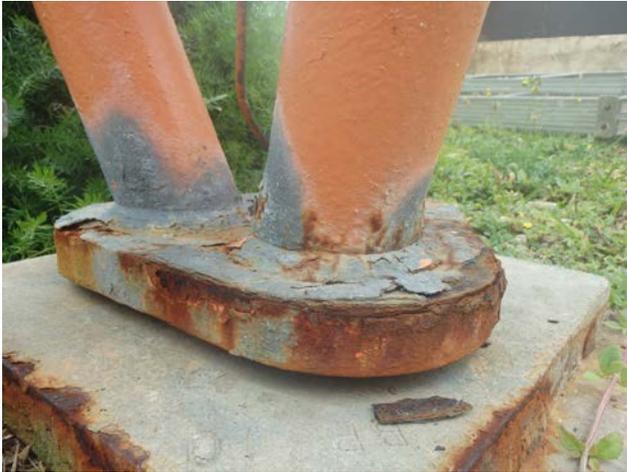
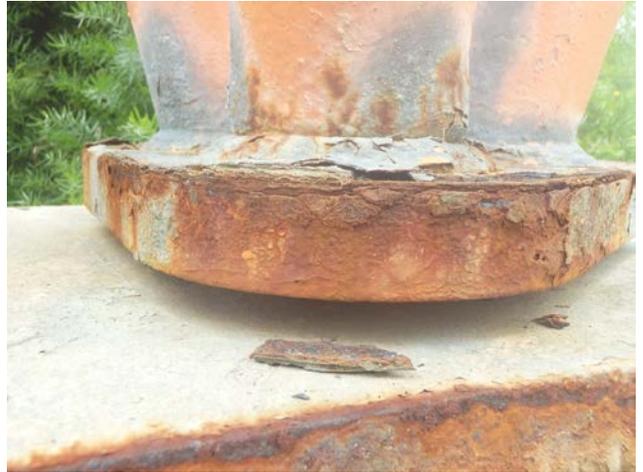
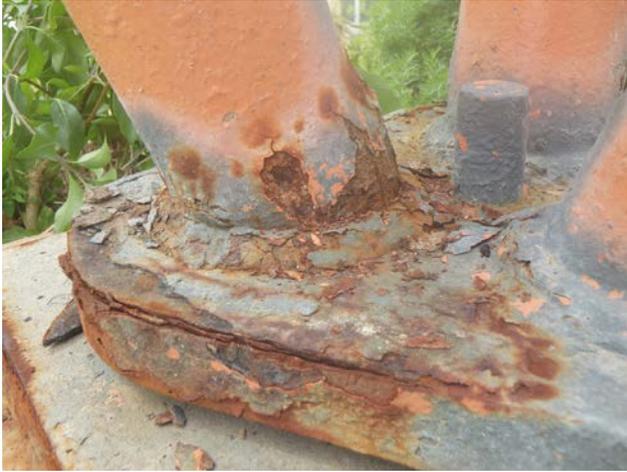
Corrosion on bearing plate
File 087

Corrosion on bearing plate
File 088

Corrosion on bearing plate
File 089

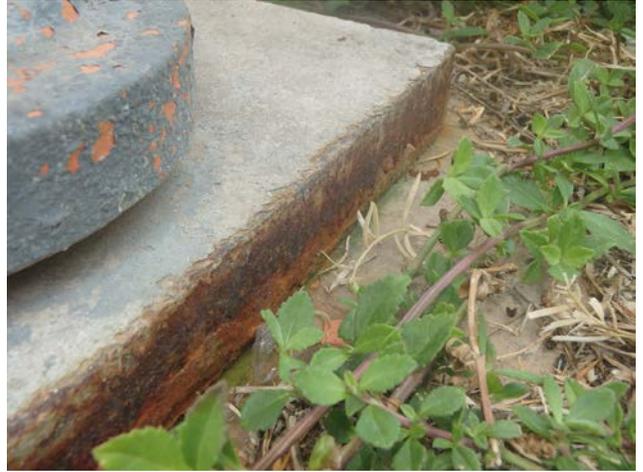
Corrosion on base plate
File 090

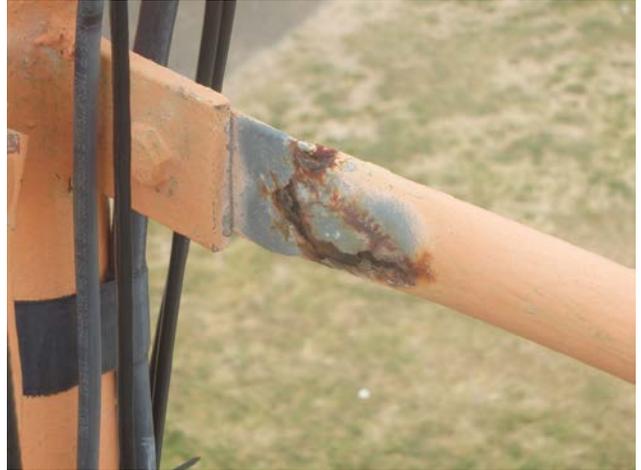
Category 3 rust on horizontal
File 098

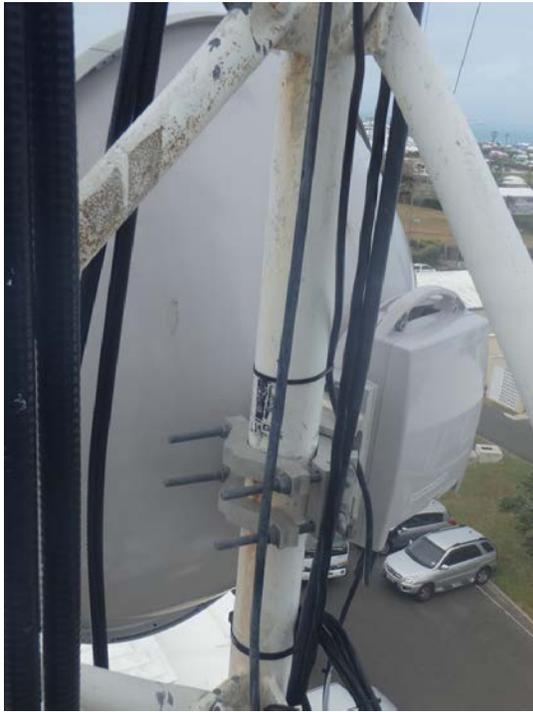
Antenna #1
File 109

Elevation	Location	Description	Recommendation	Priority
46'	B Leg	Antenna #1 mount is secured to the tower with a zip tie.	It is recommended the mount be replaced.	To be scheduled within 12 months
111'	A Leg	The top of antenna #19 is trapped behind a tower bracing member.	It is recommended the antenna be released and that a standoff be installed at the top of the tower to prevent recurrence.	To be scheduled within 12 months
63'	CA Face	Antenna #8's stiff arm is attached to a diagonal member. Advanced category 3 rust is present at this diagonal member weep hole. The stress of the stiff arm on the failing member is potentially severe enough to cause failure of the member and contribute to the failure of the structure.	Remove and reattach the stiff arm to a tower leg.	To be scheduled within 3 months

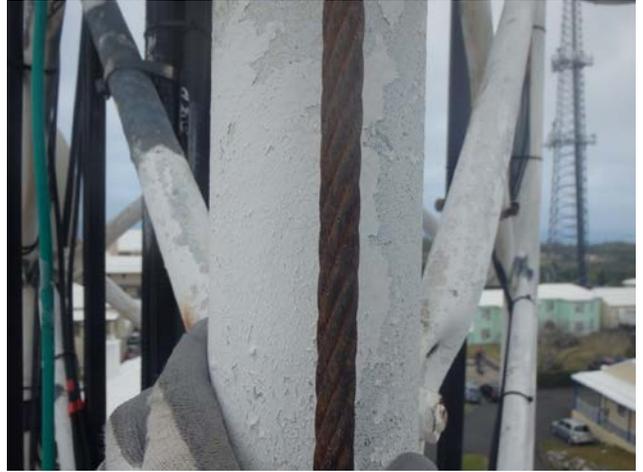
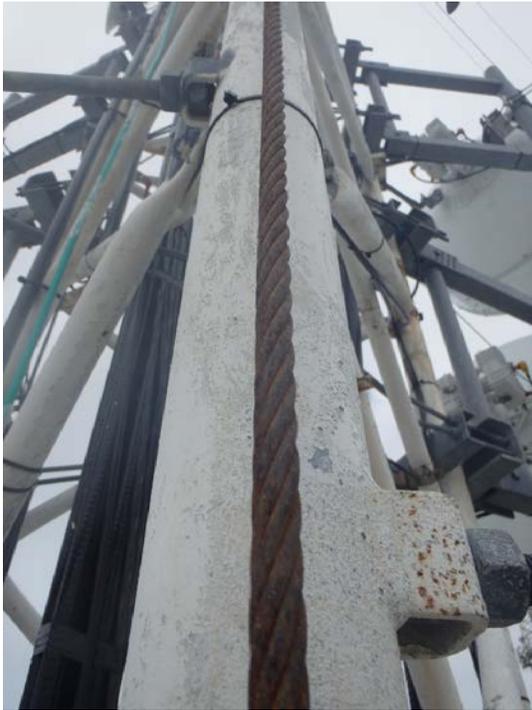
Elevation	Location	Description	Recommendation	Priority
Throughout height	C Leg	Category 3 rust is present on the safety cable.	It is recommended the safety cable system be replaced and that the safety cable kit be installed per manufacturer's specifications.	To be scheduled within 12 months

Condition of safety cable
File 190

Condition of safety cable
File 191
