Prospect Reservoir #1  
Refurbishment

**Addendum One**

# Site Investigation and Condition Assessment Report

Reservoir 1  
40 Fort Hill Road  
Devonshire

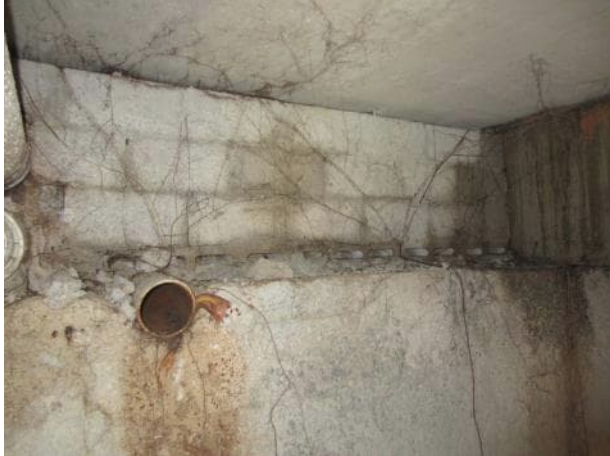
Photo 5.1.1. North bearing between B1 and B2.  
Roots visible.

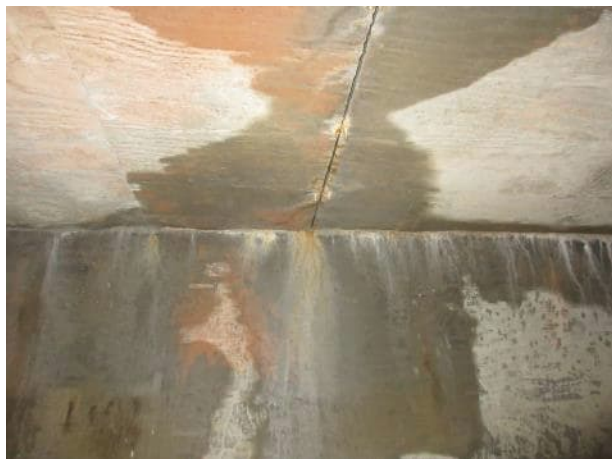
We noted that there were numerous leaks through the roof slabs. This has left staining and deposits on the beams but the leaks did not appear to cause any detrimental effects to the structure.

Photo 5.1.19. Typical water ingress between slabs over B2.

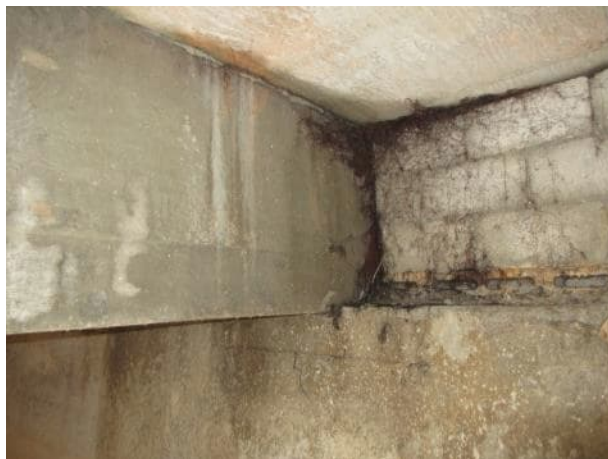
Photo 5.1.20. North bearing of B3. Roots visible.

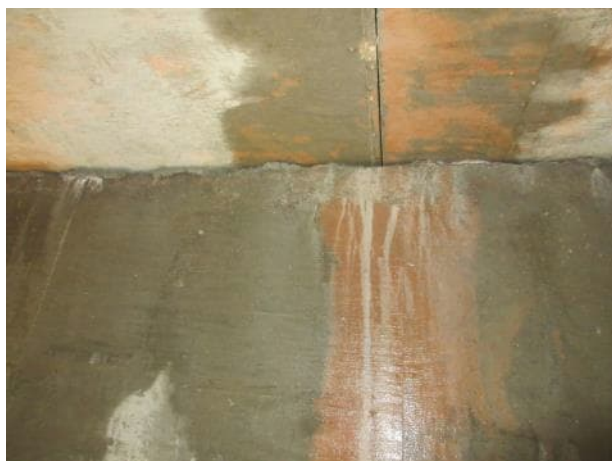
Photo 5.1.21. Water ingress over B3.

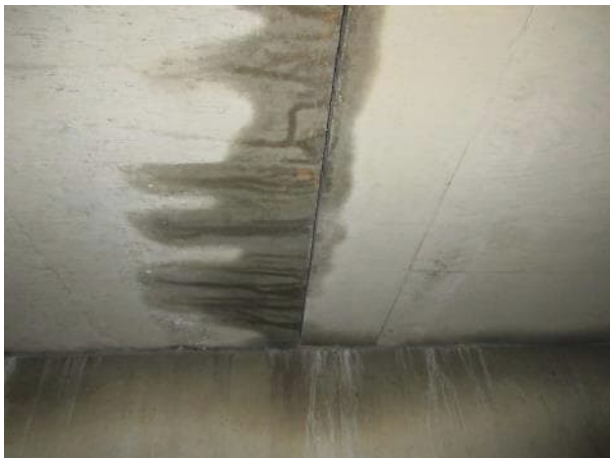
Photo 5.2.5. Water ingress between slabs.

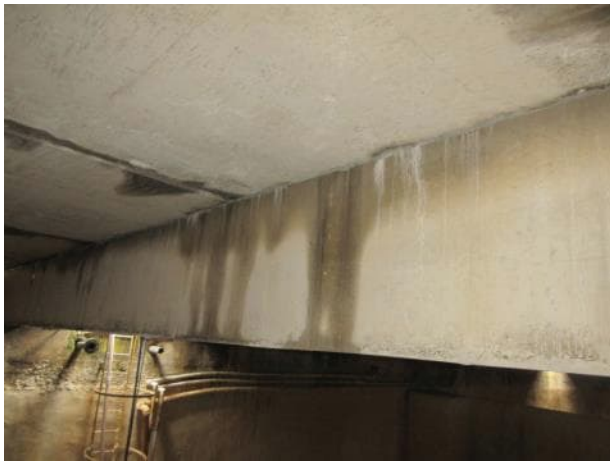
Photo 5.2.9. B7 water ingress visible.

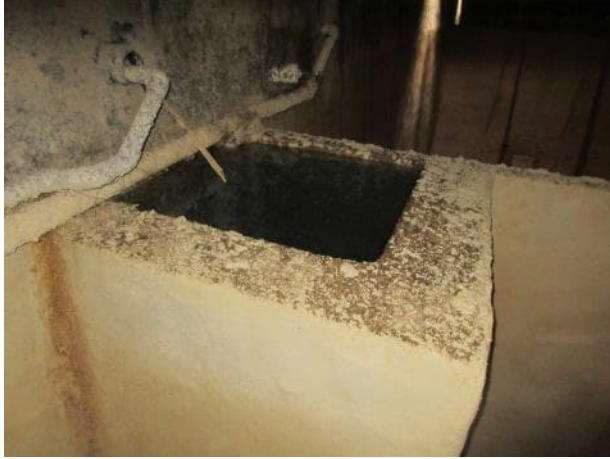
Photo 5.2.31. Water filled tower at divide wall near B10.

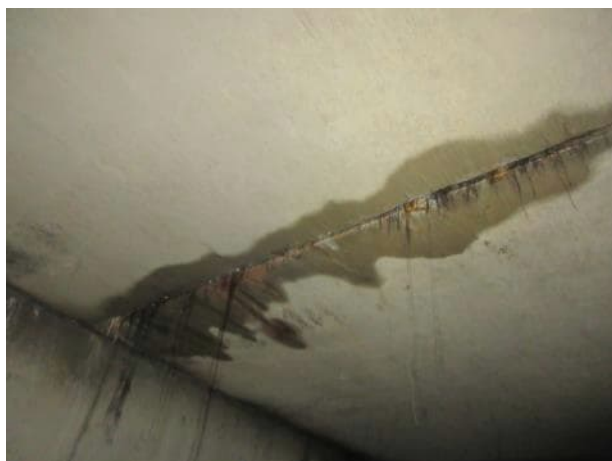
Roots were visible on various areas on the upper north and south sides of the reservoir. Roots were observed around the access on the south side of Section 3.

Photo 5.2.41. Root growth through slab joints between B8 and B9.

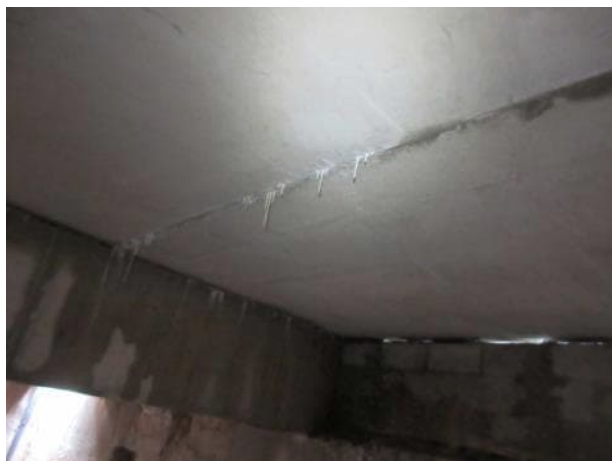
Photo 5.2.47. Deposits from water ingress between B5 and B6.

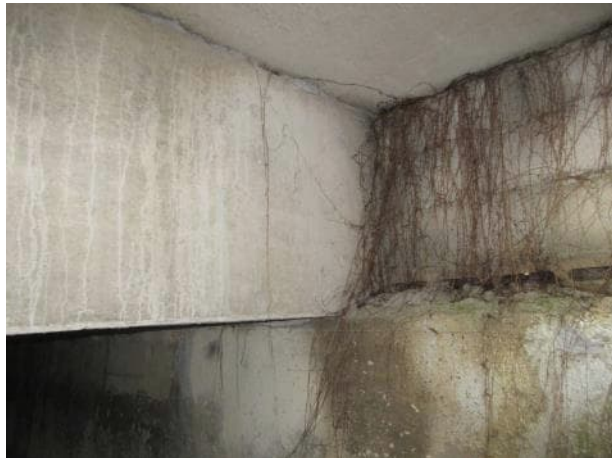
Photo 5.3.17. Beam B13 north bearing. Roots visible.

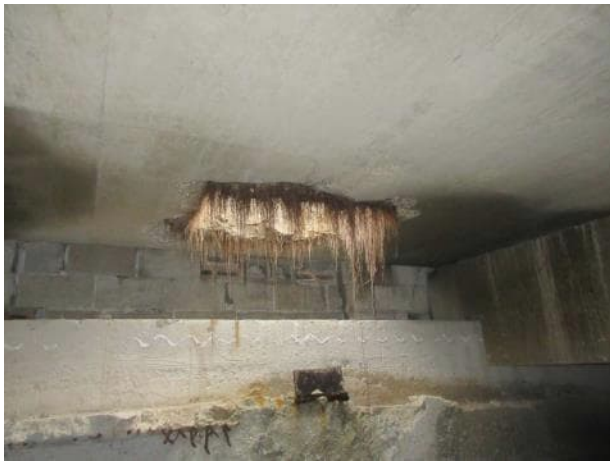
Photo 5.3.31. Roots growing in manhole.

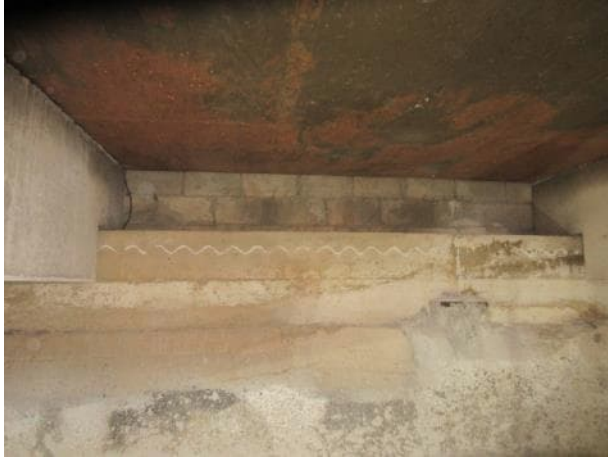
Photo 5.4.47 South bearing area between B15 and B16.

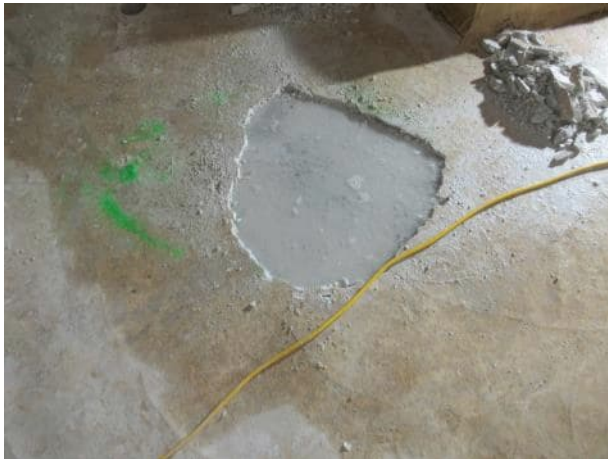
Voids were found in the floor of Section 1 and the south wall of Section 3.

Photo 5.5.1 Hollow section in Section 3 Floor (eastern end).

- The voids in Section 1 and 3 appear to be localized and we would recommend filling those areas with a cement slurry/grout.
- The new reservoir floors should be designed to span over small voids or soft material. This will ensure that the slab can span over the filled area in Section 4.
- The roof slab should be resealed to prevent water ingress. This will mitigate potential long term deterioration.
