# Site Investigation and Condition Assessment Report

Reservoir 1  
40 Fort Hill Road  
Devonshire

Mason and Associates Ltd.  
January 14, 2026

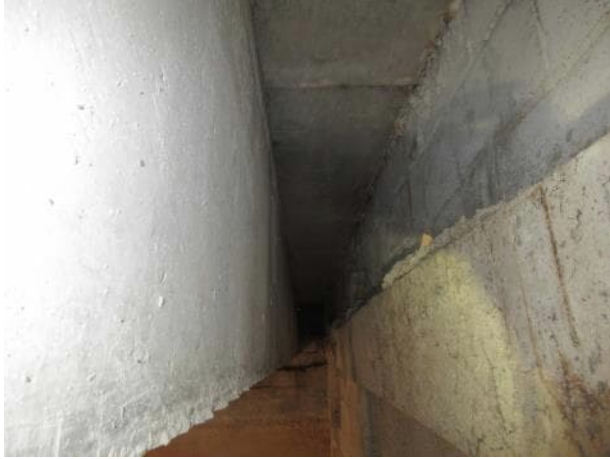
Photo 5.1.5. B1 looking toward south bearing.

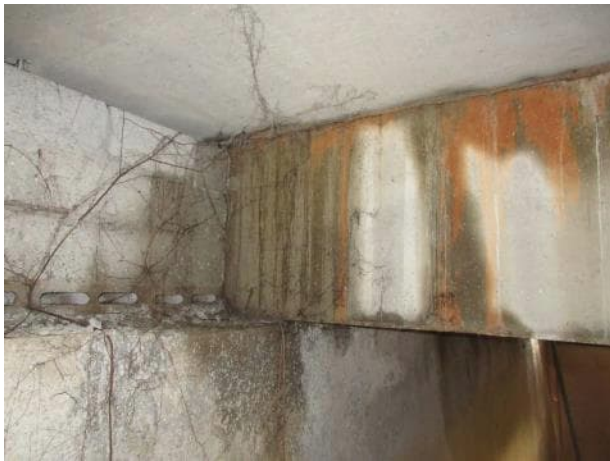
Photo 5.1.7. B2 north bearing.

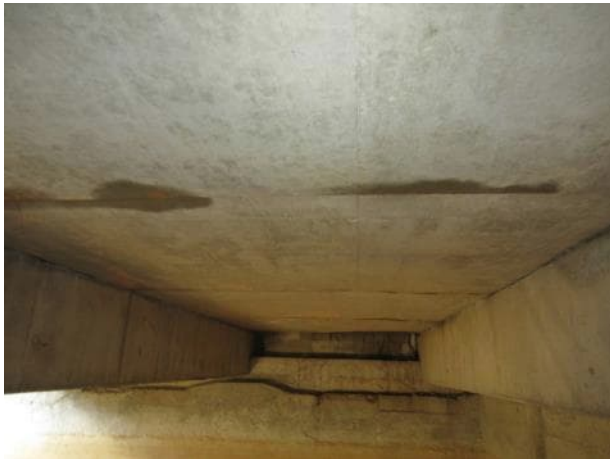
Photo 5.1.9. Slab between B1 and B2.

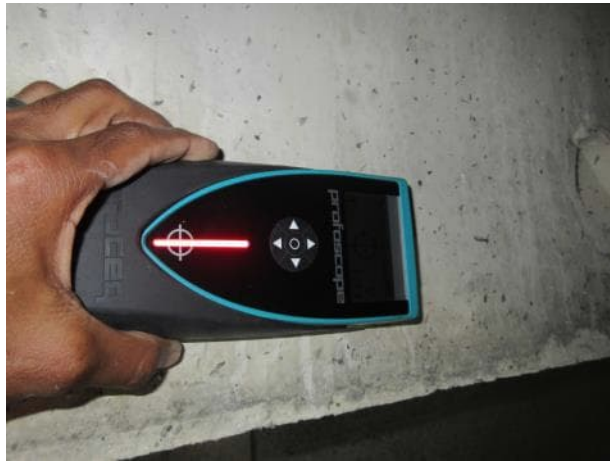
Photo 5.1.11. Rebar scan of B1.

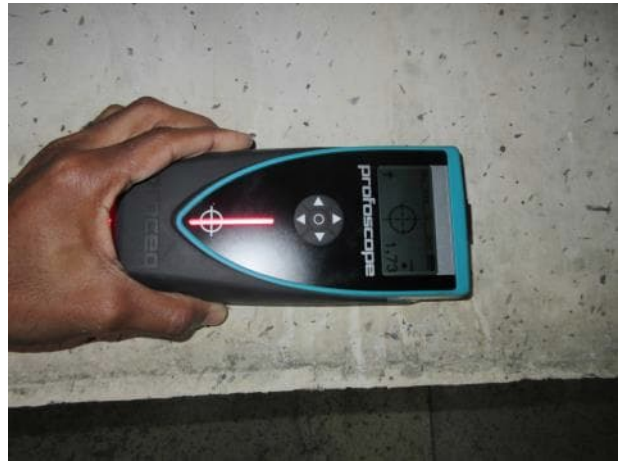
Photo 5.1.12. Rebar scan of B1.

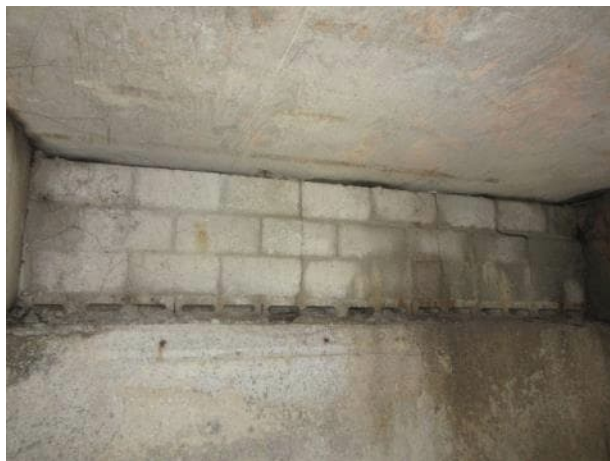
Photo 5.1.13. North bearing area between B2 and B3.

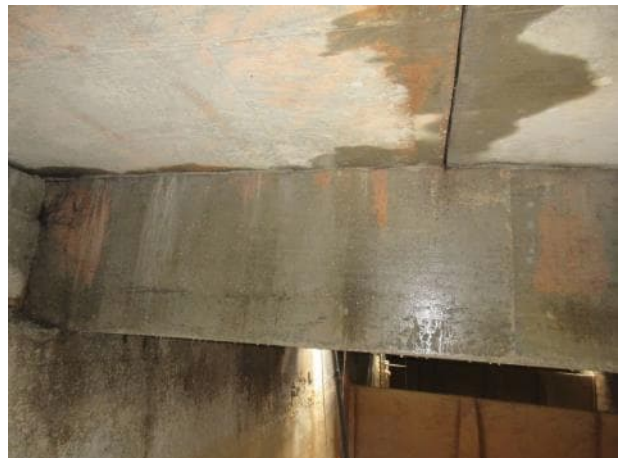
Photo 5.1.16. Beam B3 north end.

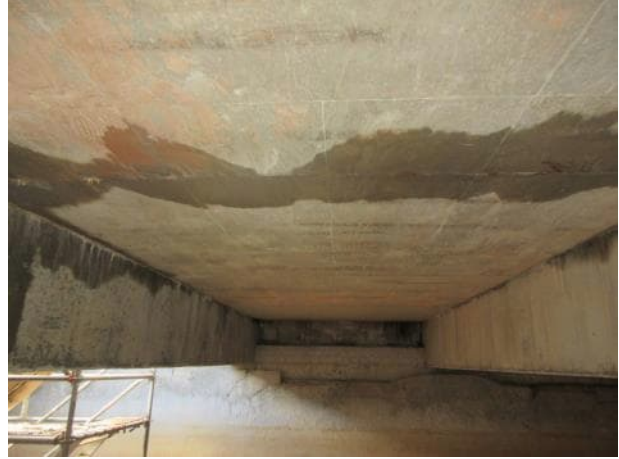
Photo 5.1.18. Underside of slabs between B2 and B3.

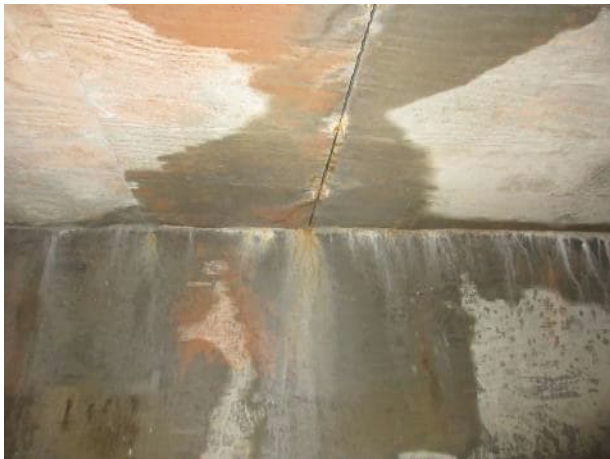
We noted that there were numerous leaks through the roof slabs. This has left staining and deposits on the beams but the leaks did not appear to cause any detrimental effects to the structure.

Photo 5.1.19. Typical water ingress between slabs over B2.

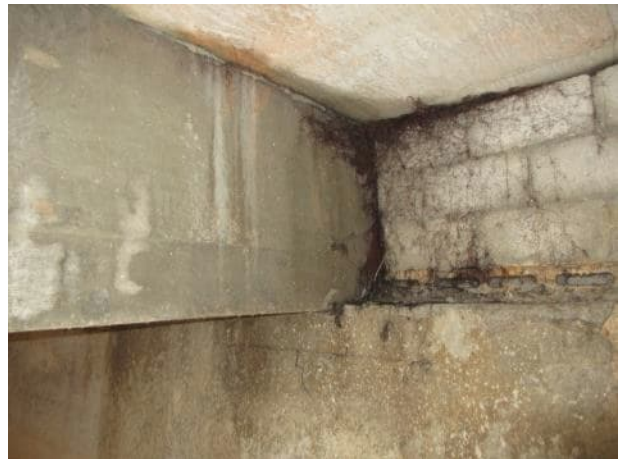
Roots were visible on various areas on the upper north and south sides of the reservoir. Roots were observed around the access on the south side of Section 3.

Photo 5.1.20. North bearing of B3. Roots visible.

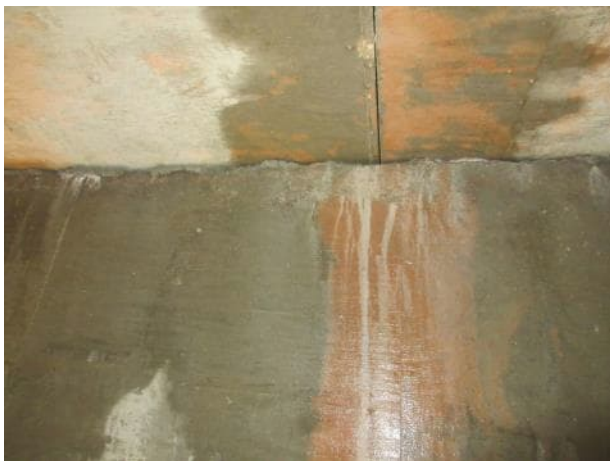
Photo 5.1.21. Water ingress over B3.

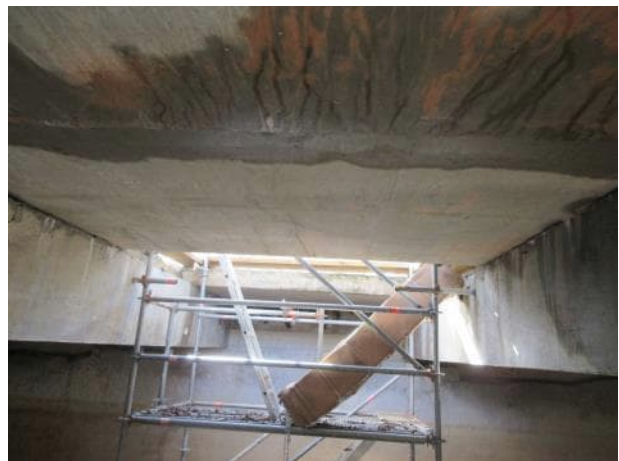
Photo 5.1.22. Underside of slab between B3 and B4.

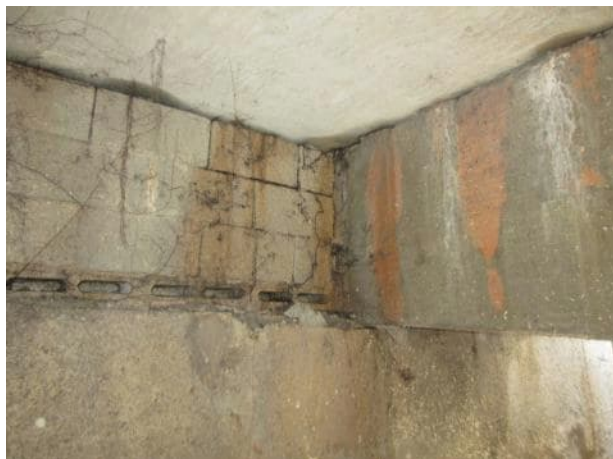
Photo 5.1.25. Beam B4 north bearing.

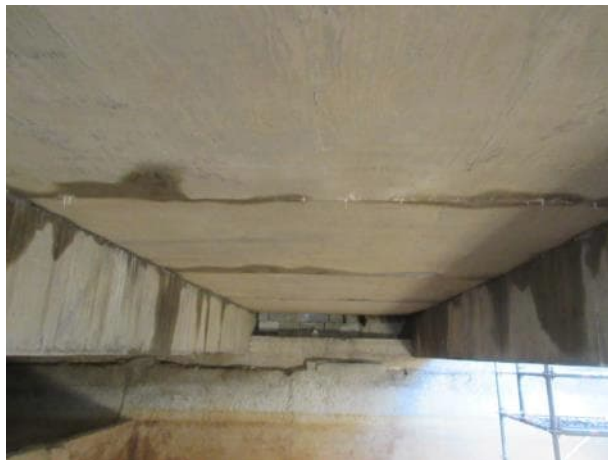
Photo 5.1.30. Underside of slabs between B4 and B5.

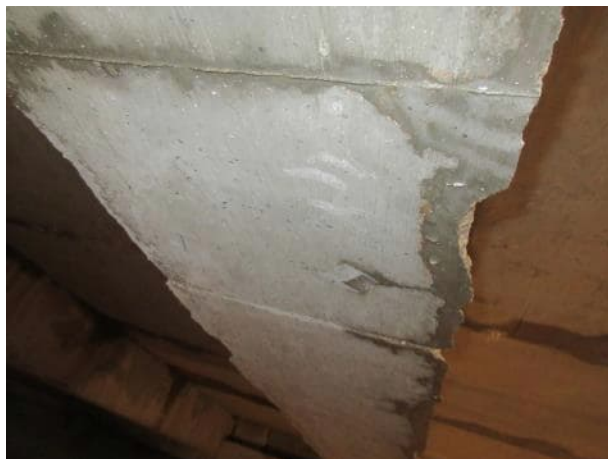
Photo 5.1.32. Underside of B5.

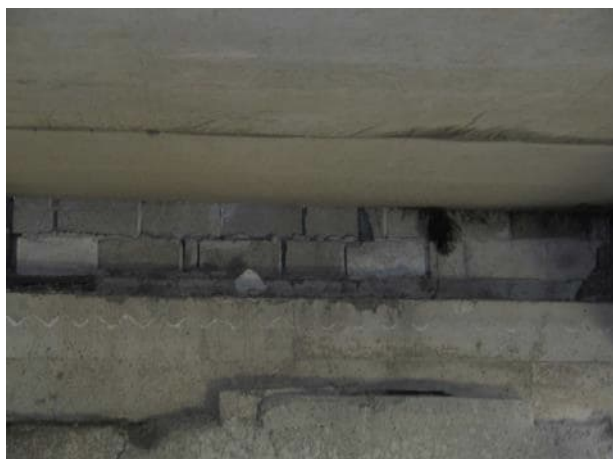
Photo 5.1.33. South bearing area between B4 and B5.

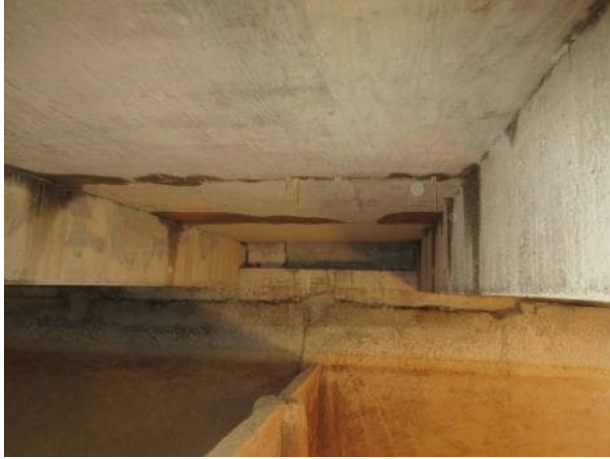
Photo 5.1.35. Underside of slab between B5 and B6.

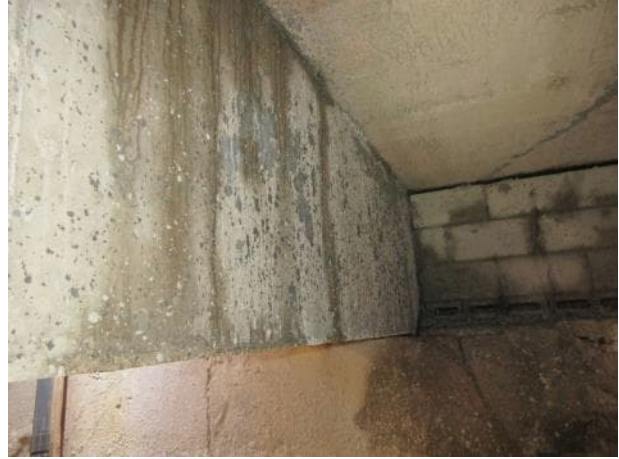
Photo 5.1.36. Beam B5 looking north.

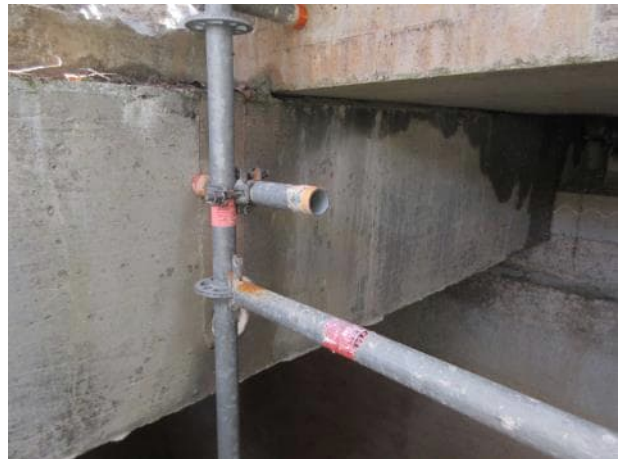
Photo 5.1.38. South end of Beam B4.

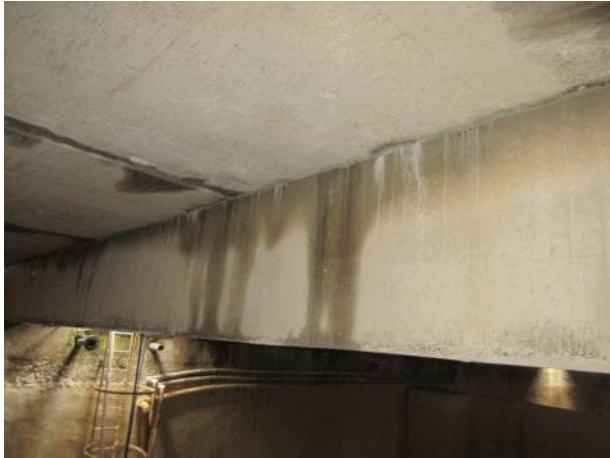
Photo 5.2.9. B7 water ingress visible.

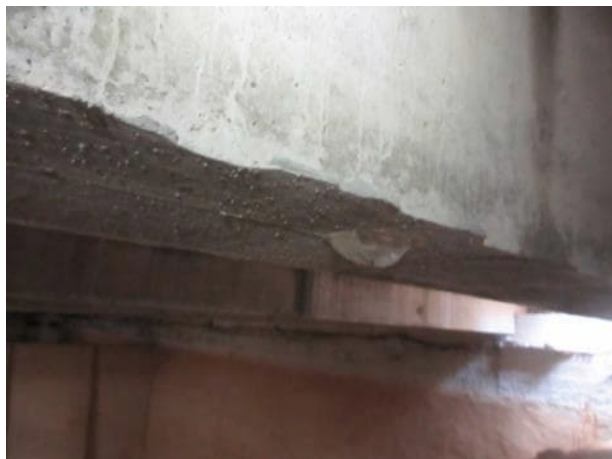
Photo 5.2.33. B10 plastic on the underside of the beam likely from the initial installation. No structural issue.

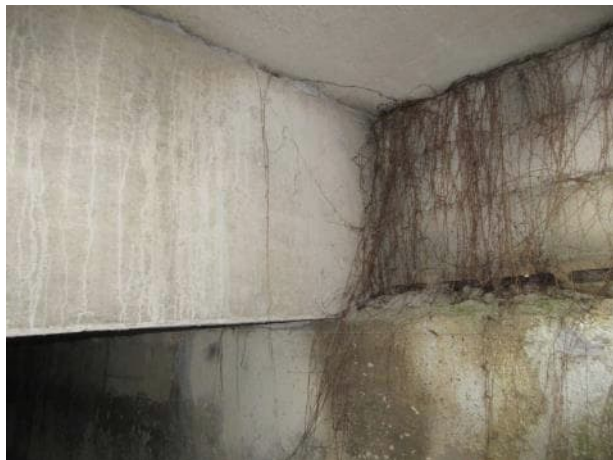
Photo 5.3.17. Beam B13 north bearing. Roots visible.

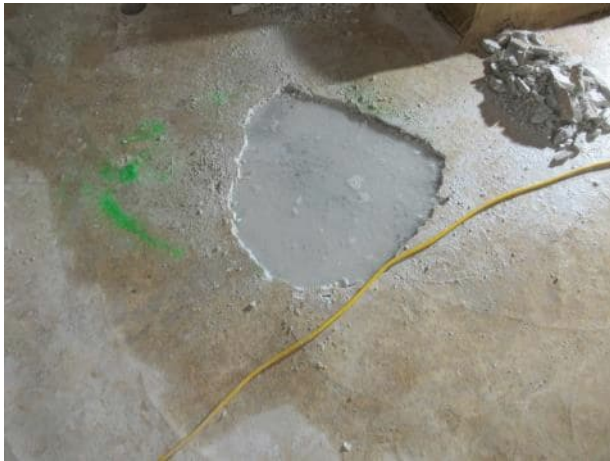
Voids were found in the floor of Section 1 and the south wall of Section 3.

Photo 5.5.1 Hollow section in Section 3 Floor (eastern end).

- The voids in Section 1 and 3 appear to be localized and we would recommend filling those areas with a cement slurry/grout.
- The new reservoir floors should be designed to span over small voids or soft material. This will ensure that the slab can span over the filled area in Section 4.
- The roof slab should be resealed to prevent water ingress. This will mitigate potential long term deterioration.

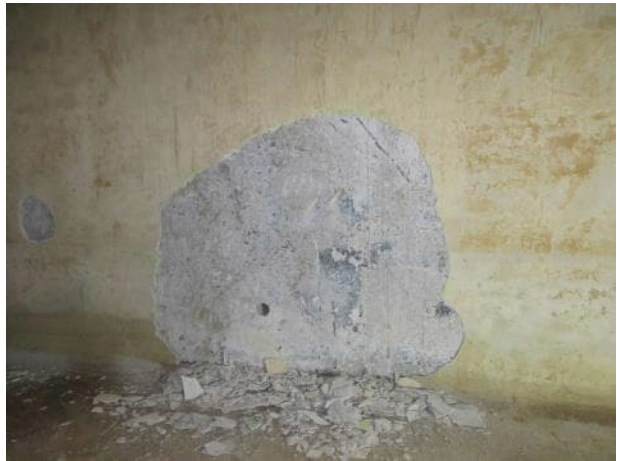
Photo 5.5.2 North wall section 3.

No issues were observed when the loose coatings were removed from the walls and floors. The concrete below appeared sound.

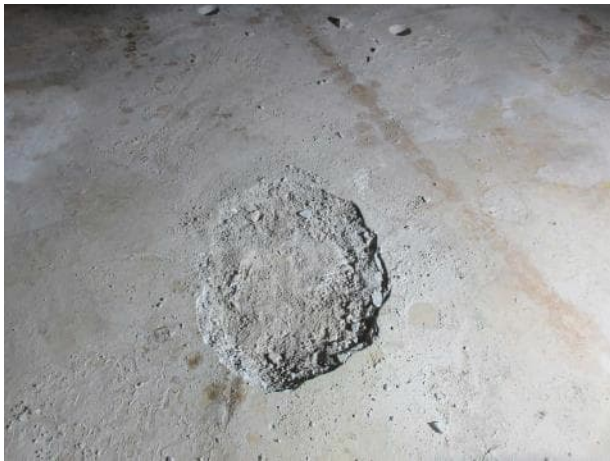
Photo 5.5.17 Hollow floor coating in Section 4 south side.
