Site Name:	Prospect Tower
Structure Type:	Guyed Tower
Structure Height:	220'
Make:	Rohn
Model:	Model 80
Tower Owner:	Government of Bermuda
Latitude:	32.299186
Longitude:	-64.765877
Date of Visit:	4/26/2017
Employees on Site:	Angie Shyrigh

Proventus Structural Services, LLC

To fulfill the inspection requirements set forth in the TIA/EIA222-G, Annex J.1 standard for Maintenance and Condition Assessment of communication structures.

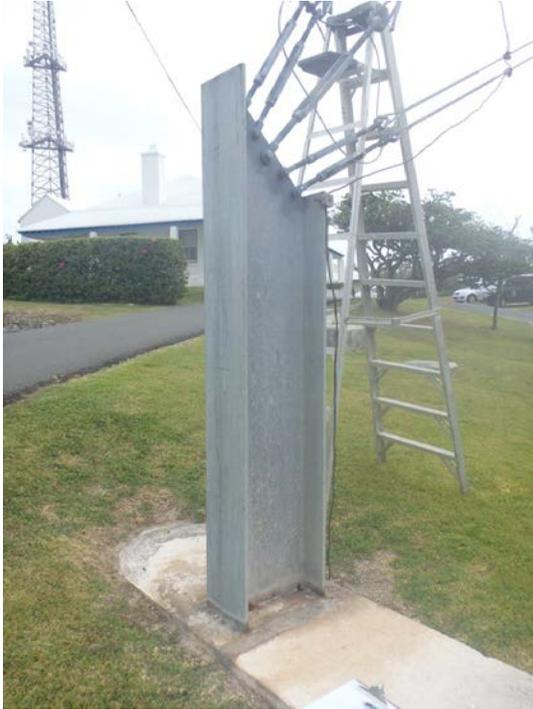
Anchor A
File 001

Elevation	Location	Description	Recommendation	Priority
Ground	Anchor A	Scaling rust is present and advancing at the base of the Anchor A elevation beam.	It is recommended the Engineer of Record be consulted to determine corrective action.	To be scheduled within 12 months
Ground	Anchor B	Scaling rust is present at the guy anchor rods and approximately ¼" material from the diameter of each anchor rod is present.	It is recommended the Engineer of Record be consulted to determine corrective action.	To be scheduled within 12 months
Ground	Base plate	Extensive category 3 pitting rust is present on the base plate as well as the bearing plate.	It is recommended the Engineer of Record be consulted to determine corrective action.	To be scheduled within 12 months
Throughout height	Tower bracing	Numerous tower bracing members (approximately 35% of the diagonals and horizontals) have category 3 rust and are rusted from the inside out at the weep holes.	Replacement of the members would be recommended for much smaller quantities of rusted through bracing members, however due to the quantity, and in light of the condition of other essential components, it is recommended the tower be replaced.	To be scheduled within 2 years

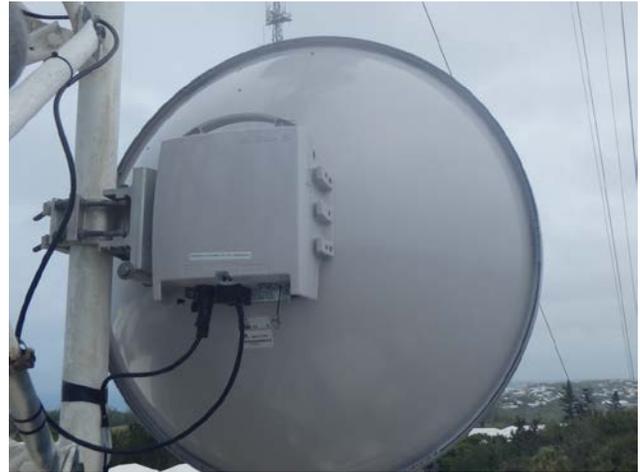
Antenna #1
File 110

Elevation	Location	Description	Recommendation	Priority
46'	B Leg	Antenna #1 mount is secured to the tower with a zip tie.	It is recommended the mount be replaced.	To be scheduled within 12 months
111'	A Leg	The top of antenna #19 is trapped behind a tower bracing member.	It is recommended the antenna be released and that a standoff be installed at the top of the tower to prevent recurrence.	To be scheduled within 12 months
63'	CA Face	Antenna #8's stiff arm is attached to a diagonal member. Advanced category 3 rust is present at this diagonal member weep hole. The stress of the stiff arm on the failing member is potentially severe enough to cause failure of the member and contribute to the failure of the structure.	Remove and reattach the stiff arm to a tower leg.	To be scheduled within 3 months

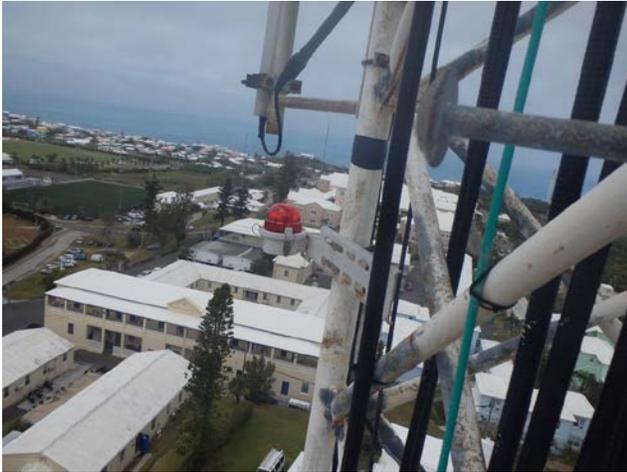
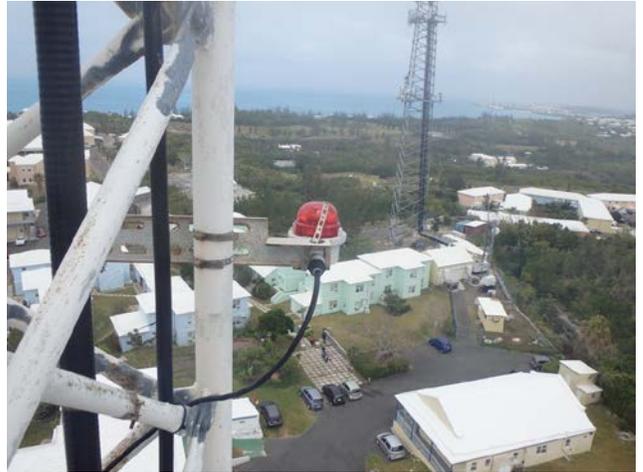
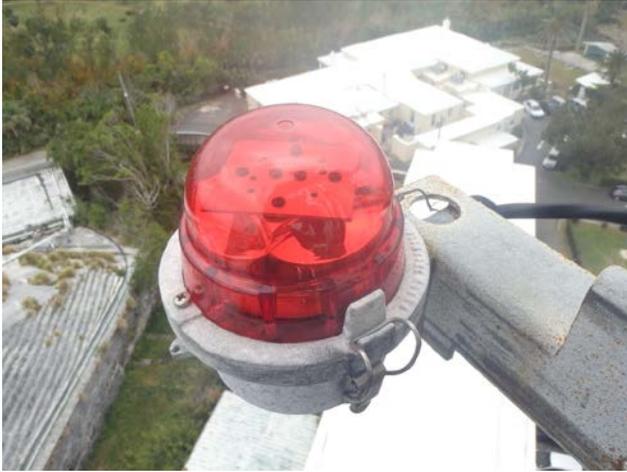
Side light
File 179

Elevation	Location	Description	Recommendation	Priority
109'	B Leg	The side light has no closure clips and is secured with a hose clamp.	It is recommended that replacement hose clamps from the manufacturer be installed.	To be scheduled within 3 months
