## Annex B: Project Location Details

Below are the location details for the aggregated solar PV project across thirty-three (33) government-owned buildings.

PROJECT NAME  
**RMI SOLAR PROJECTS**

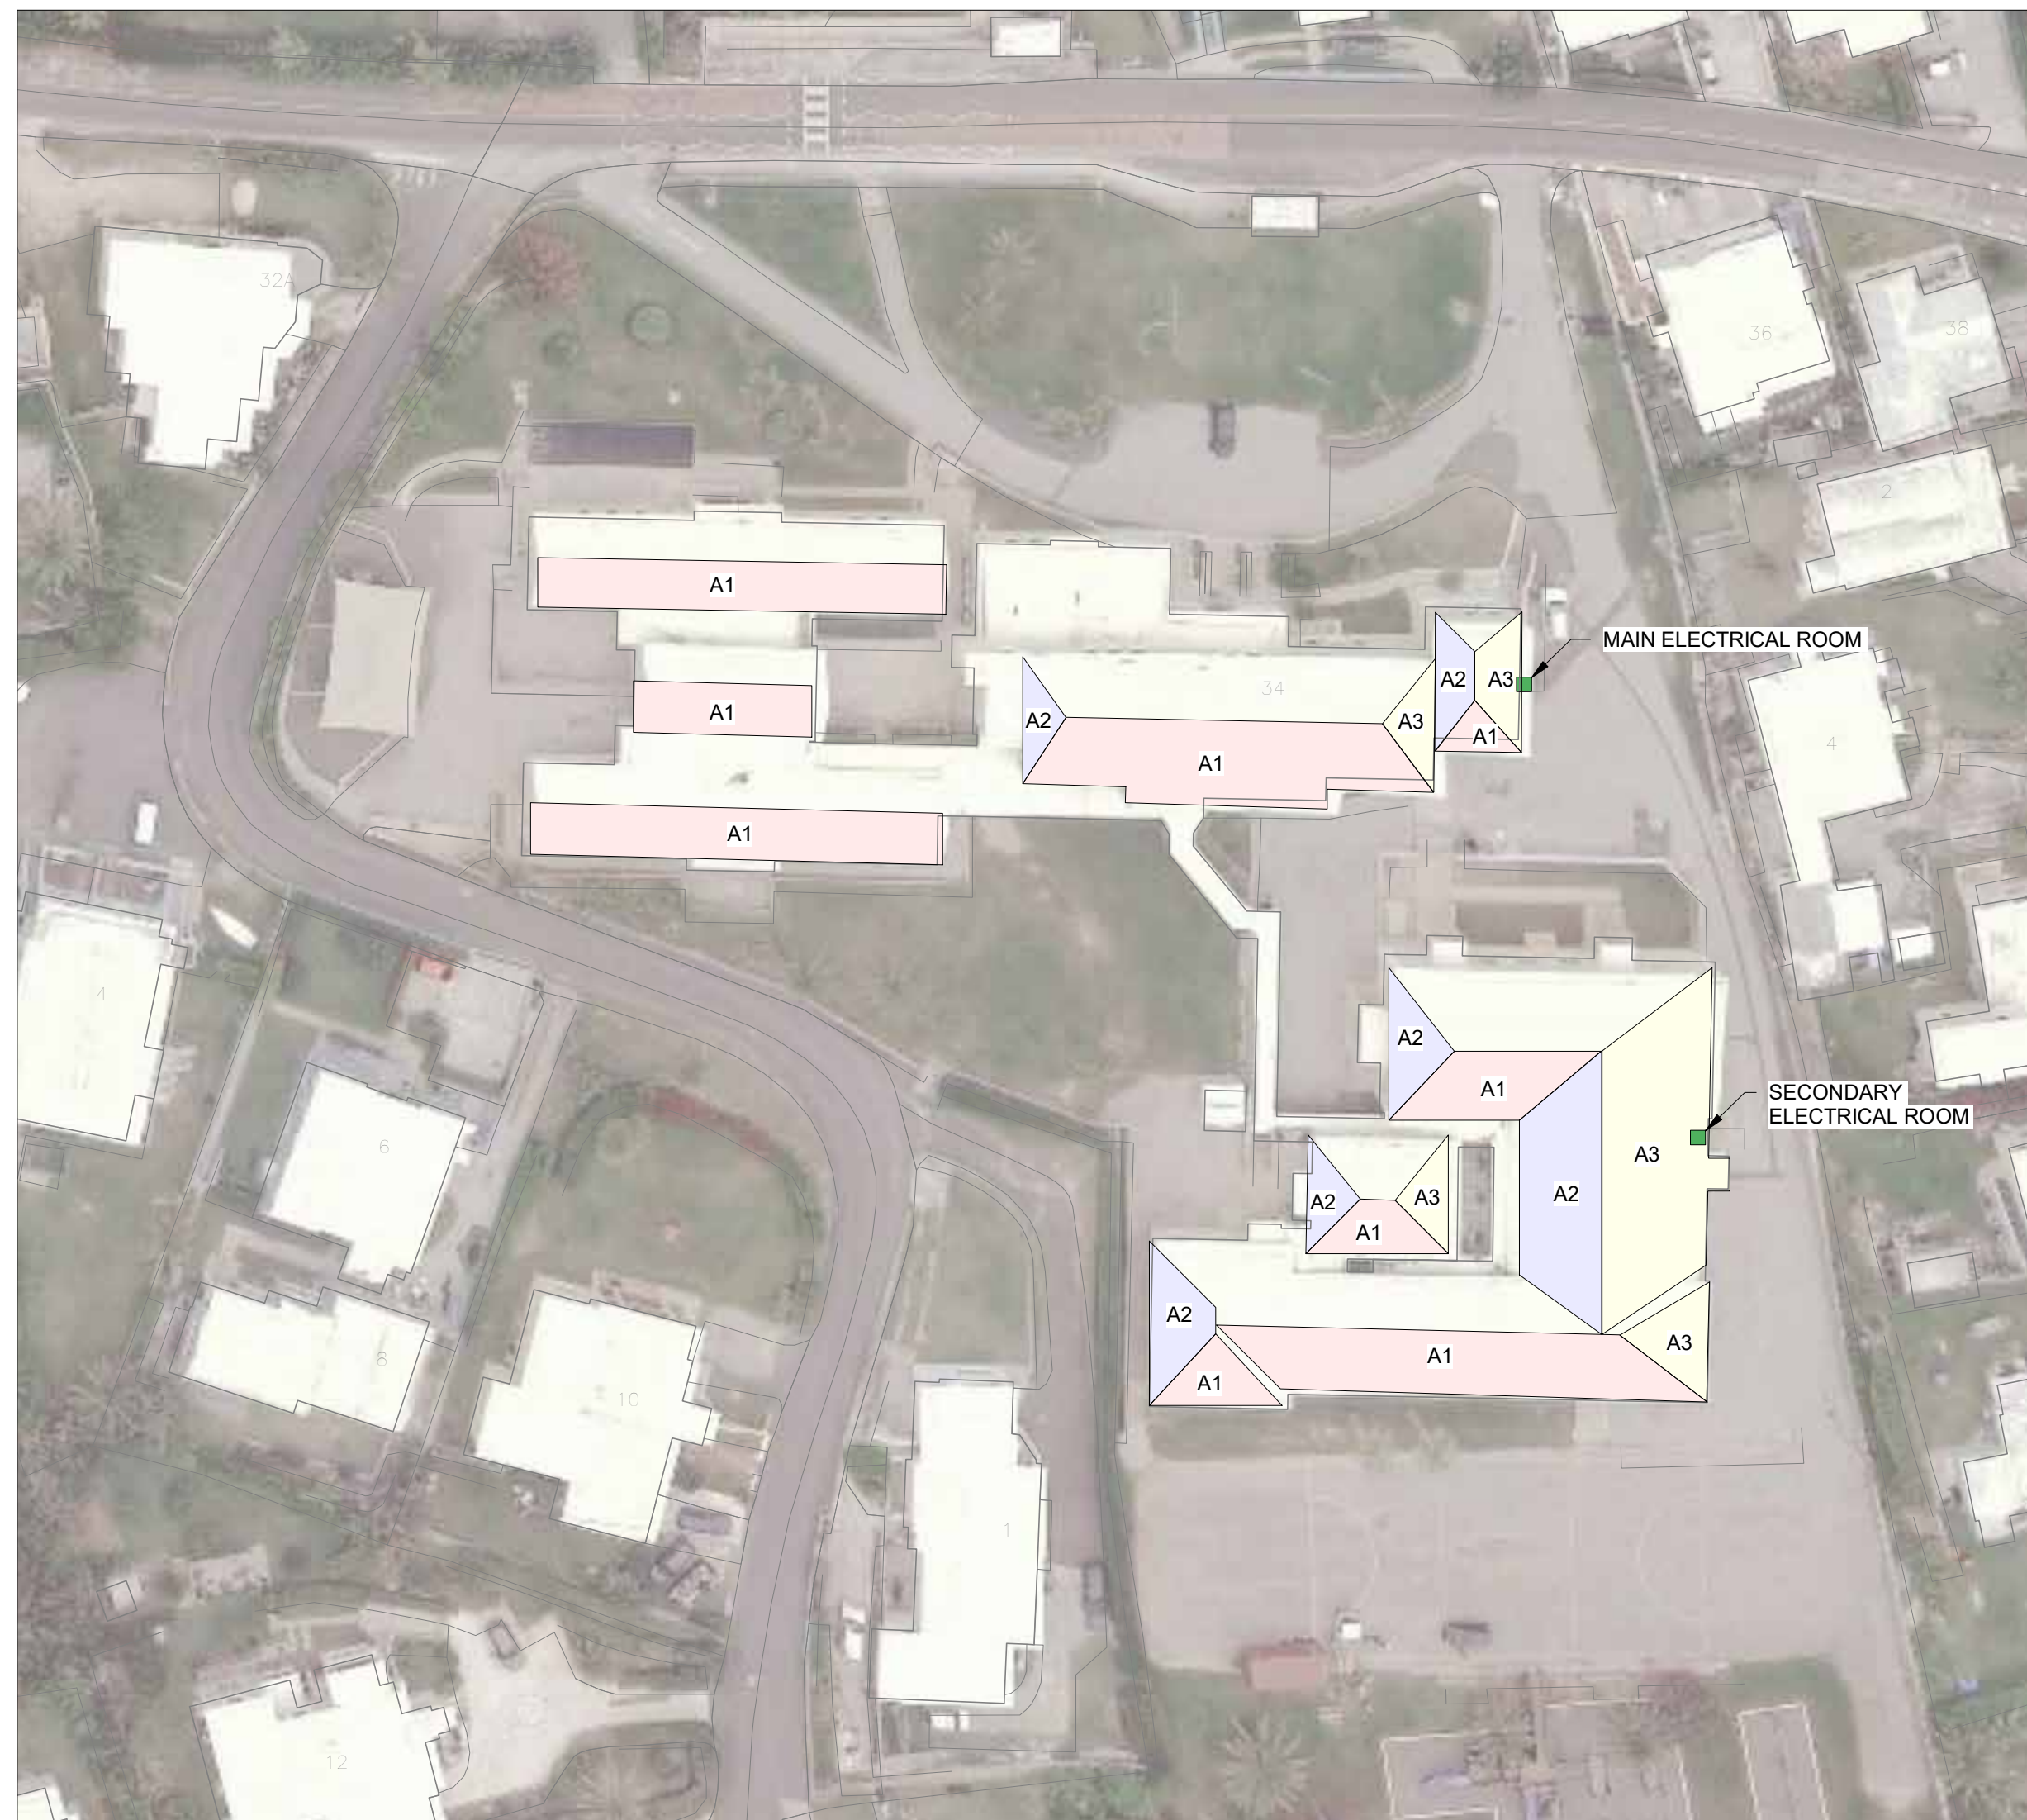
1 WEST PEMBROKE PRIMARY SCHOOL - SITE PLAN  
 C211 1" = 40'-0"

STRUCTURE TYPES:  
 1. SLATE BERMUDA ROOF WITH TIMBER FRAME. IN REASONABLE CONDITION.  
 2. TPO OVER PLYWOOD OR CEMENT BOARD. IN GOOD CONDITION.

ELECTRICAL NOTES:  
 1. THE MAIN DISTRIBUTION PANEL IS HOUSED IN THE LOWER LEVEL OF THE ENTRANCE BUILDING WITH A SECONDARY SUB-PANEL IN AN ADJACENT BUILDING. INDICATED ON THE PLAN  
 2. BOTH MAIN AND SECONDARY ELECTRICAL ROOMS ARE SERVED WITH 120/240V SINGLE PHASE FEEDS. \*THIS SHOULD BE CONFIRMED ON SITE WITH AN ELECTRICAL TEST.

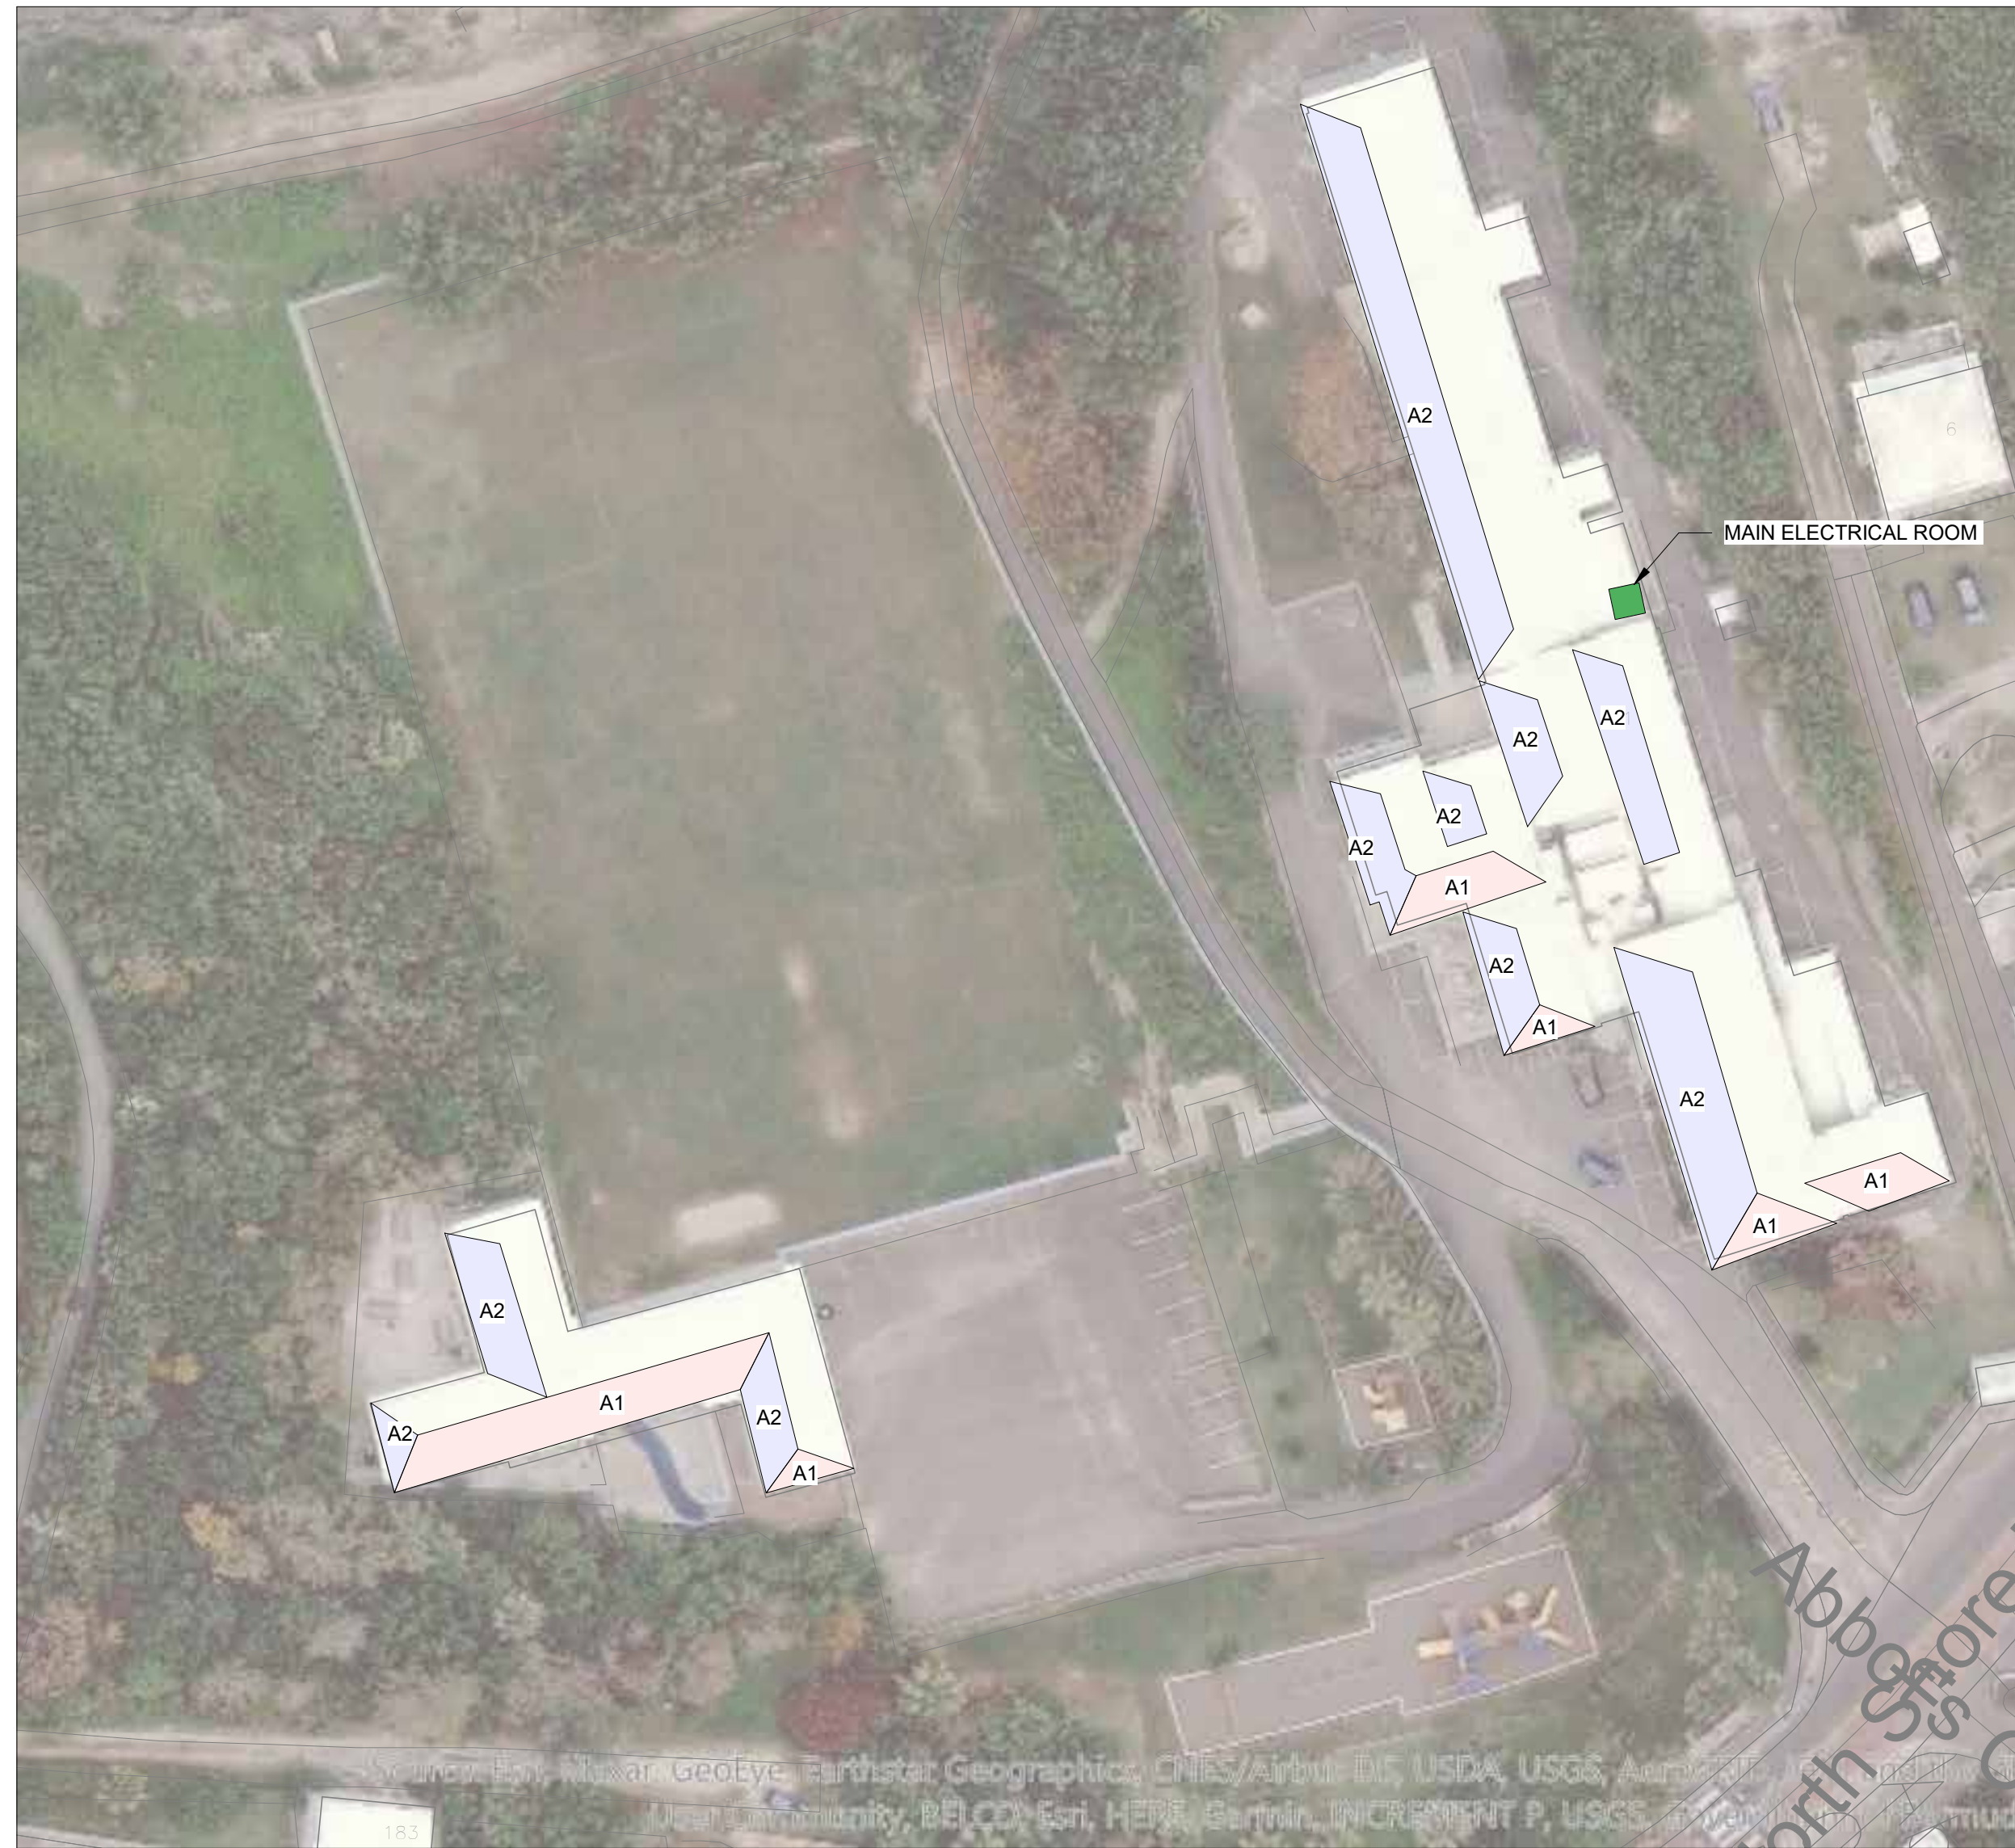
1 LYCEUM PRESCHOOL, FRANCIS PATON PRIMARY - SITE PLAN  
C218 1" = 40'-0"

- 1. SLATE BERMUDA ROOF WITH TIMBER FRAME. IN FAIR CONDITION.

- 1. THE MAIN ELECTRICAL ROOM IS LOCATED ON THE EASTERN SIDE OF THE BUILDING. INDICATED ON THE PLANS. IT WAS NOT INSPECTED BUT UNDERSTOOD THERE IS SUB PANEL LOCATED WITHIN THE SEPERATE LYCEUM PRESCHOOL.
- 2. INFORMATION FROM THE PANLES INDICATES THERE IS 120/240V SINGLE PHASE FEED SUPPLIED TO THE PROPERTY. \*THIS SHOULD BE CONFIRMED ON SITE WITH AN ELECTRICAL TEST.

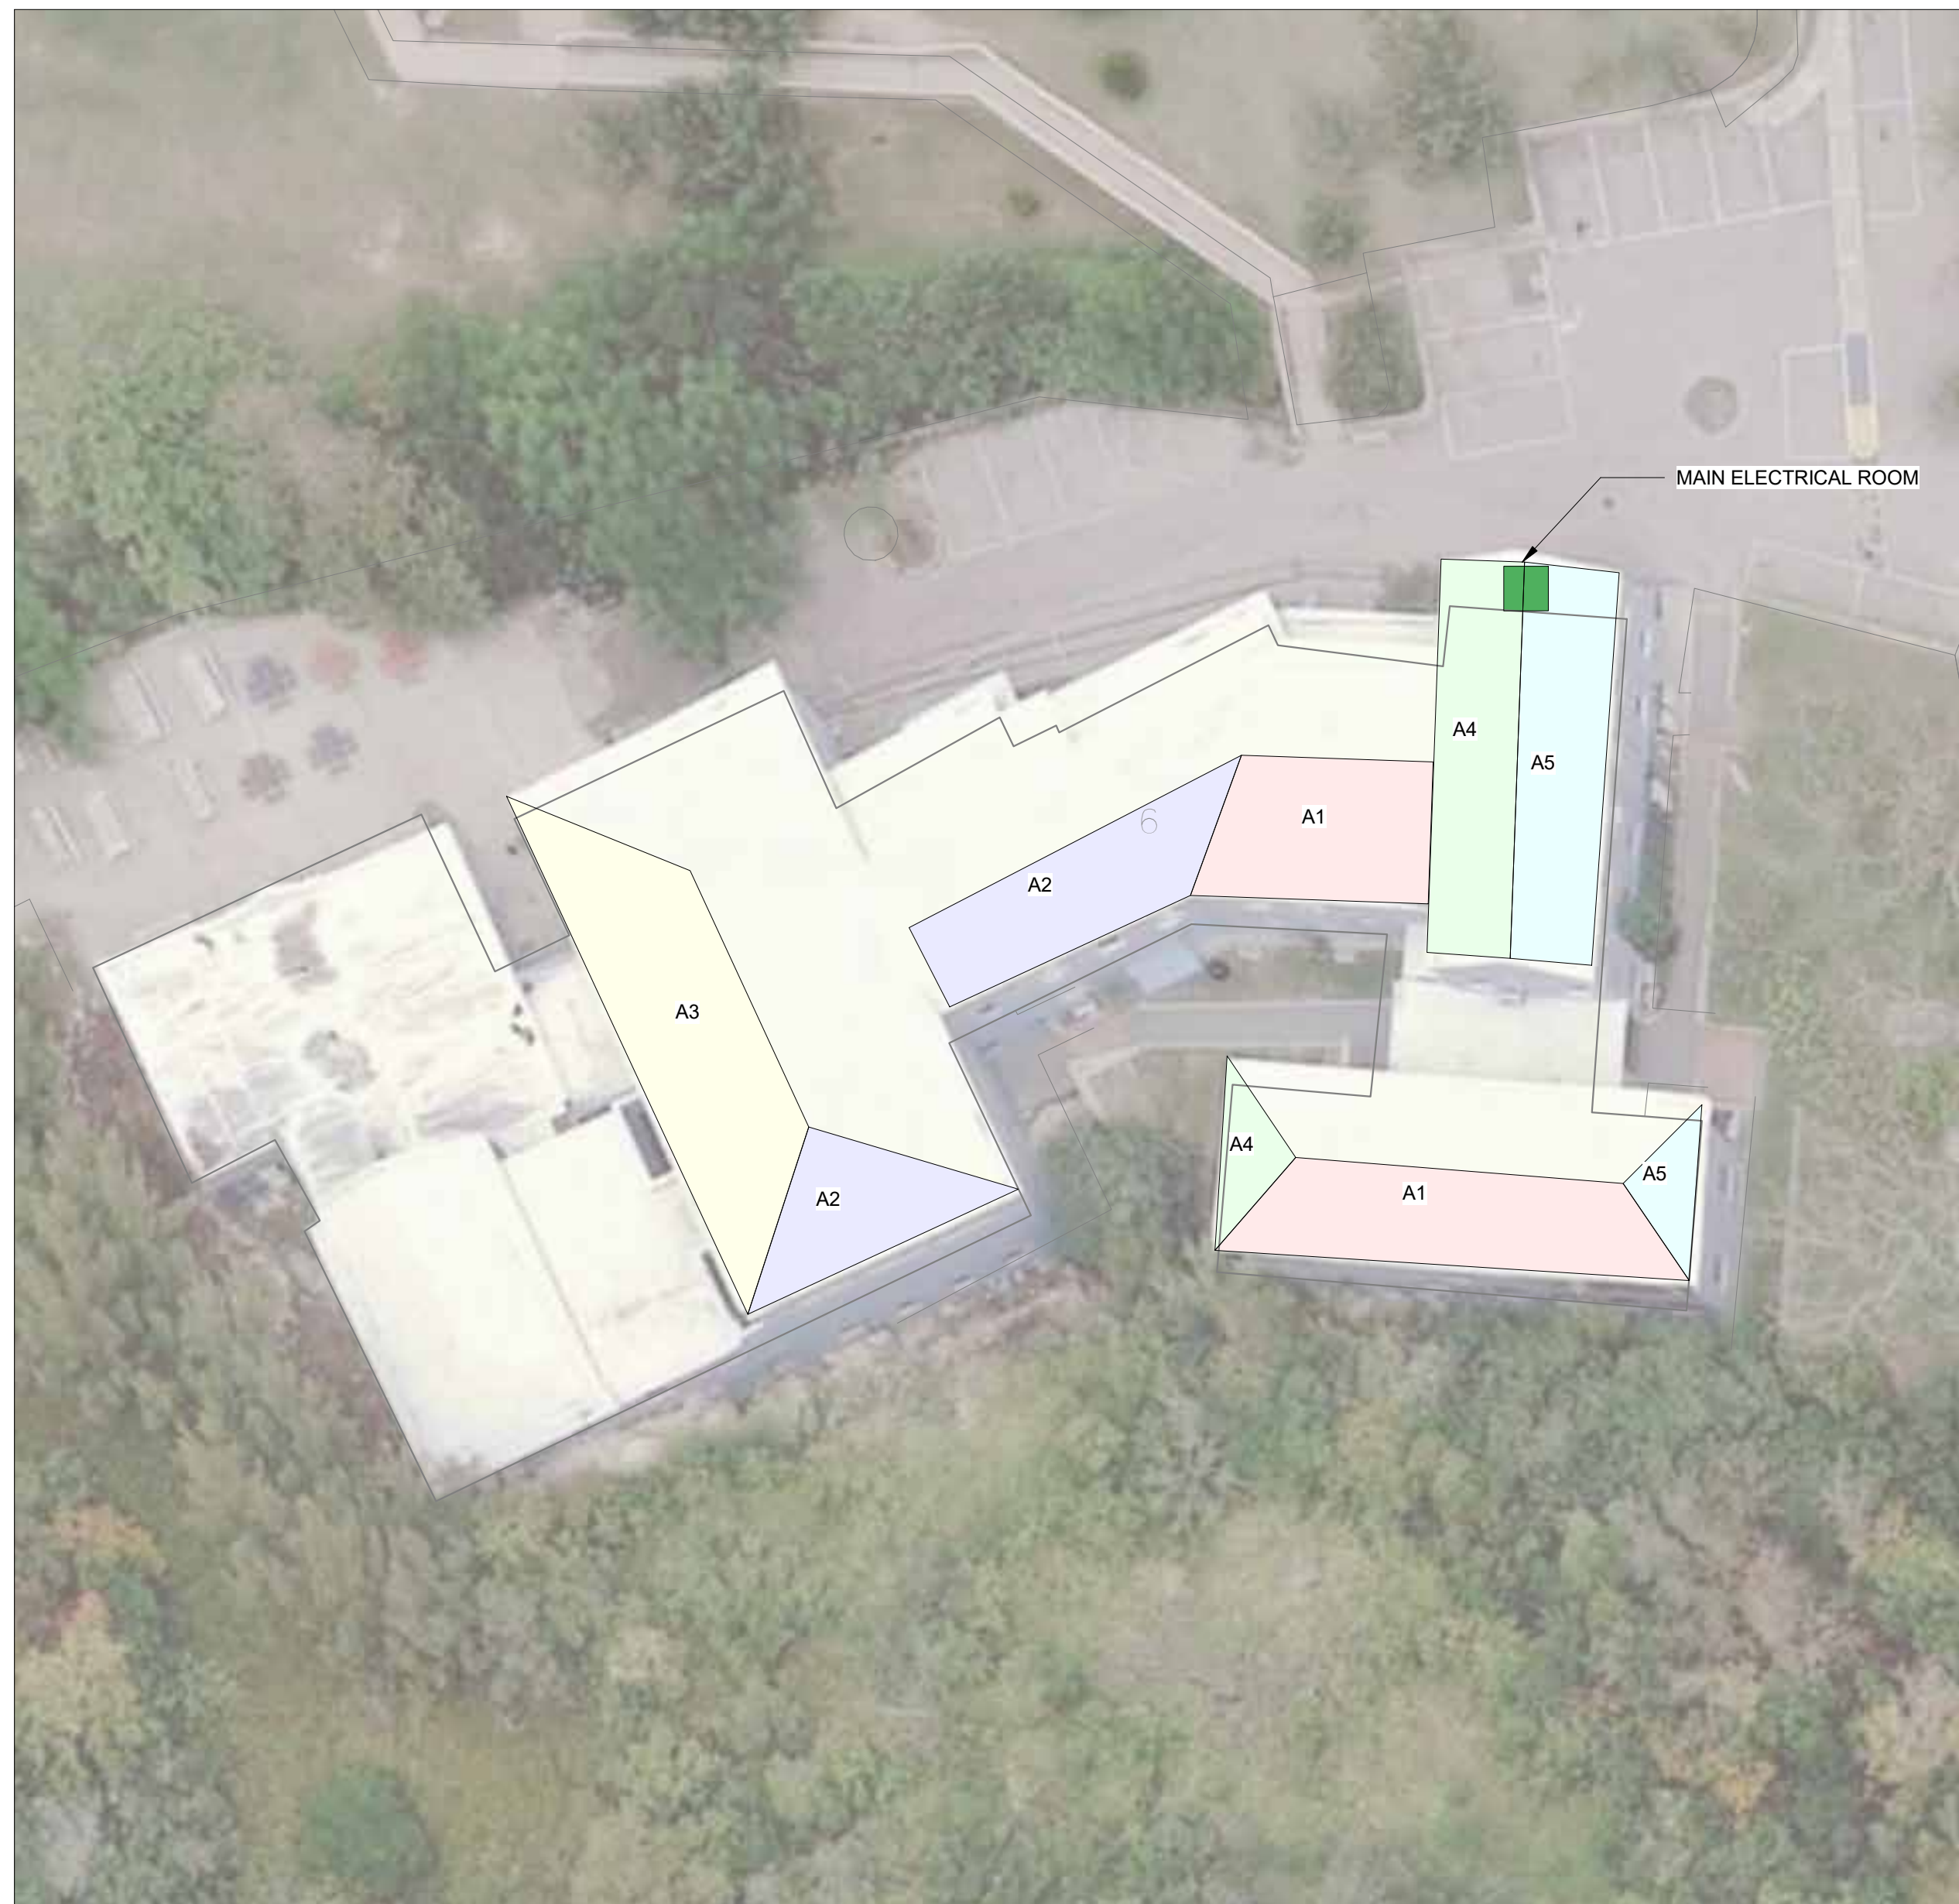
1 PORT ROYAL PRIMARY SCHOOL - SITE PLAN  
 C220 1" = 20'-0"

- SLATE BERMUDA ROOF WITH TIMBER FRAME. IN REASONABLE CONDITION.
- CONCRETE ROOF.

- THE MAIN ELECTRICAL ROOM IS LOCATED ON THE GROUND FLOOR ON THE NORTH WESTERN END OF THE BUILDING. INDICATED ON THE PLAN.
- INFORMATION ON THE PANEL INDICATED THERE IS 120/240V SINGLE-PHASE FEED SUPPLIED TO THE BUILDING. \*THIS SHOULD BE CONFIRMED ON SITE WITH AN ELECTRICAL TEST.
- THE MAIN ELECTRICAL ROOM WAS BEING UTILISED AS ADDITIONAL STORAGE RESULTING IN INSUFFICIENT CLEARANCE IN FRONT OF THE PANELS, THIS SHOULD BE CLEARED TO MAINTAIN CODE COMPLIANCE.

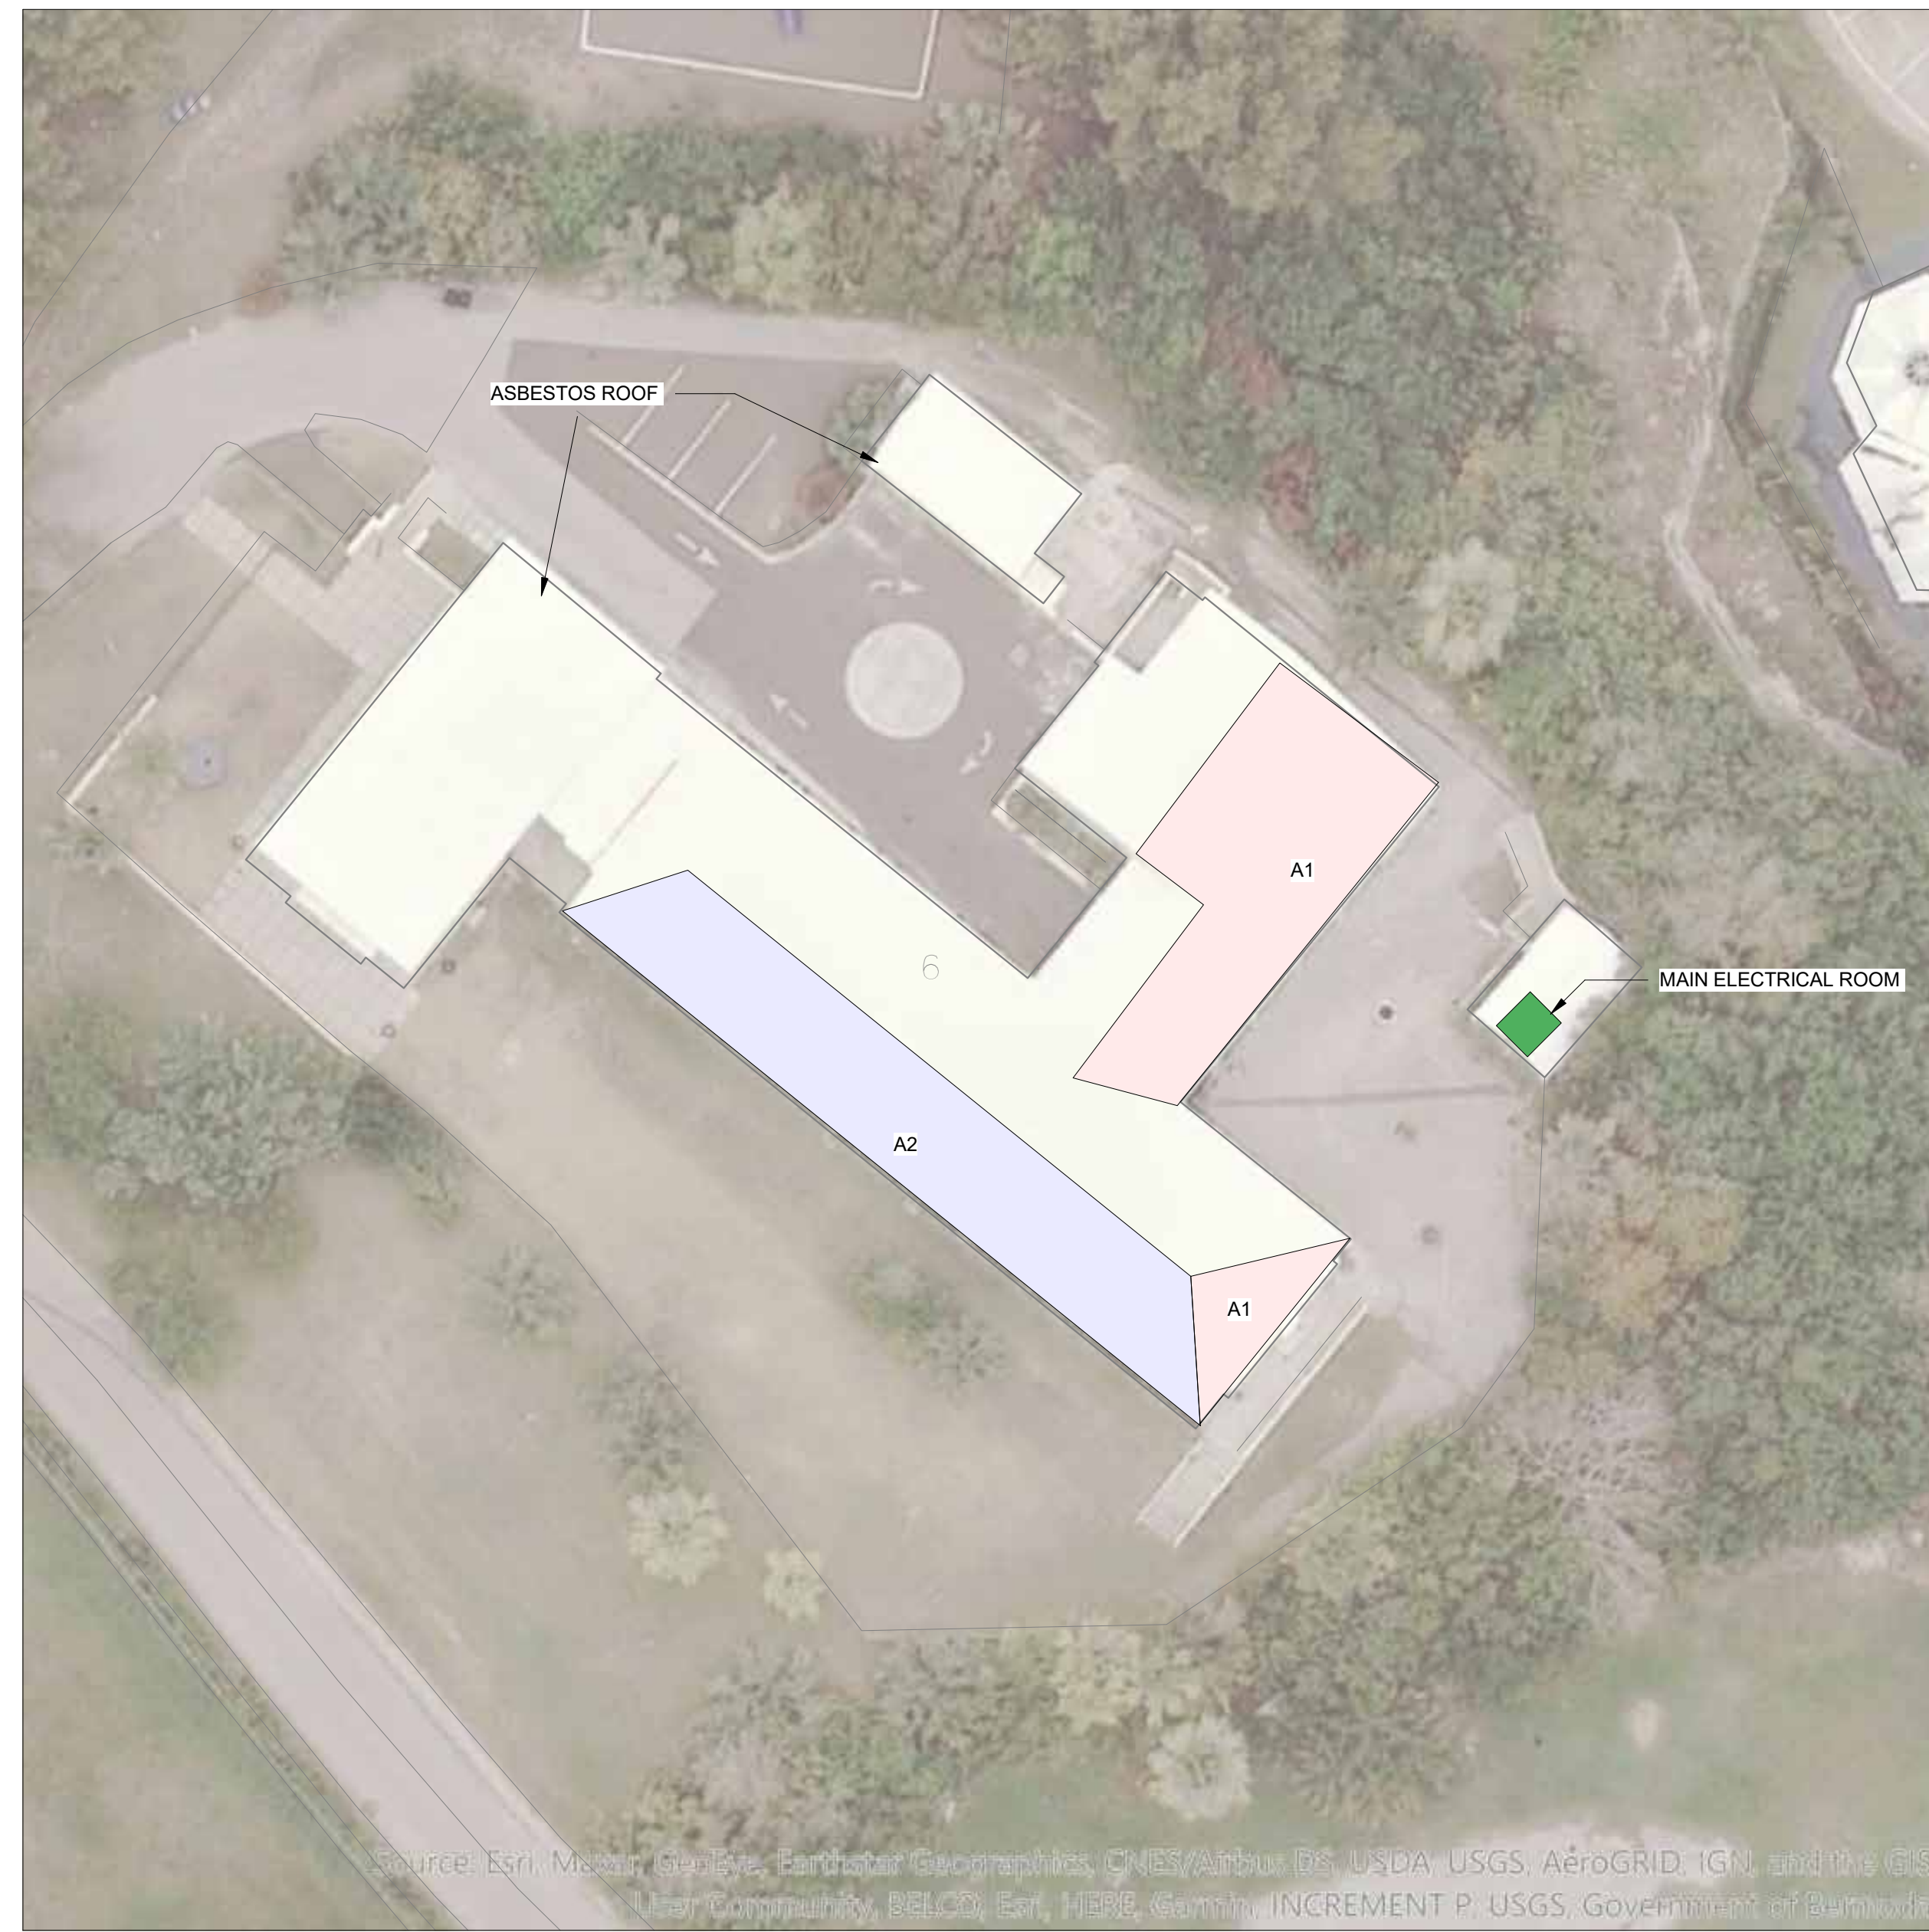
1 PROSPECT PRESCHOOL - SITE PLAN  
C221 1" = 20'-0"

- SLATE BERMUDA ROOF WITH TIMBER FRAME. IN REASONABLE CONDITION.
- CORRUGATED ASBESTOS ROOF WITH TIMBER FRAME.

- THE MAIN ELECTRICAL ROOM IS LOCATED IN A SEPERATE STRUCTURE TO THE EAST OF THE MAIN BUILDING, INDICATED ON THE PLAN.
- INFORMATION ON THE PANELS INDICATES THERE IS 120/240V SINGLE-PHASE POWER SUPPLY. \*THIS SHOULD BE CONFIRMED ON SITE WITH AN ELECTRICAL TEST.
- THE ELECTRICAL EQUIPMENT SHOWED SIGNS OF AGE RELATED DETERIORATION AND REFRESH OF THE EQUIPMENT SHOULD BE CONSIDERED.
- THE MAIN ELECTRICAL ROOM WAS BEING UTILISED AS ADDITIONAL STORAGE RESULTING IN INSUFFICIENT CLEARANCE IN FRONT OF THE PANELS, THIS SHOULD BE CLEARED TO MAINTAIN CODE COMPLIANCE.
