Prospect Reservoir #1  
Refurbishment

**Addendum One**

# Site Investigation and Condition Assessment Report

Reservoir 1  
40 Fort Hill Road  
Devonshire

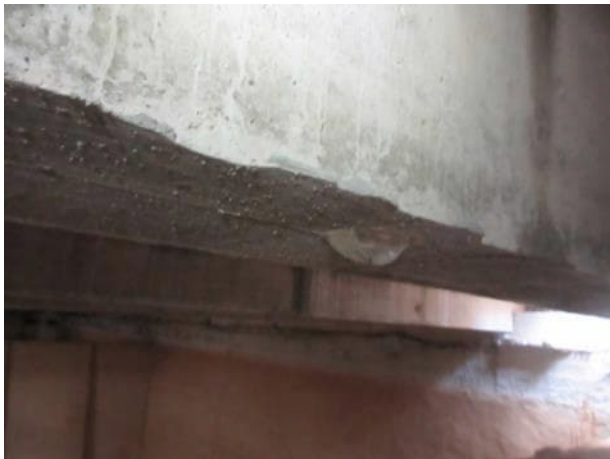
Photo 5.2.33. B10 plastic on the underside of the beam likely from the initial installation. No structural issue.

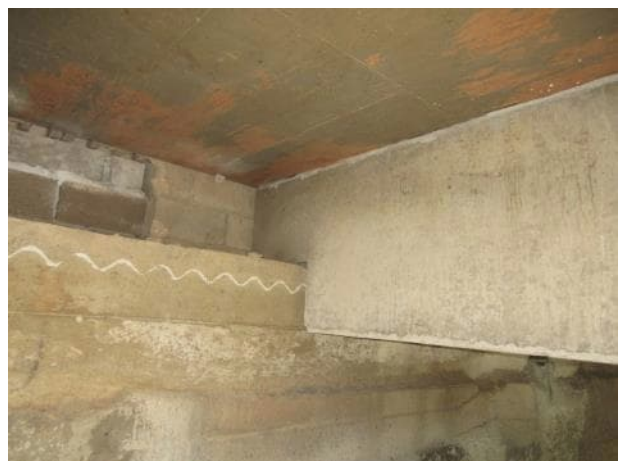
Photo 5.4.46 South bearing B16.

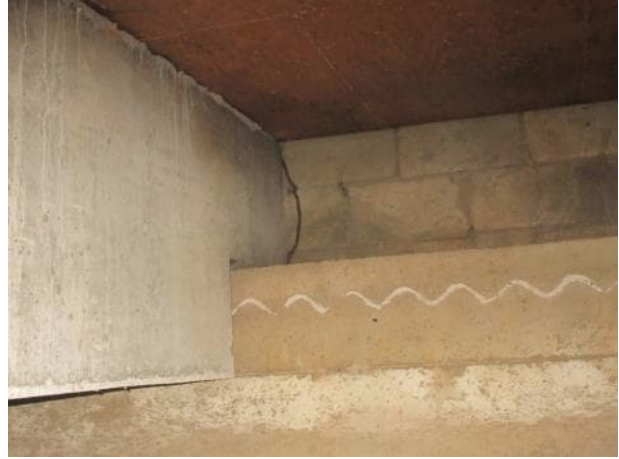
Photo 5.4.48 South bearing B16.

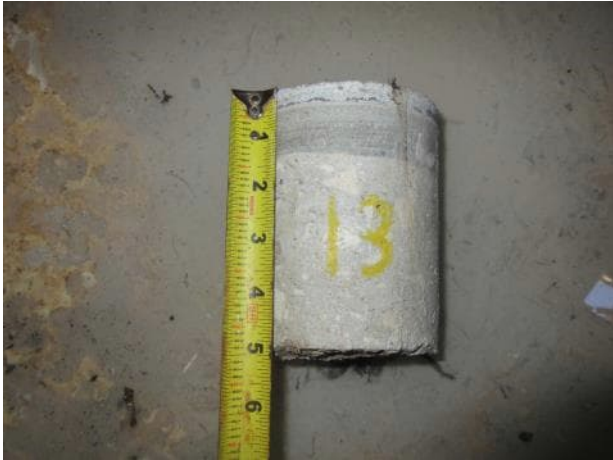
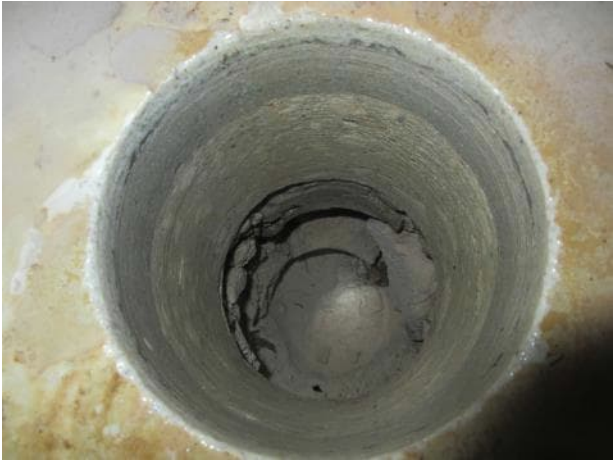
Voids were found in the floor of Section 1 and the south wall of Section 3.

| 13 | 25 Nov 25 | Section 1; floor<br>15" deep with small void below | 5" | 4" |

- The voids in Section 1 and 3 appear to be localized and we would recommend filling those areas with a cement slurry/grout.
- The new reservoir floors should be designed to span over small voids or soft material. This will ensure that the slab can span over the filled area in Section 4.
- The roof slab should be resealed to prevent water ingress. This will mitigate potential long term deterioration.

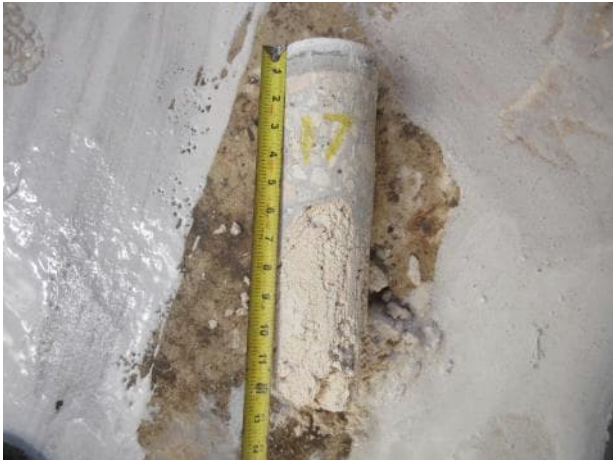
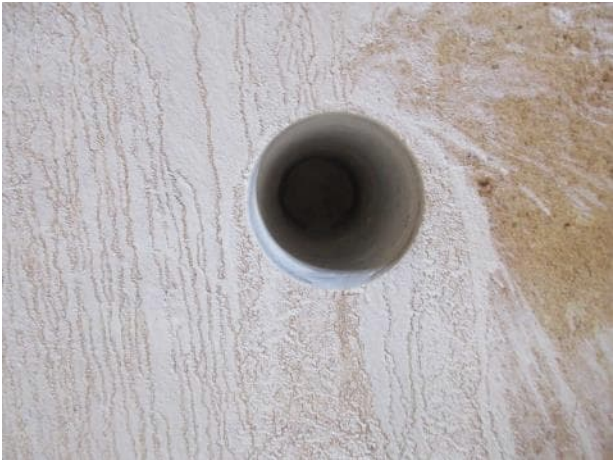
| 17 | 26 Nov 25 | Section 1; floor<br>Near void | 7" | 4" |

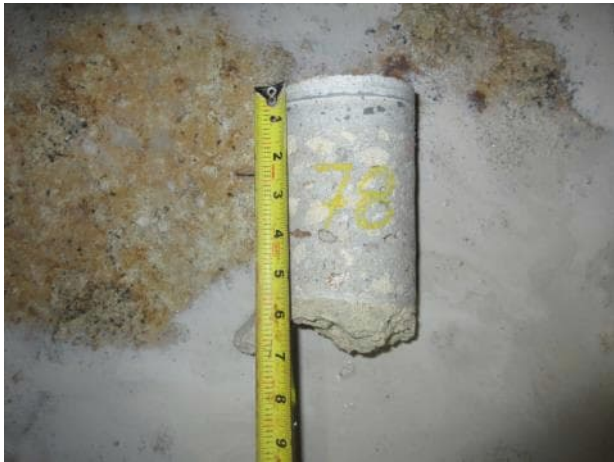
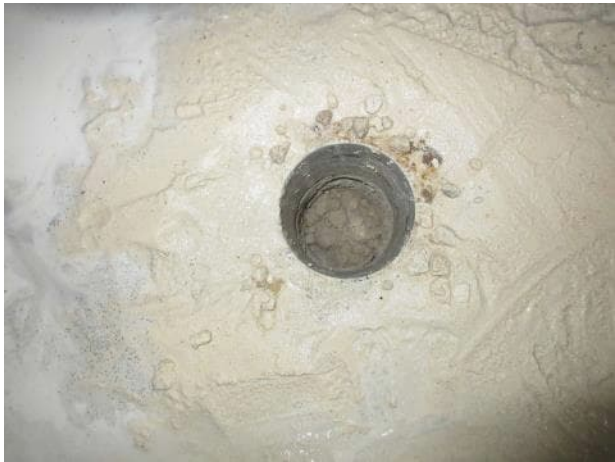
| 78 | 3 Dec 25 | Section 4; floor<br>Possible fill material below | 5 ½" | 4" |

The initial scope of work included more cores in Section 4 due to the presence of large cracks at the base of the north and south walls. No voids were found behind the walls or under the floor, however, the closest core to the south crack (Core #78) appeared to have fill material below the slab.

No void was found in Section 4 where the large cracks were located. There appeared to be fill material under one section of the floor and we believe that settlement of the structure over the fill has caused the cracks at the base of the north and south walls. The filled area did not appear to extend far based on the core samples. No reinforcing steel was found in any of the cores confirming that the walls and floors are not reinforced. This is not unusual given the age of the reservoir.

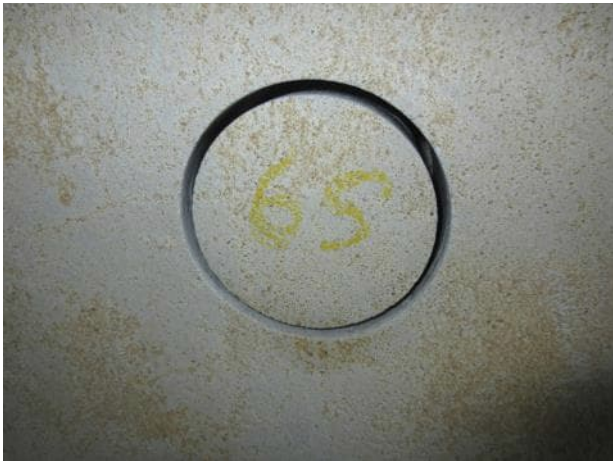
| 6S | 29 Nov 25 | Section 2; south wall | Could not be retrieved | 4" |

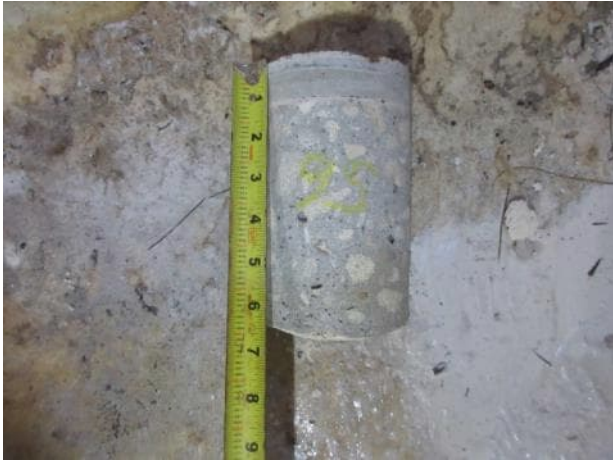
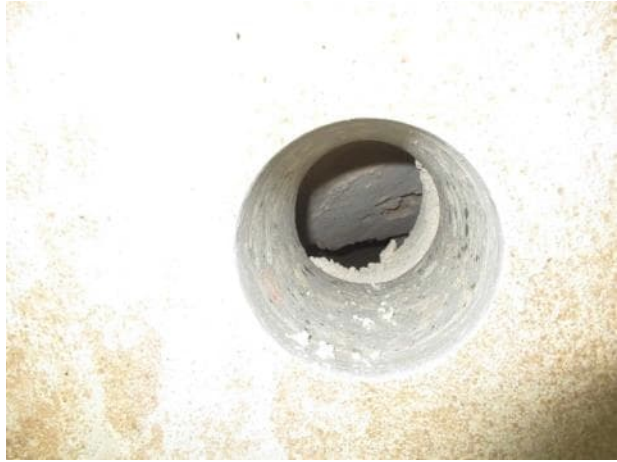
| 9S | 1 Dec 25 | Section 3; south wall<br>Large void behind wall | 6" – 8" | 4" |

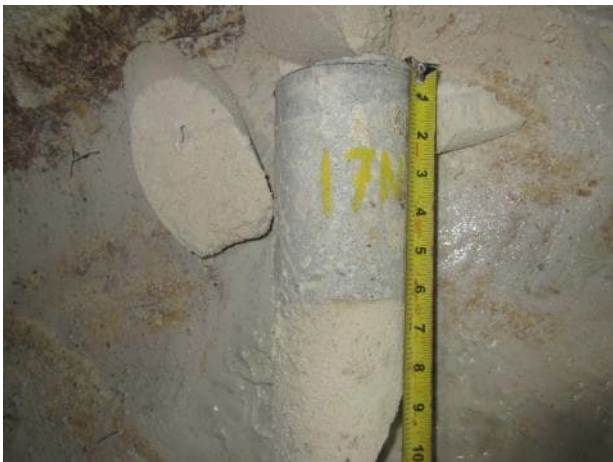
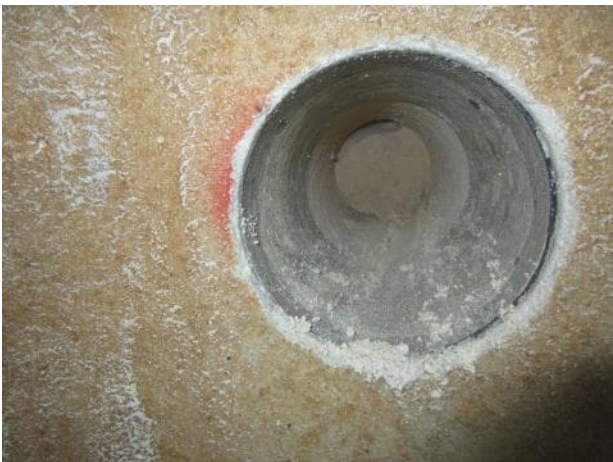
| 17N | 4 Dec 25 | Section 4; north wall<br>Coating delaminated | 6" | 4" |

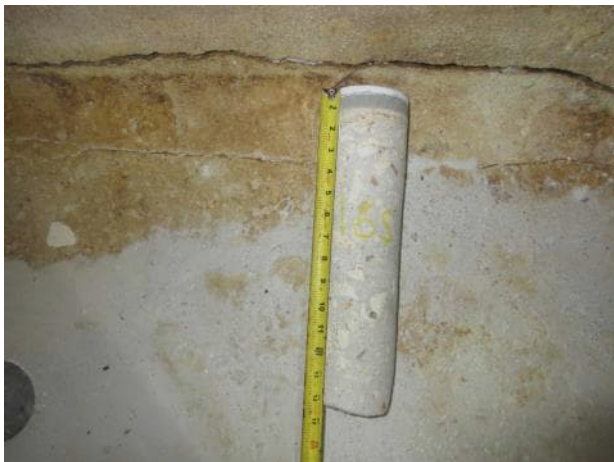
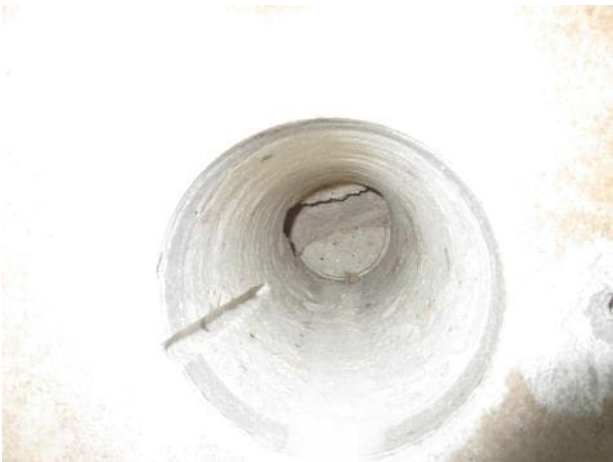
| 16S | 3 Dec 25 | Section 4; south wall<br>Small void behind | 14 ½" | 4" |
