# Site Investigation and Condition Assessment Report

Reservoir 1  
40 Fort Hill Road  
Devonshire

Mason and Associates Ltd.  
January 14, 2026

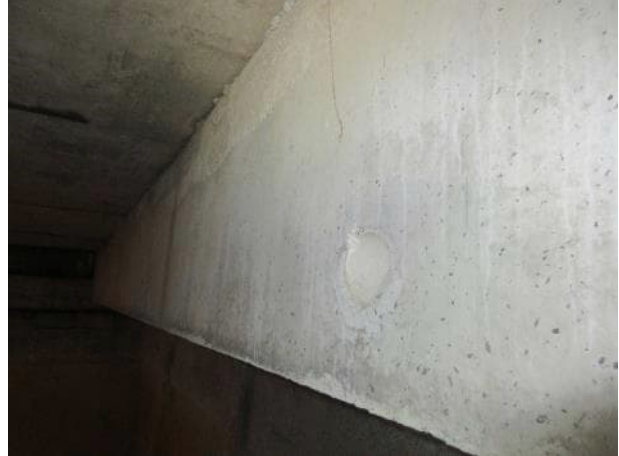
Photo 5.1.2. B1 looking south.

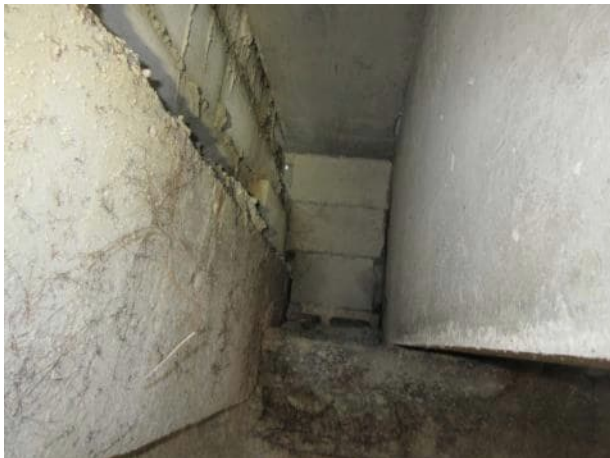
Photo 5.1.3. B1 looking north.

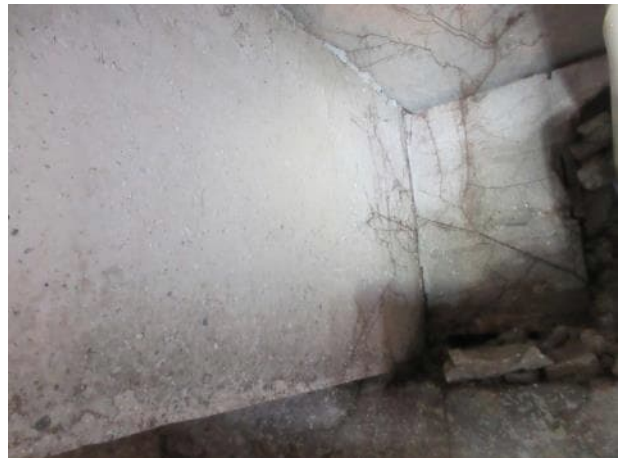
Photo 5.1.4. B1 north bearing.

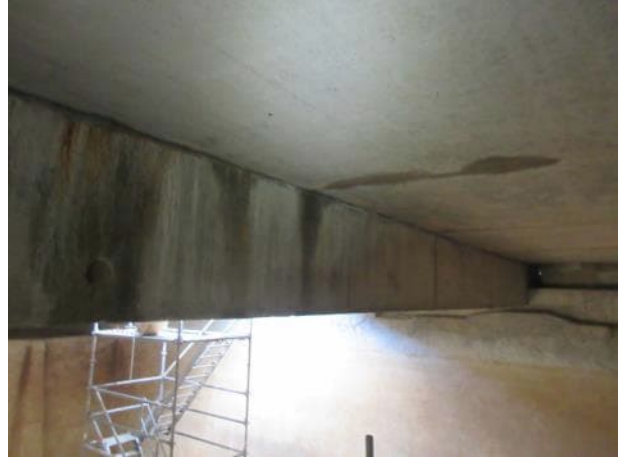
Photo 5.1.6. Beam B2.

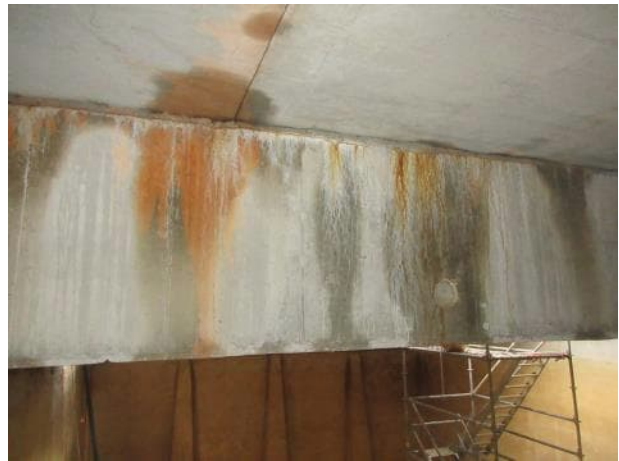
Photo 5.1.8. Beam B2.

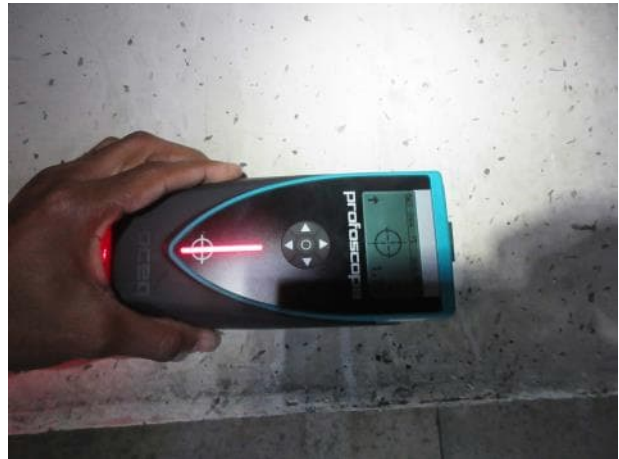
Photo 5.1.10. Rebar scan of B1.

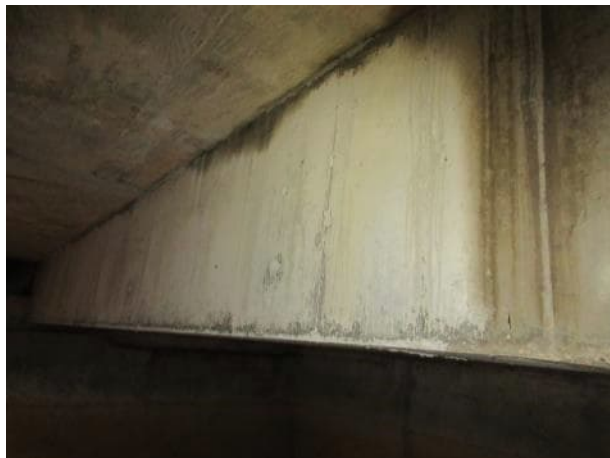
Photo 5.1.15. Beam B2.

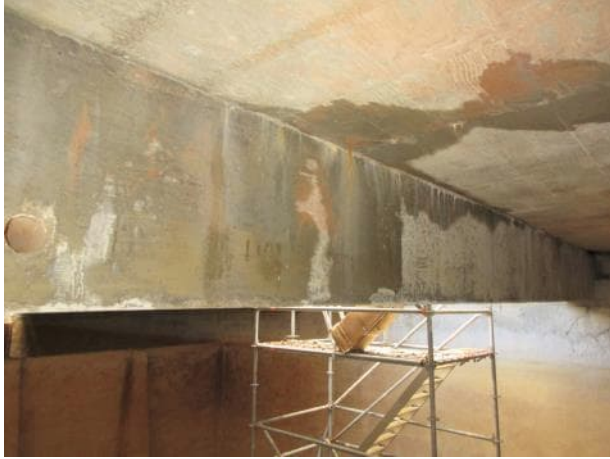
Photo 5.1.17. Beam B3.

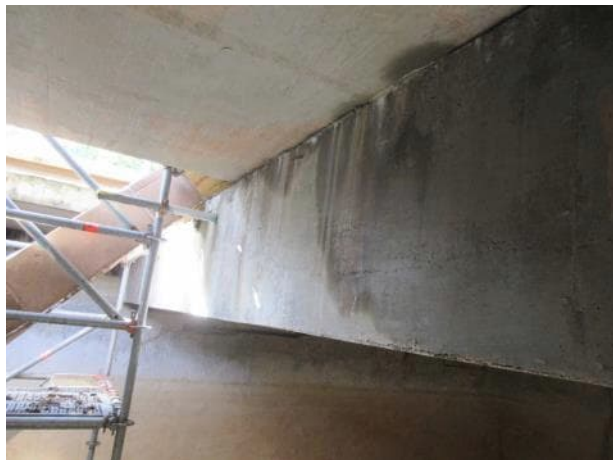
Photo 5.1.23. Beam B3.

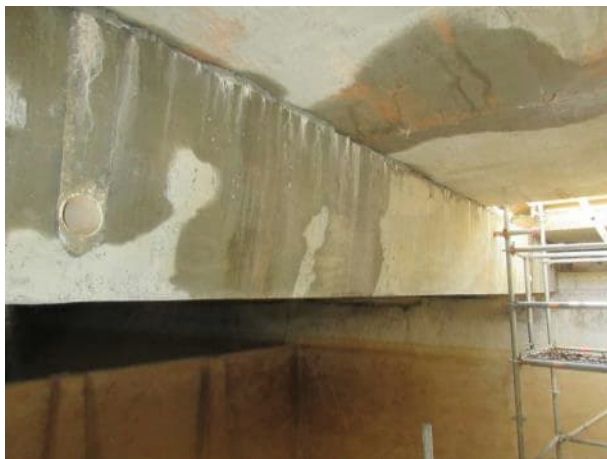
Photo 5.1.26. Beam B4.

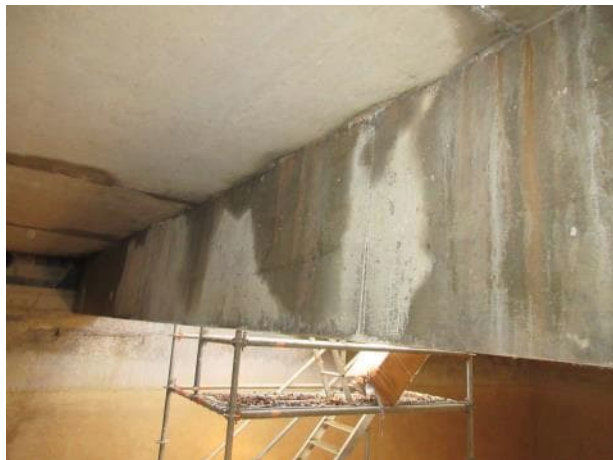
Photo 5.1.29. Beam B4.

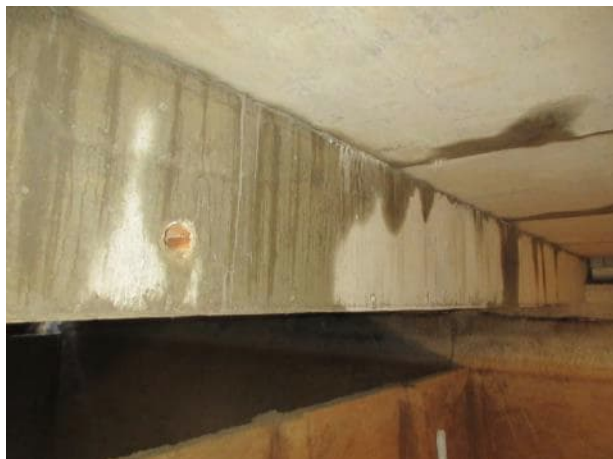
Photo 5.1.31. Beam B5.

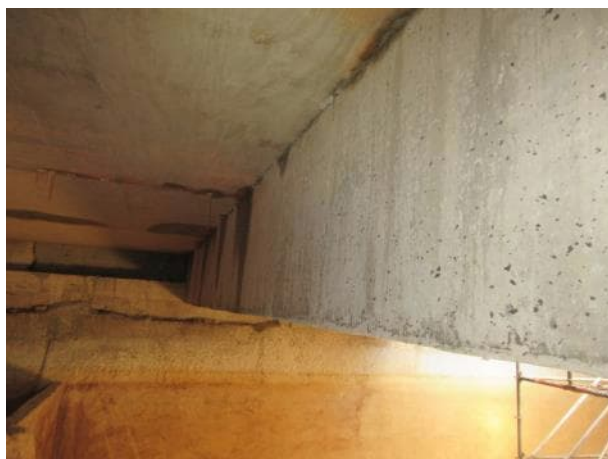
Photo 5.1.34. Beam B5.

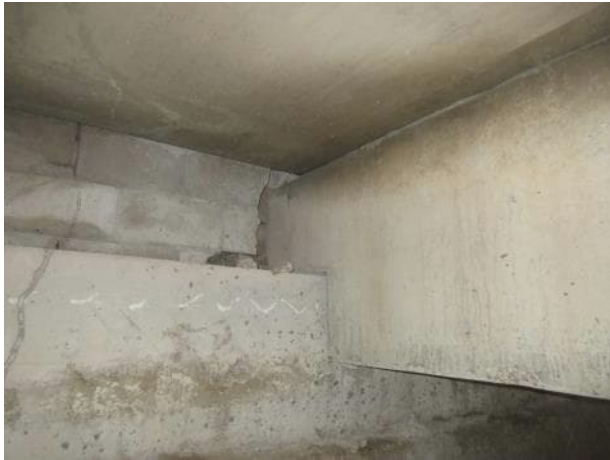
Photo 5.2.1. South end of B6 bearing.

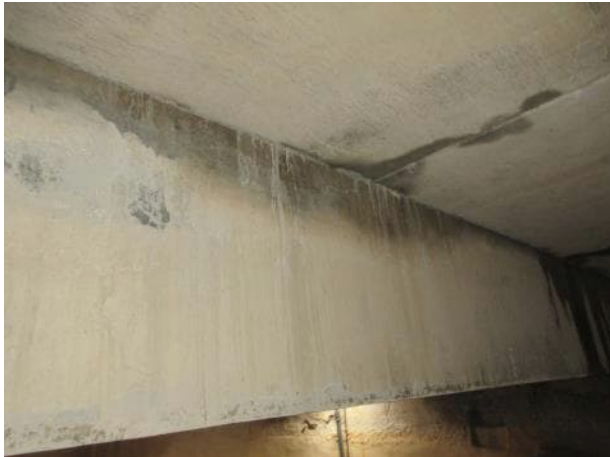
Photo 5.2.3. Beam B6.

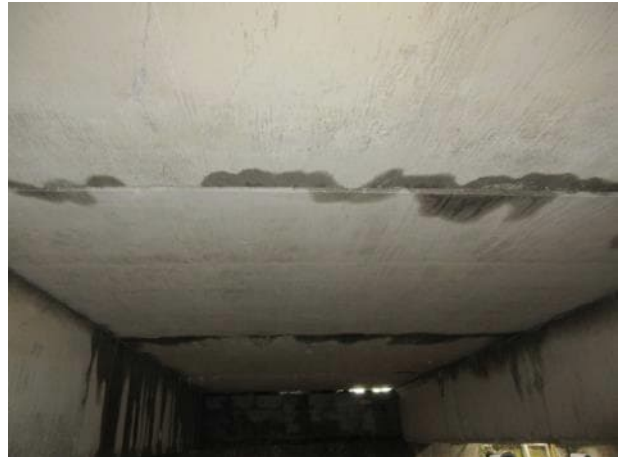
Photo 5.2.4. Underside of slab between B6 and B7.

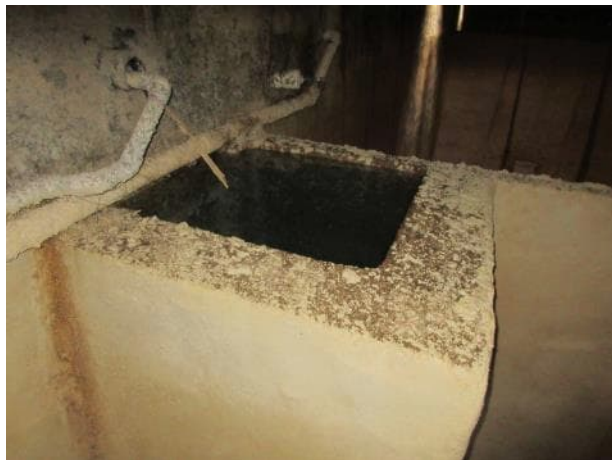
Photo 5.2.31. Water filled tower at divide wall near B10.

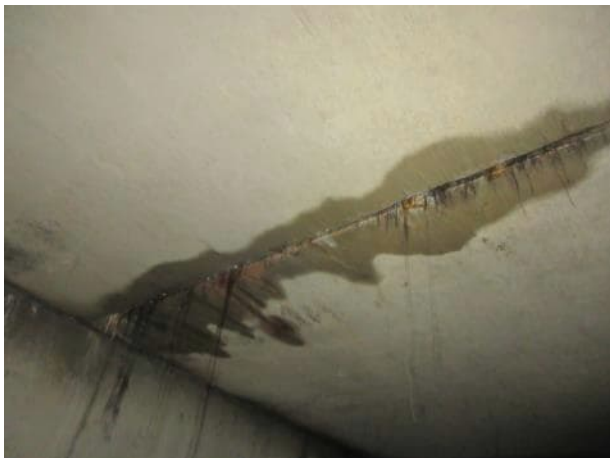
Roots were visible on various areas on the upper north and south sides of the reservoir. Roots were observed around the access on the south side of Section 3.

Photo 5.2.41. Root growth through slab joints between B8 and B9.

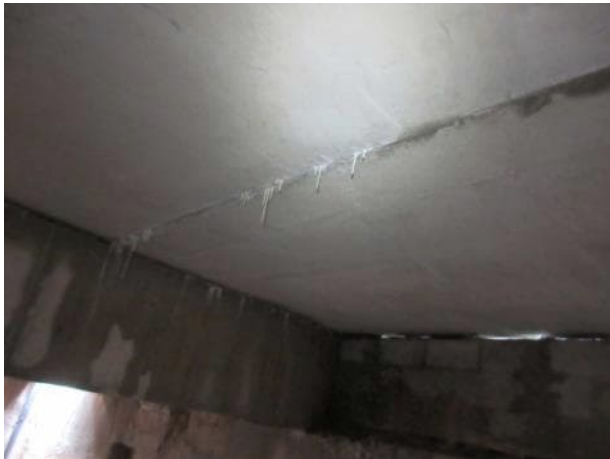
We noted that there were numerous leaks through the roof slabs. This has left staining and deposits on the beams but the leaks did not appear to cause any detrimental effects to the structure.

Photo 5.2.47. Deposits from water ingress between B5 and B6.

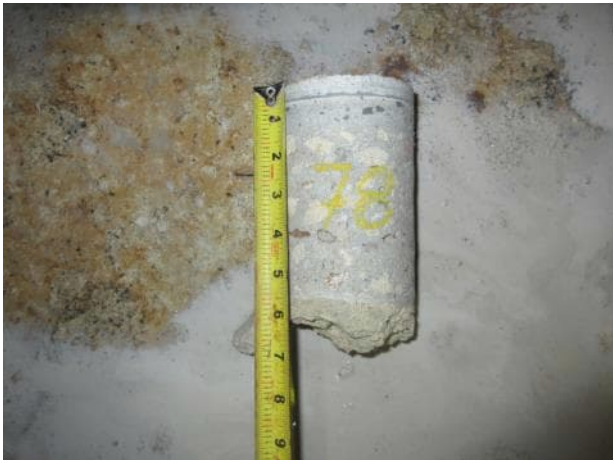
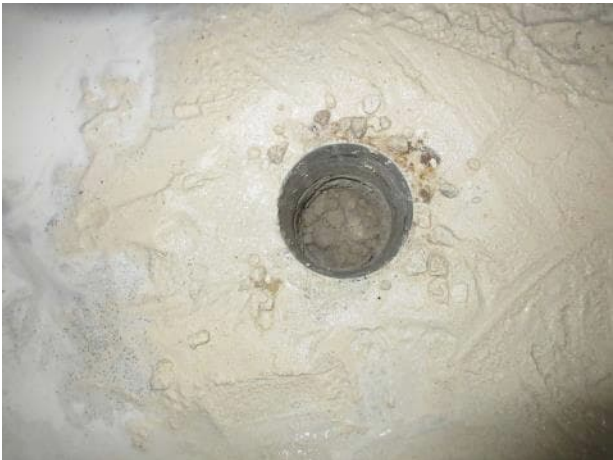
| 78 | 3 Dec 25 | Section 4; floor<br>Possible fill material below | 5 ½" | 4" |

The initial scope of work included more cores in Section 4 due to the presence of large cracks at the base of the north and south walls. No voids were found behind the walls or under the floor, however, the closest core to the south crack (Core #78) appeared to have fill material below the slab.

No void was found in Section 4 where the large cracks were located. There appeared to be fill material under one section of the floor and we believe that settlement of the structure over the fill has caused the cracks at the base of the north and south walls. The filled area did not appear to extend far based on the core samples. No reinforcing steel was found in any of the cores confirming that the walls and floors are not reinforced. This is not unusual given the age of the reservoir.

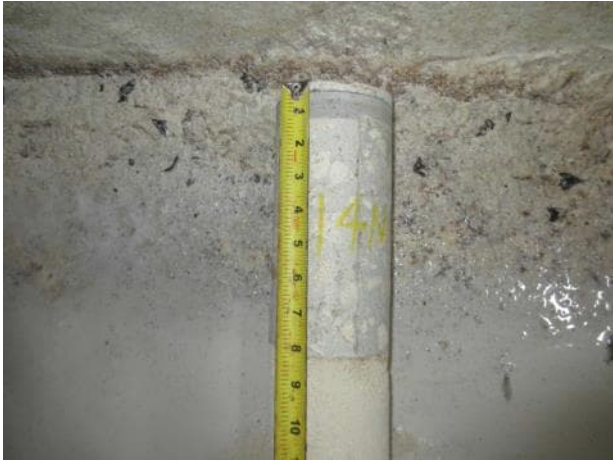
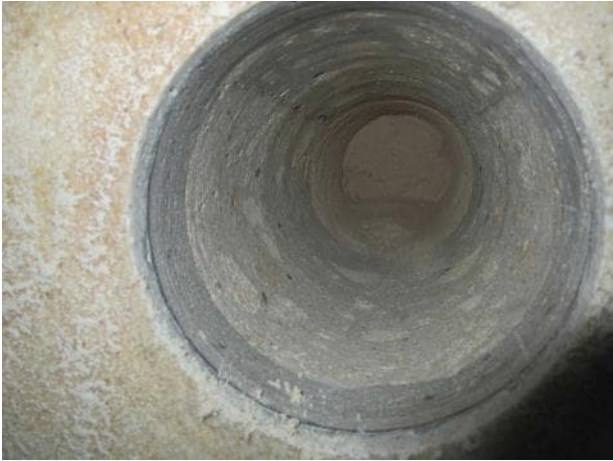
| 14N | 4 Dec 25 | Section 4; north wall | 8 ¼" | 4" |

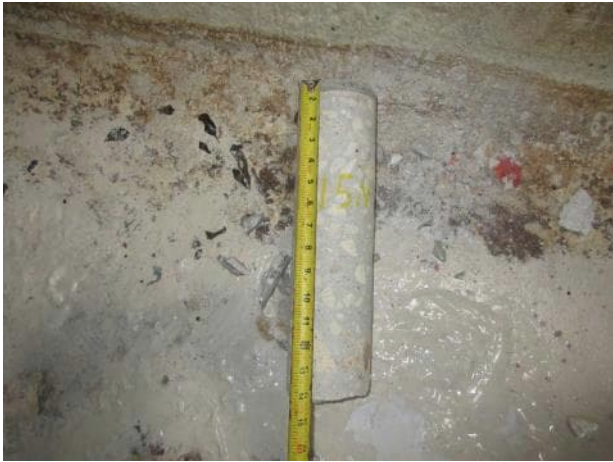
| 15N | 4 Dec 25 | Section 4; north wall | 7" | 4" |

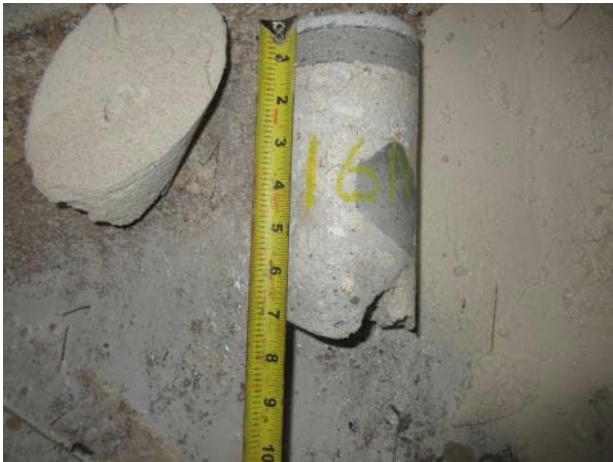
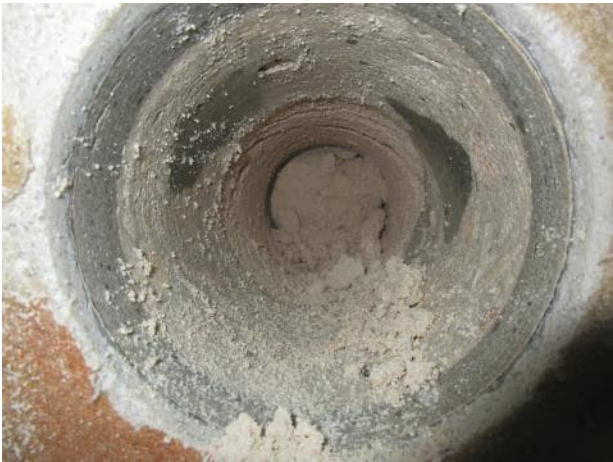
| 16N | 4 Dec 25 | Section 4; north wall | 5 1/2" – 7" | 4" |

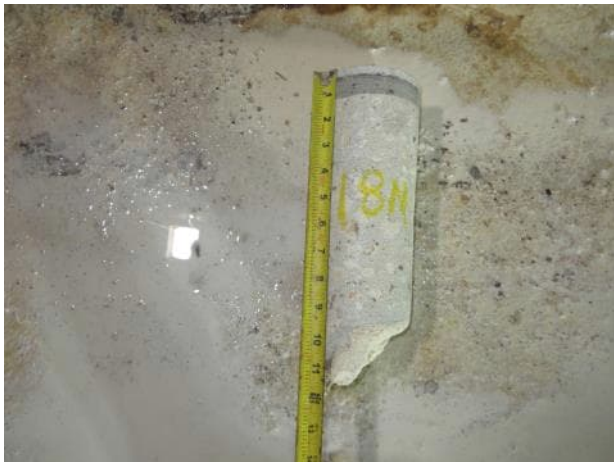
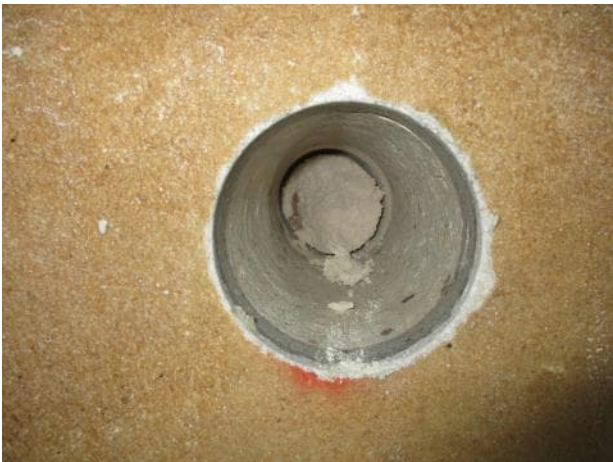
| 18N | 4 Dec 25 | Section 4; north wall | 9 ½" | 4" |

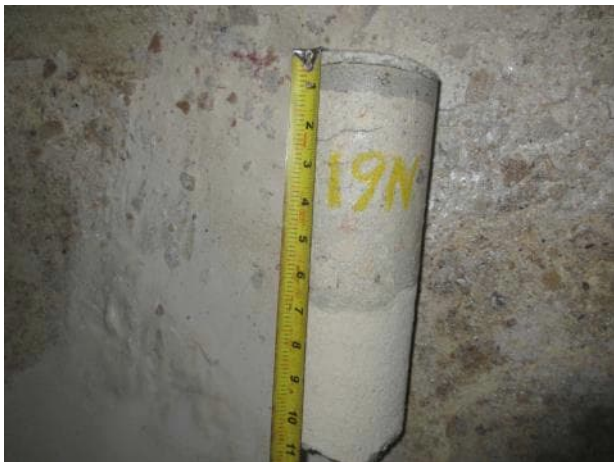
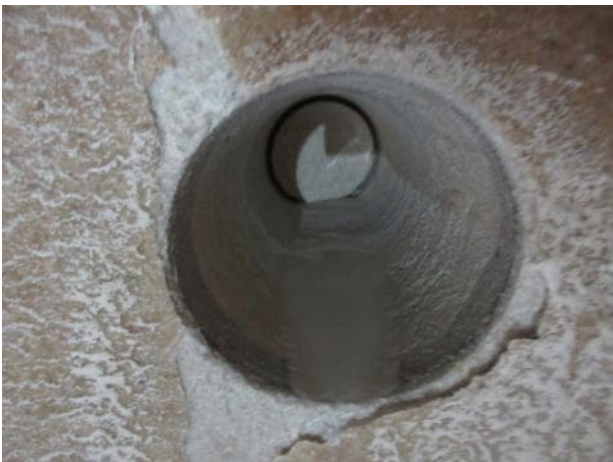
| 19N | 4 Dec 25 | Section 4; north wall | 6 ½" | 4" |

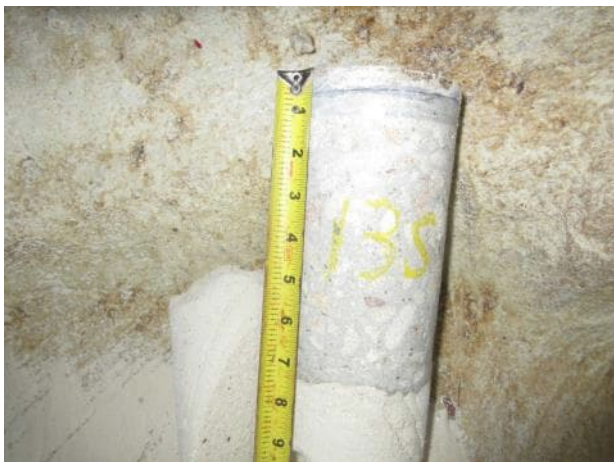
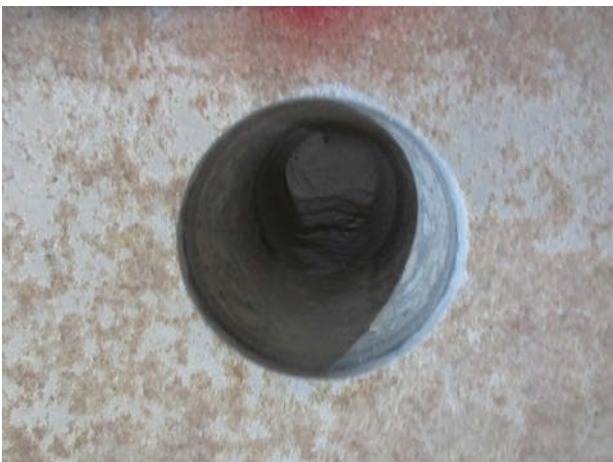
| 13S | 3 Dec 25 | Section 4; south wall | 7 ¼" | 4" |

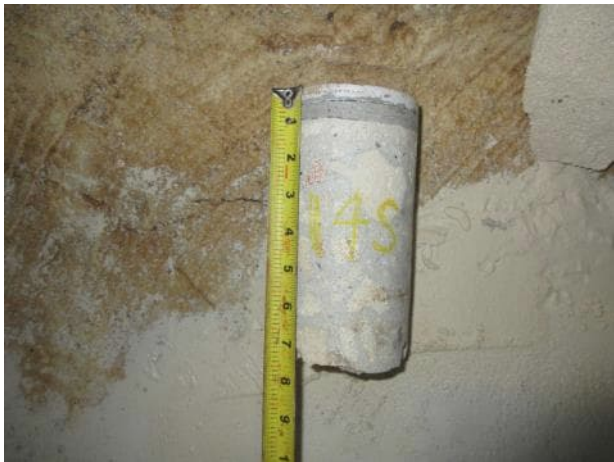
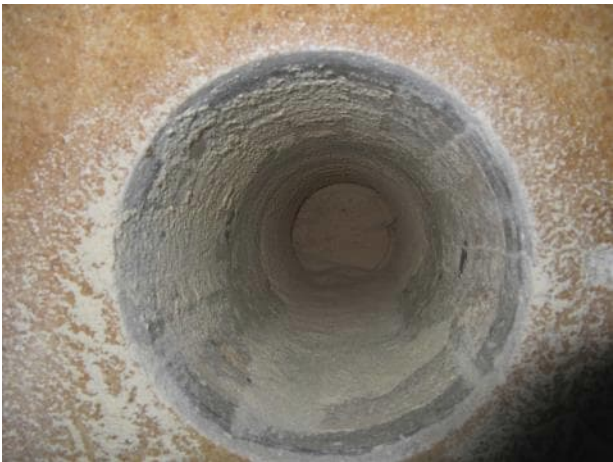
| 14S | 4 Dec 25 | Section 4; south wall | 7 ½" | 4" |

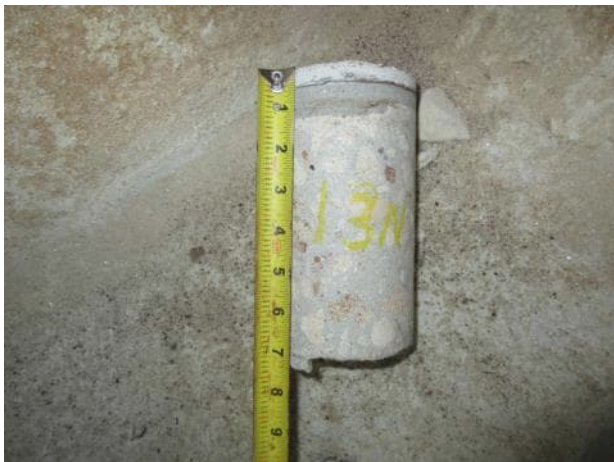
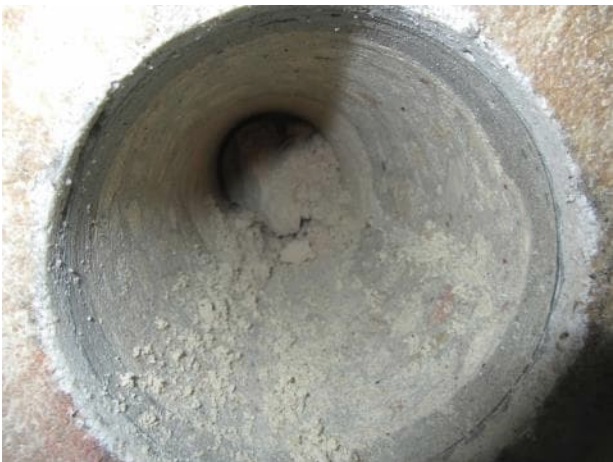
| 15S | 3 Dec 25 | Section 4; south wall | 8 ½" | 4" |

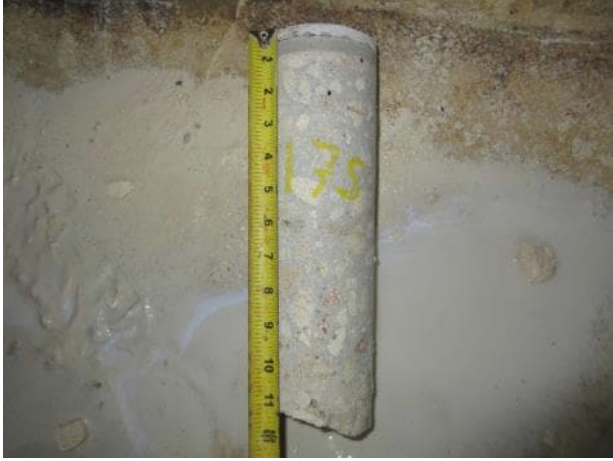
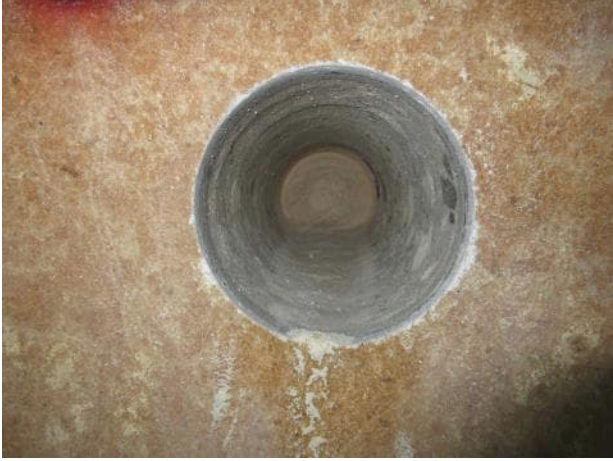
| 17S | 3 Dec 25 | Section 4; south wall | 11 ¼" | 4" |

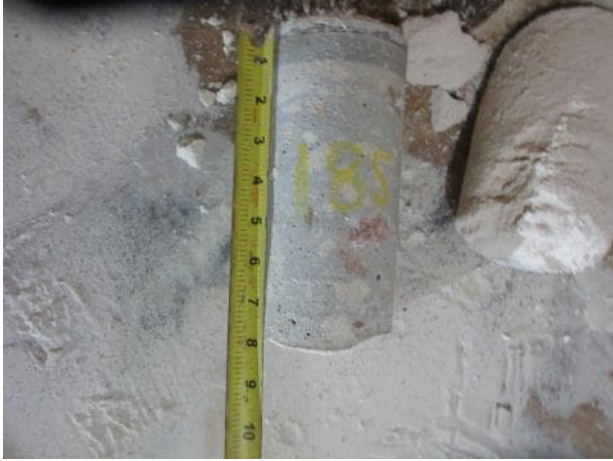
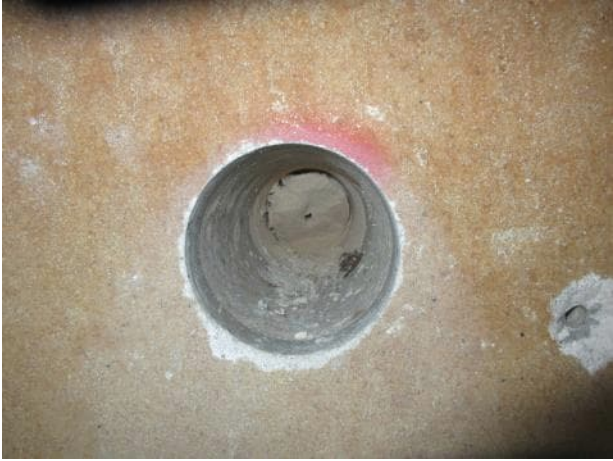
| 18S | 3 Dec 25 | Section 4; south wall | 8" | 4" |

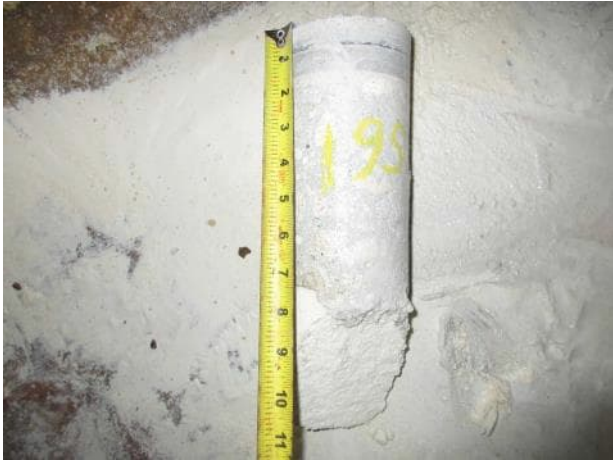
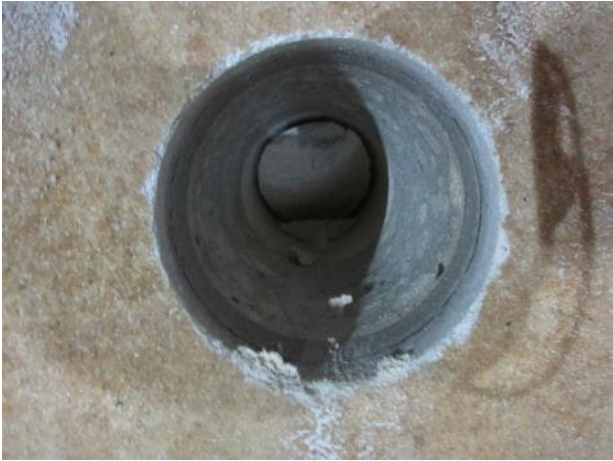
| 19S | 3 Dec 25 | Section 4; north wall | 7 ¼" | 4" |
